Bald Eagle Lake Drain

Condition Assessment Report
Prepared By: Geoff S. Wilson, P.E.

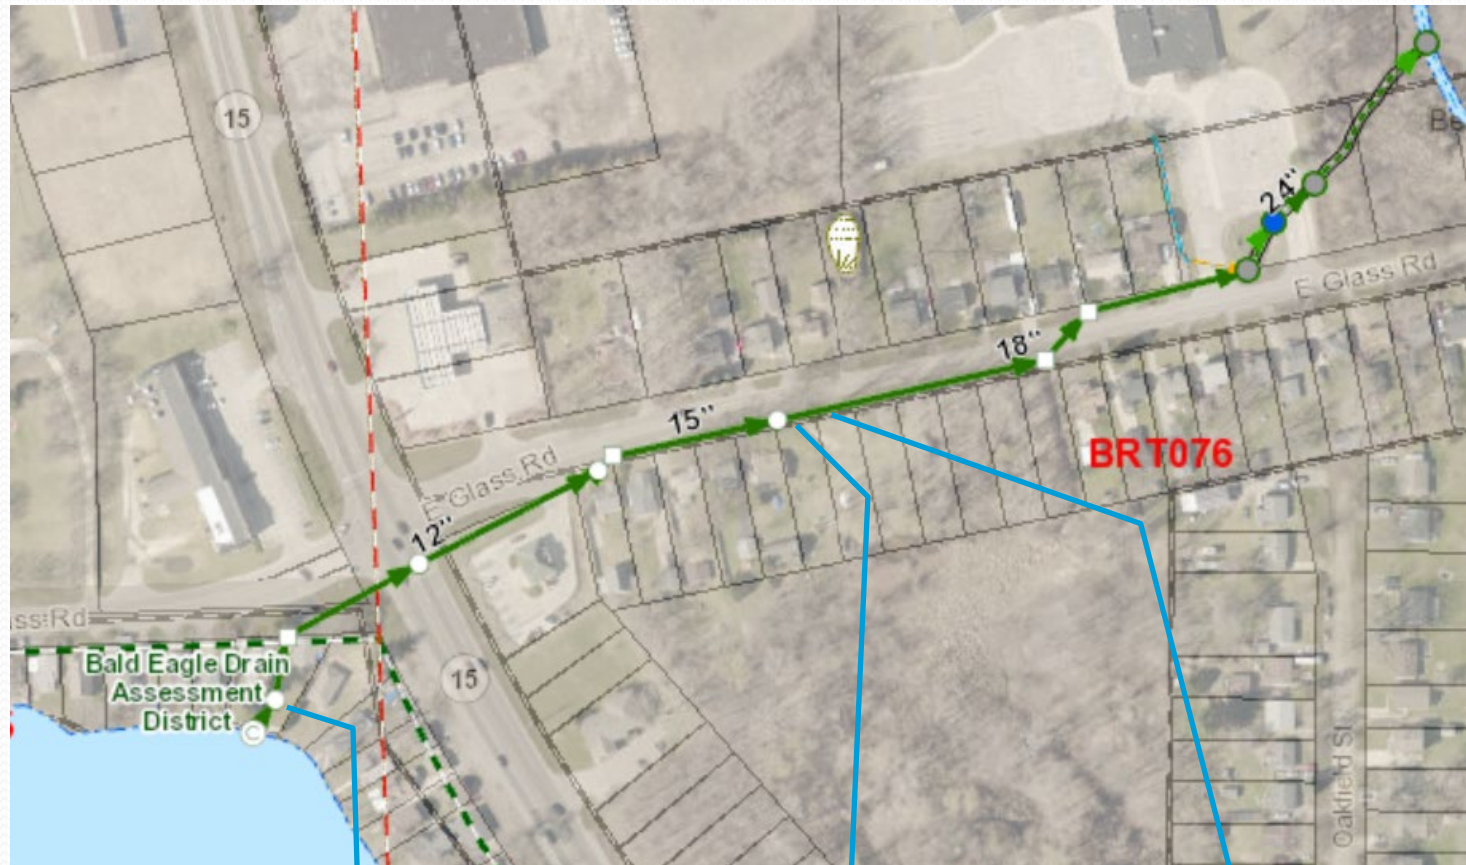
Emergency 1: Pipe
failure and lake
structure replacement

Emergency 2:
Pipe failure

Emergency 3:
Pipe failure

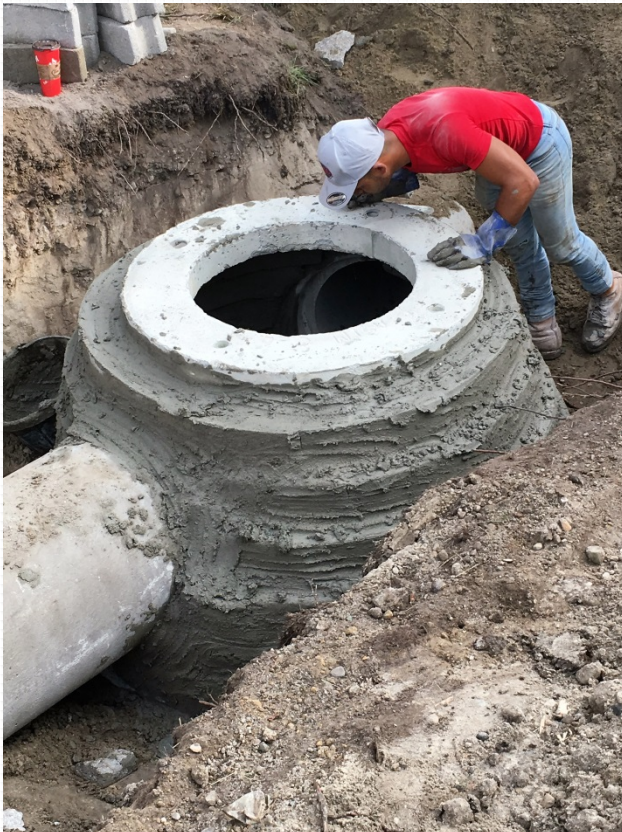
Emergency 1: Pipe and structure construction to replace failed pipe

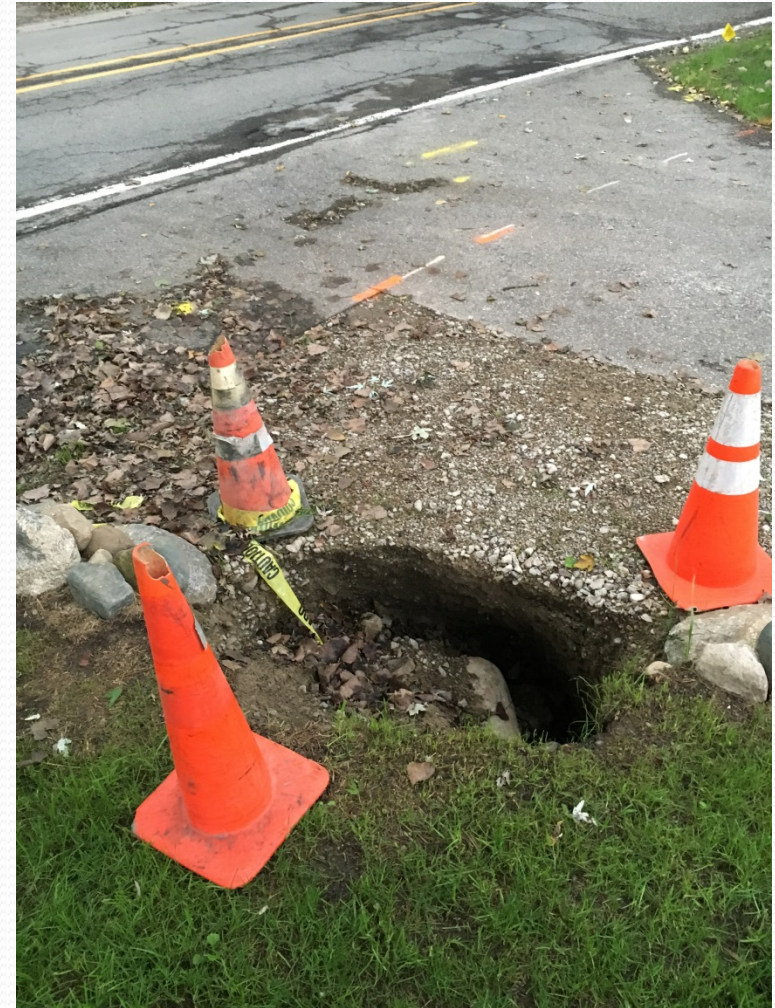
Emergency 3: Sinkhole over failed pipe

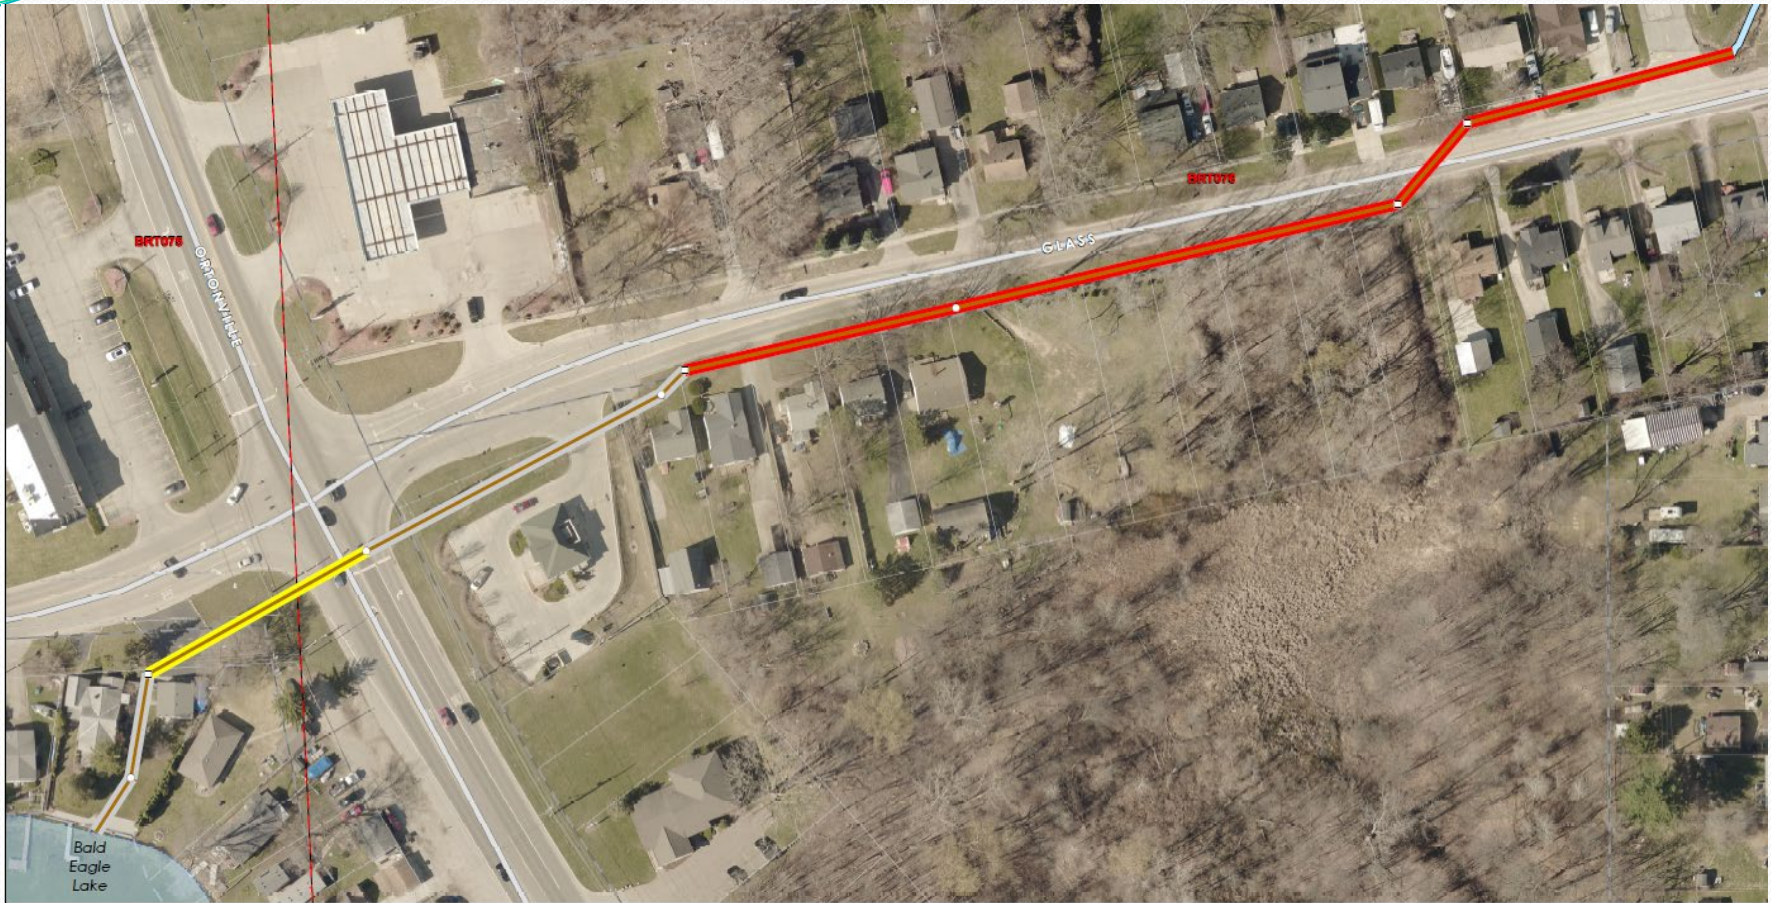
Condition Assessment Map

- Segments with a “5” rating are the most severely deteriorated.
- Segments unable to be assessed were due to severe deterioration.

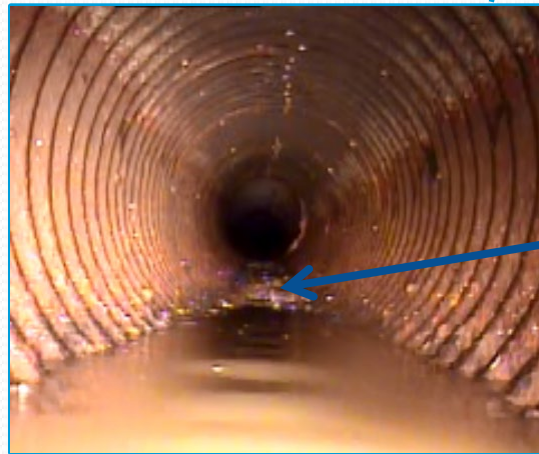
- Typical conditions include corroded metal and small but frequent holes and voids in the pipe.
- Once holes and voids are present, conditions deteriorate rapidly and sinkholes begin to form.
- Sinkholes are expensive to fix and risk property and utility damage.

View from inside of pipe (looking upstream)

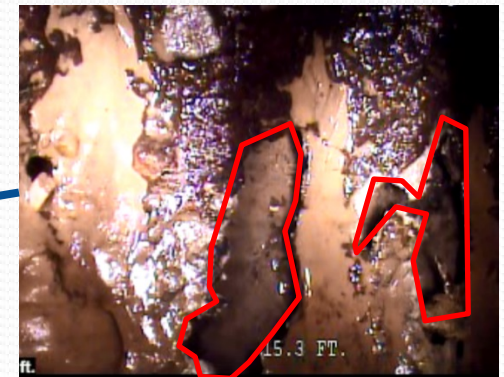
View of pipe wall (soil visible beyond holes)

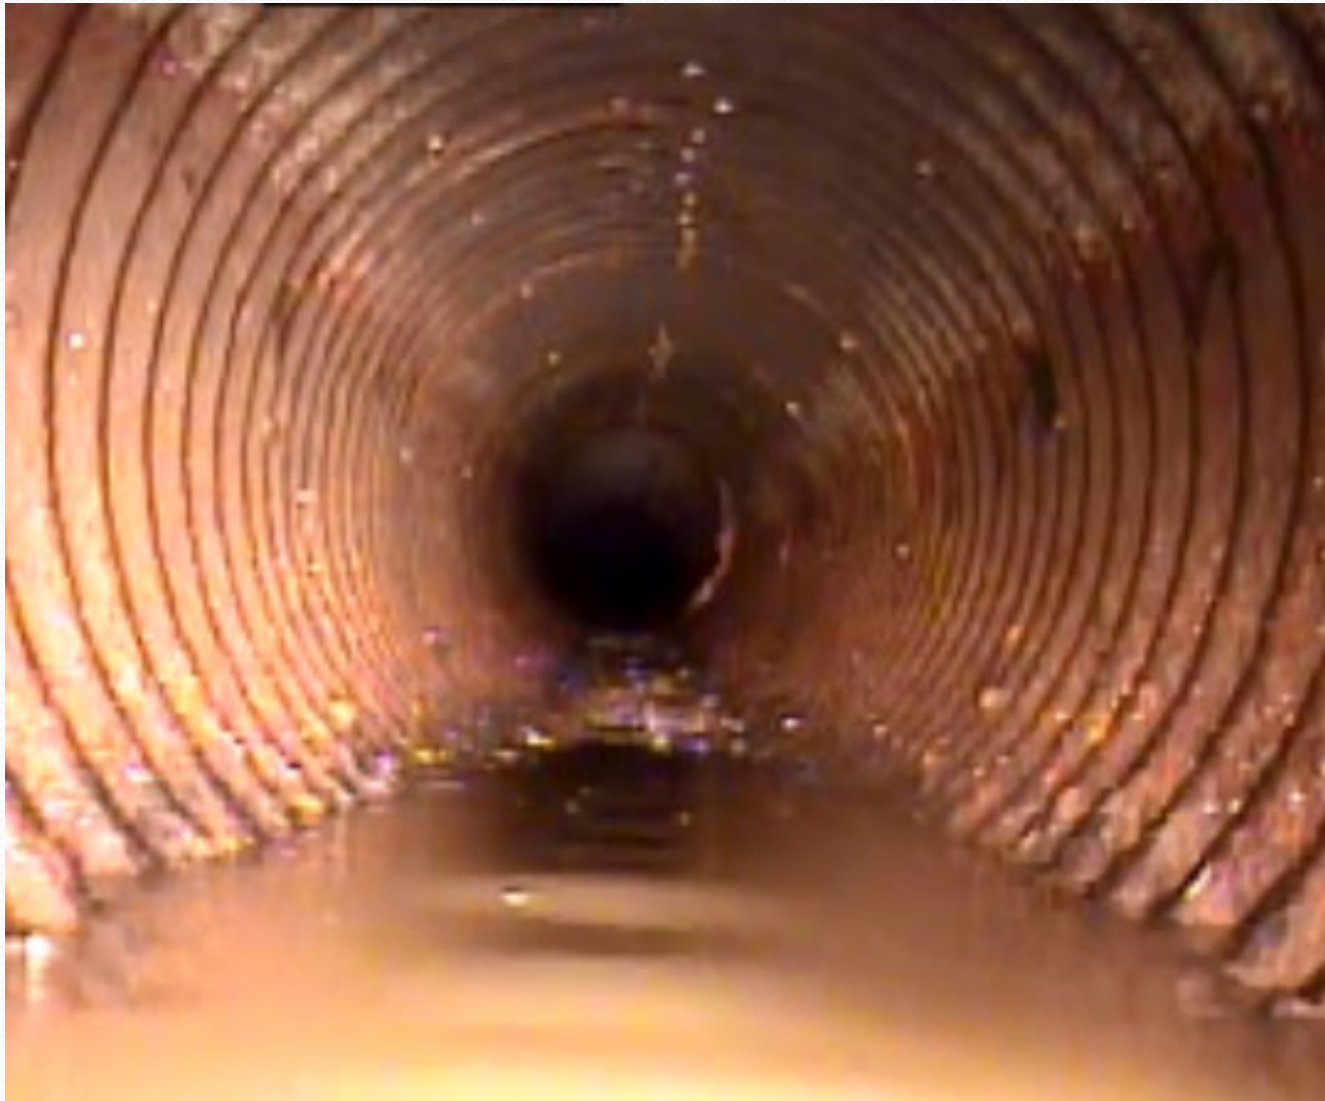
View from inside of pipe (looking upstream)

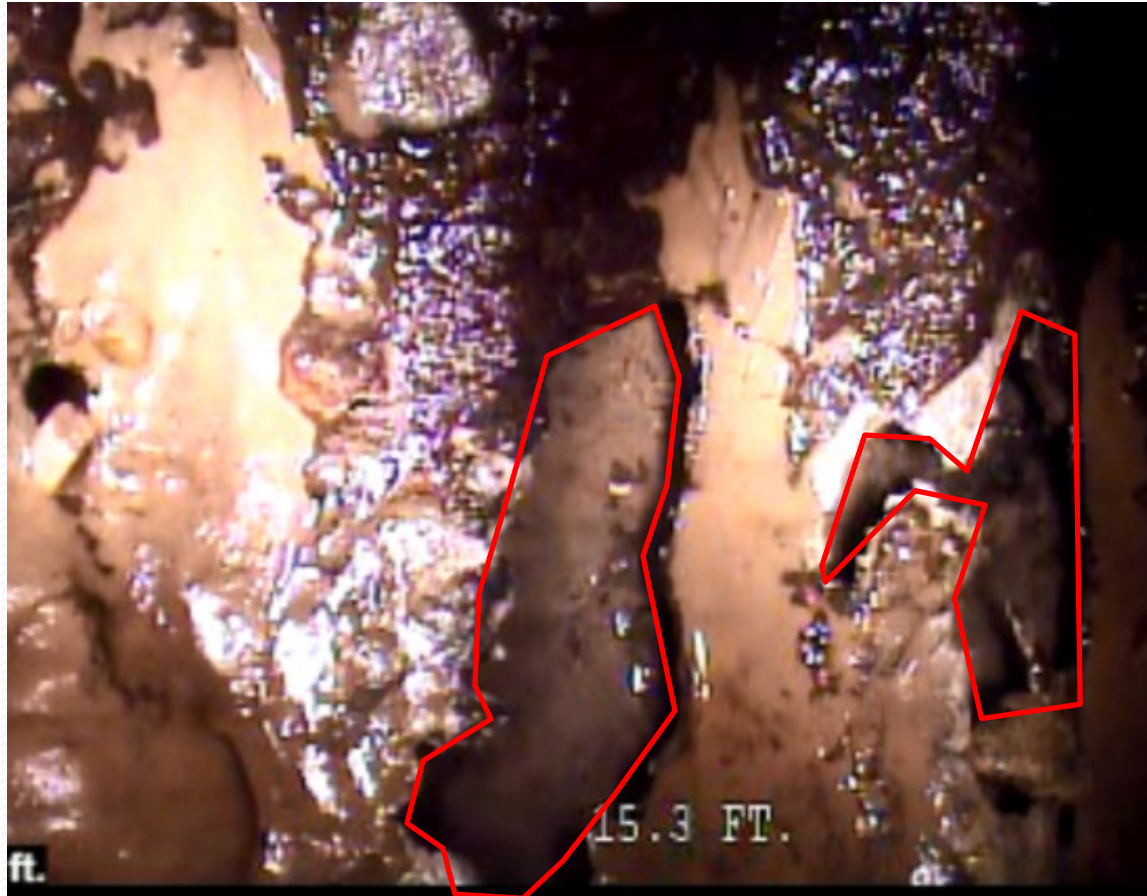
View of pipe wall (soil visible beyond holes)
