Subject: GWK Permit – Red Run Drain Flooding

# **RED RUN INTERCOUNTY DRAIN**

UAS FLIGHT, PROCESS, AND BANK  
CONDITIONS

**Hubbell, Roth & Clark, Inc.**

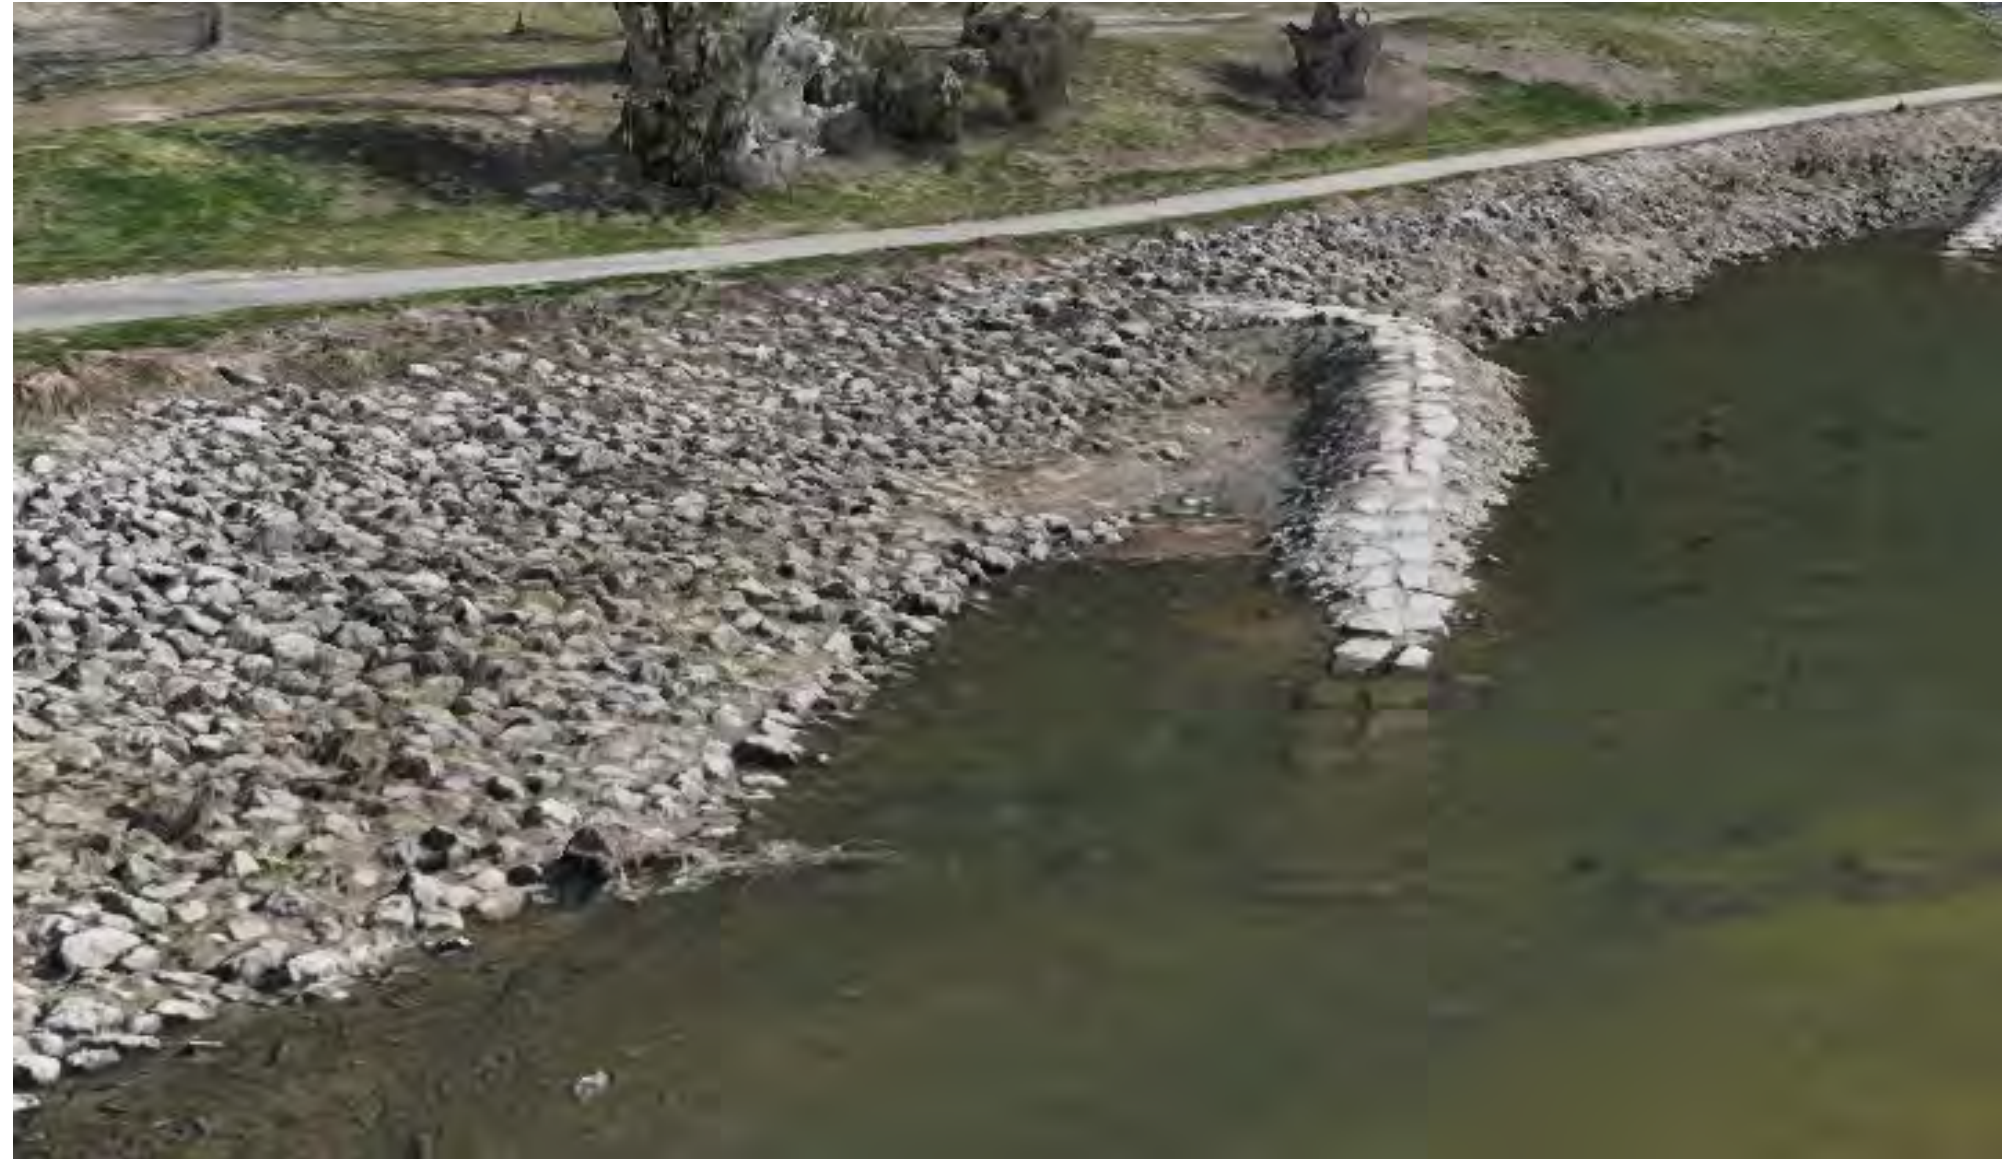
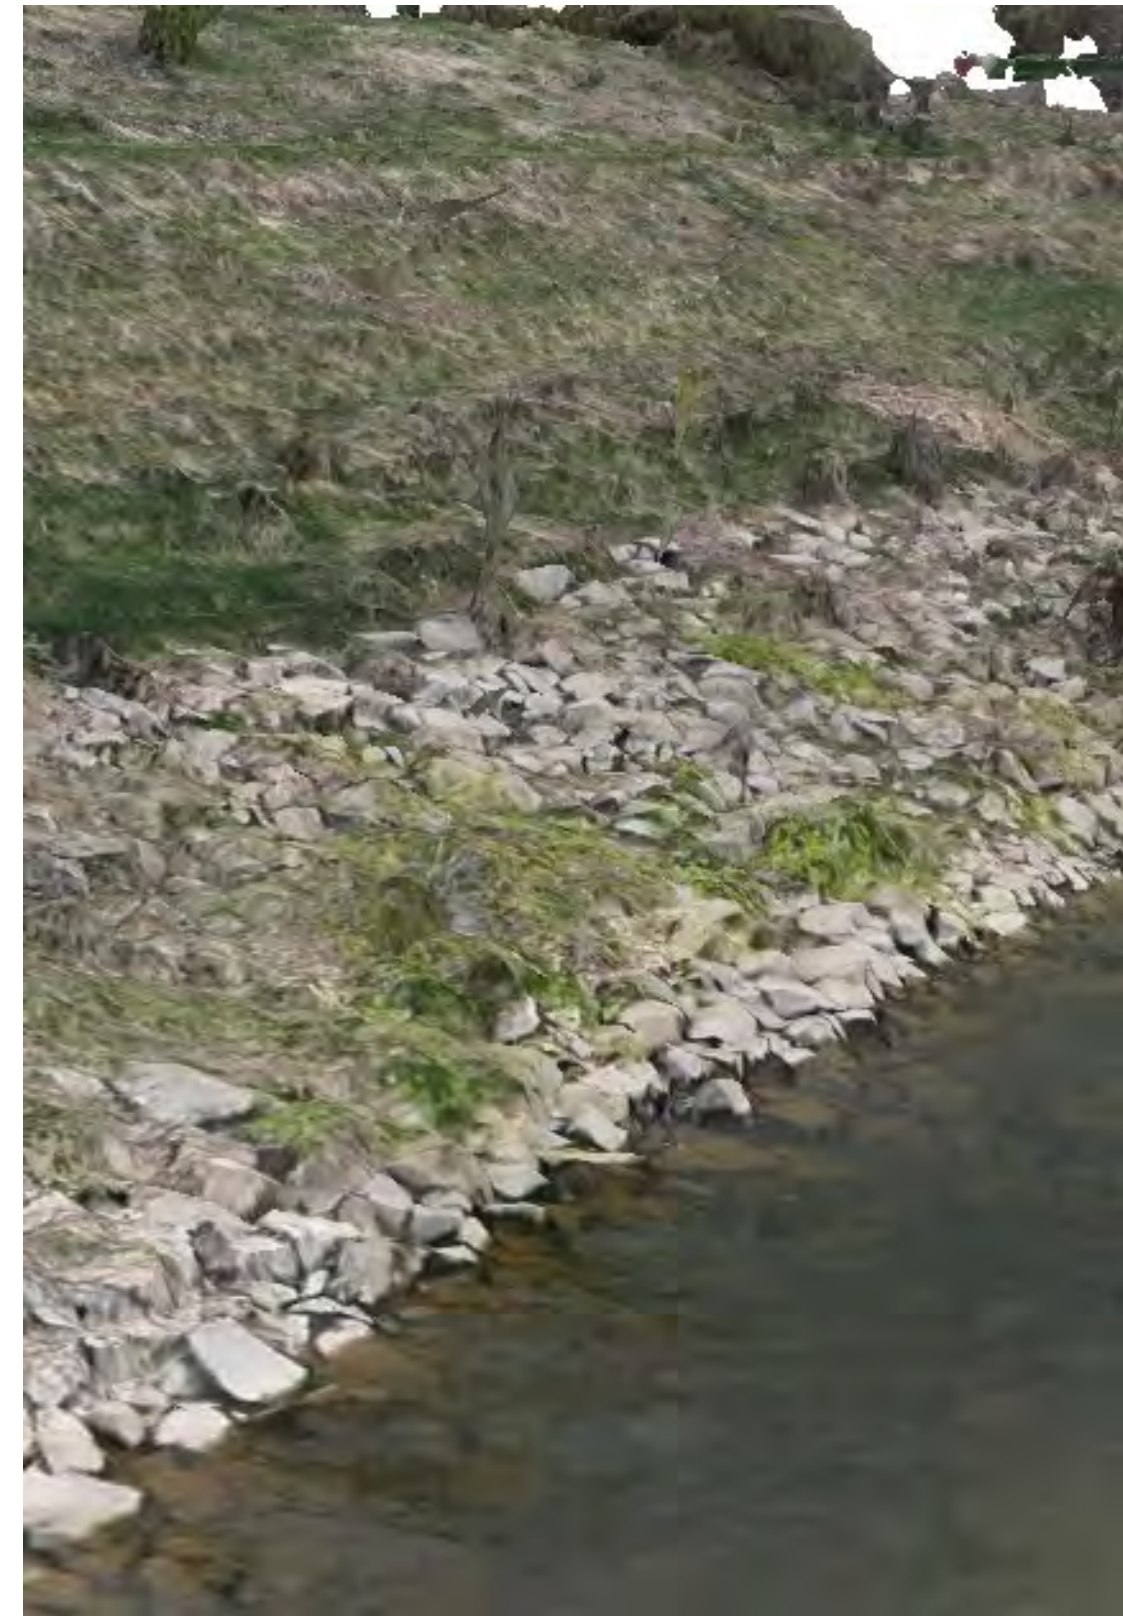
# **BANK CONDITION – No Erosion**

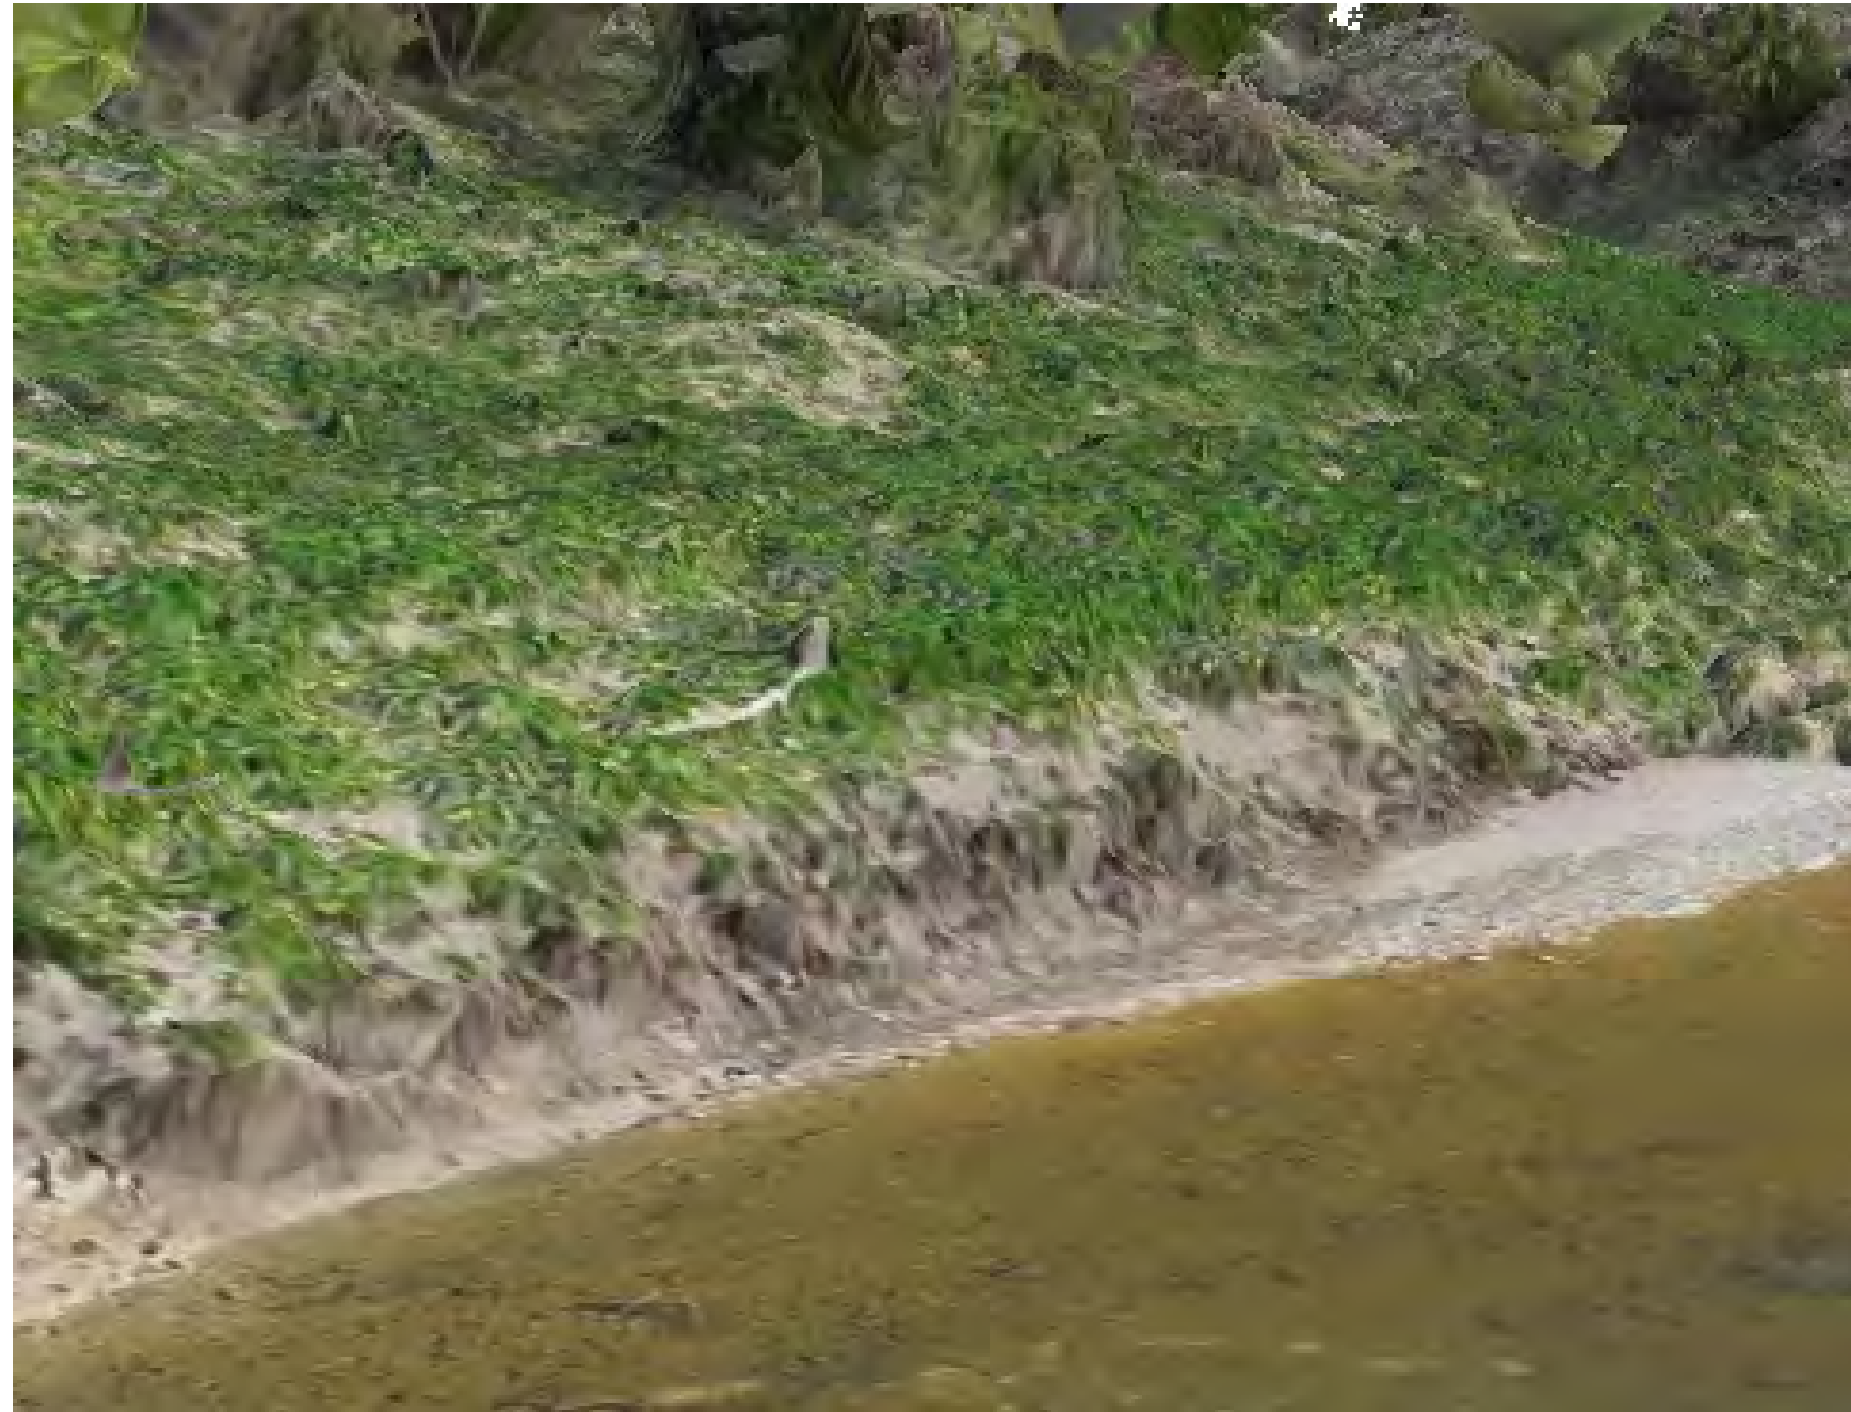
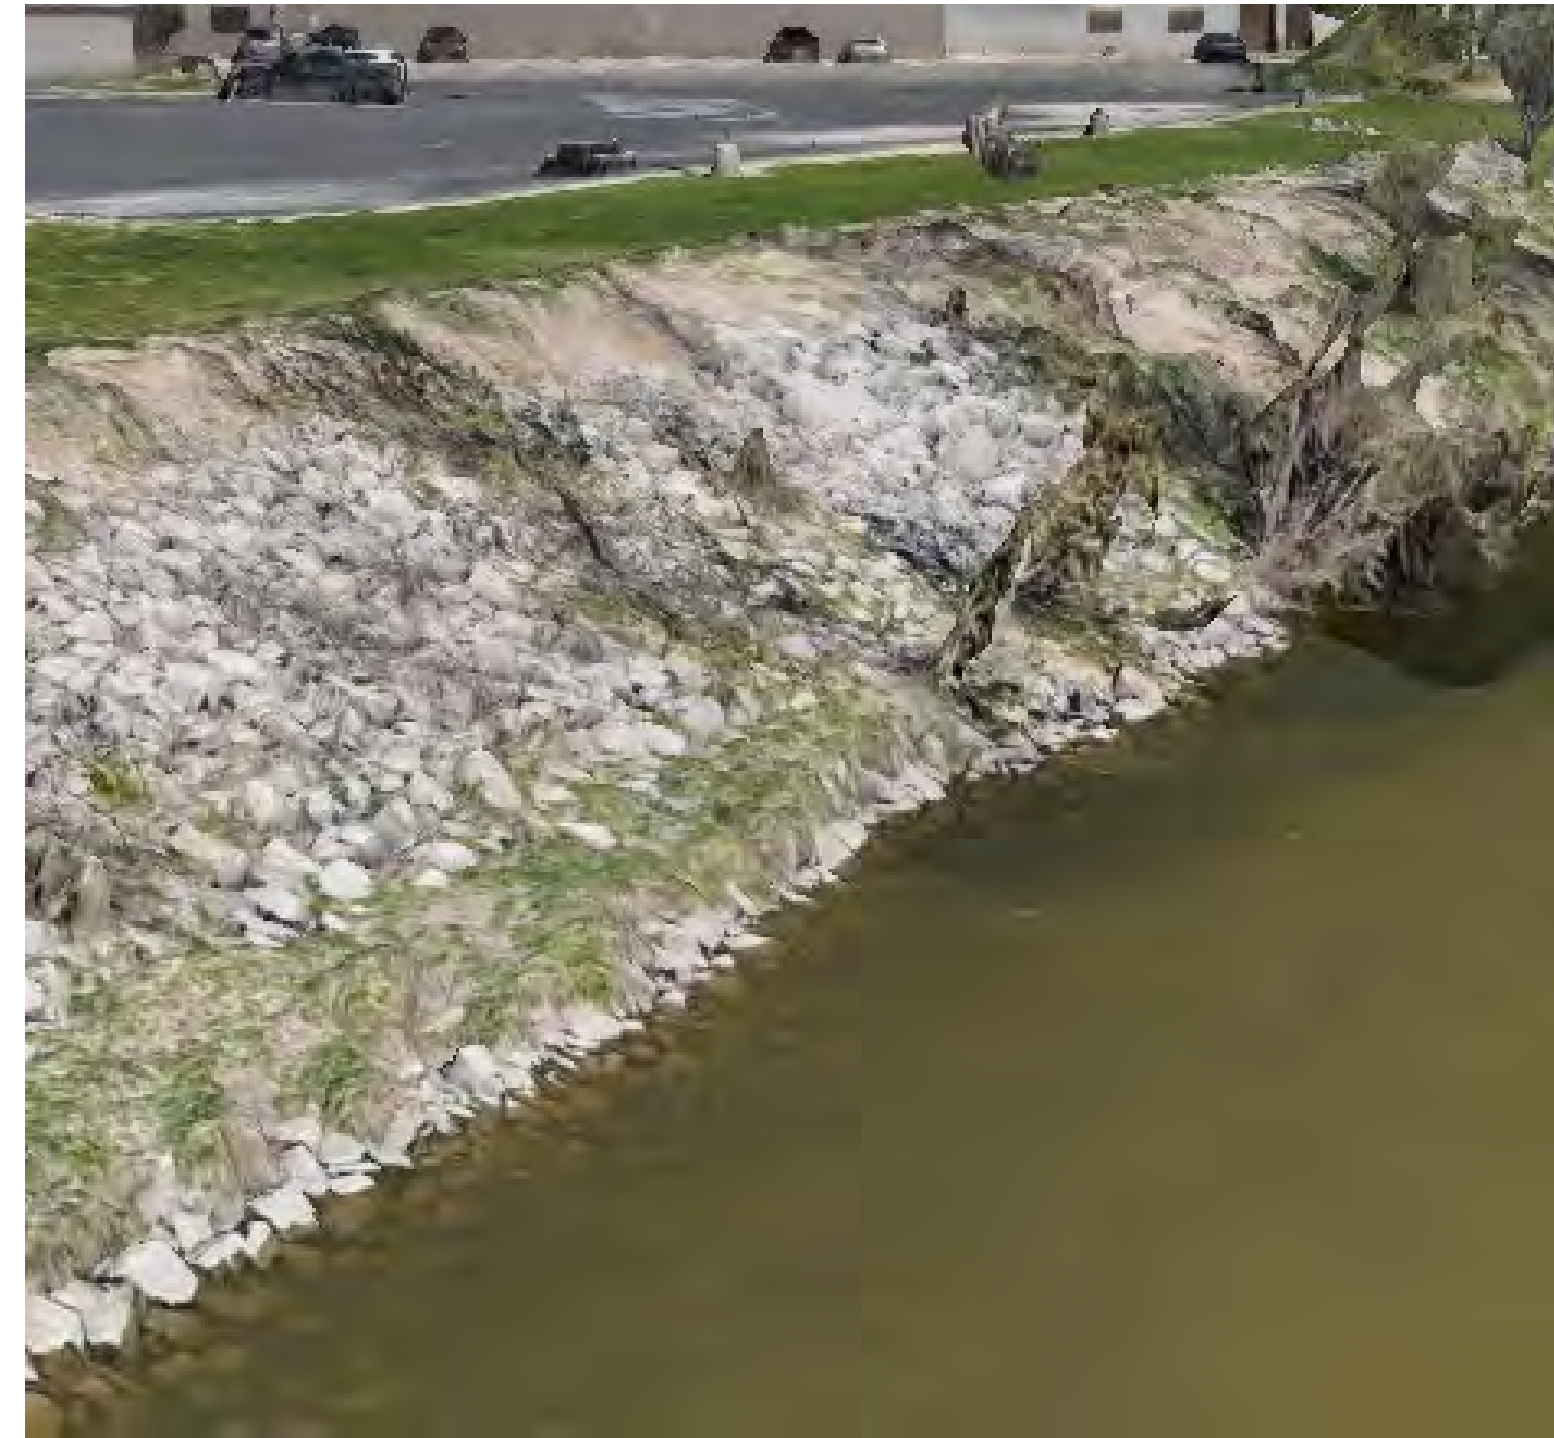
## **BANK CONDITION – Mild Erosion**

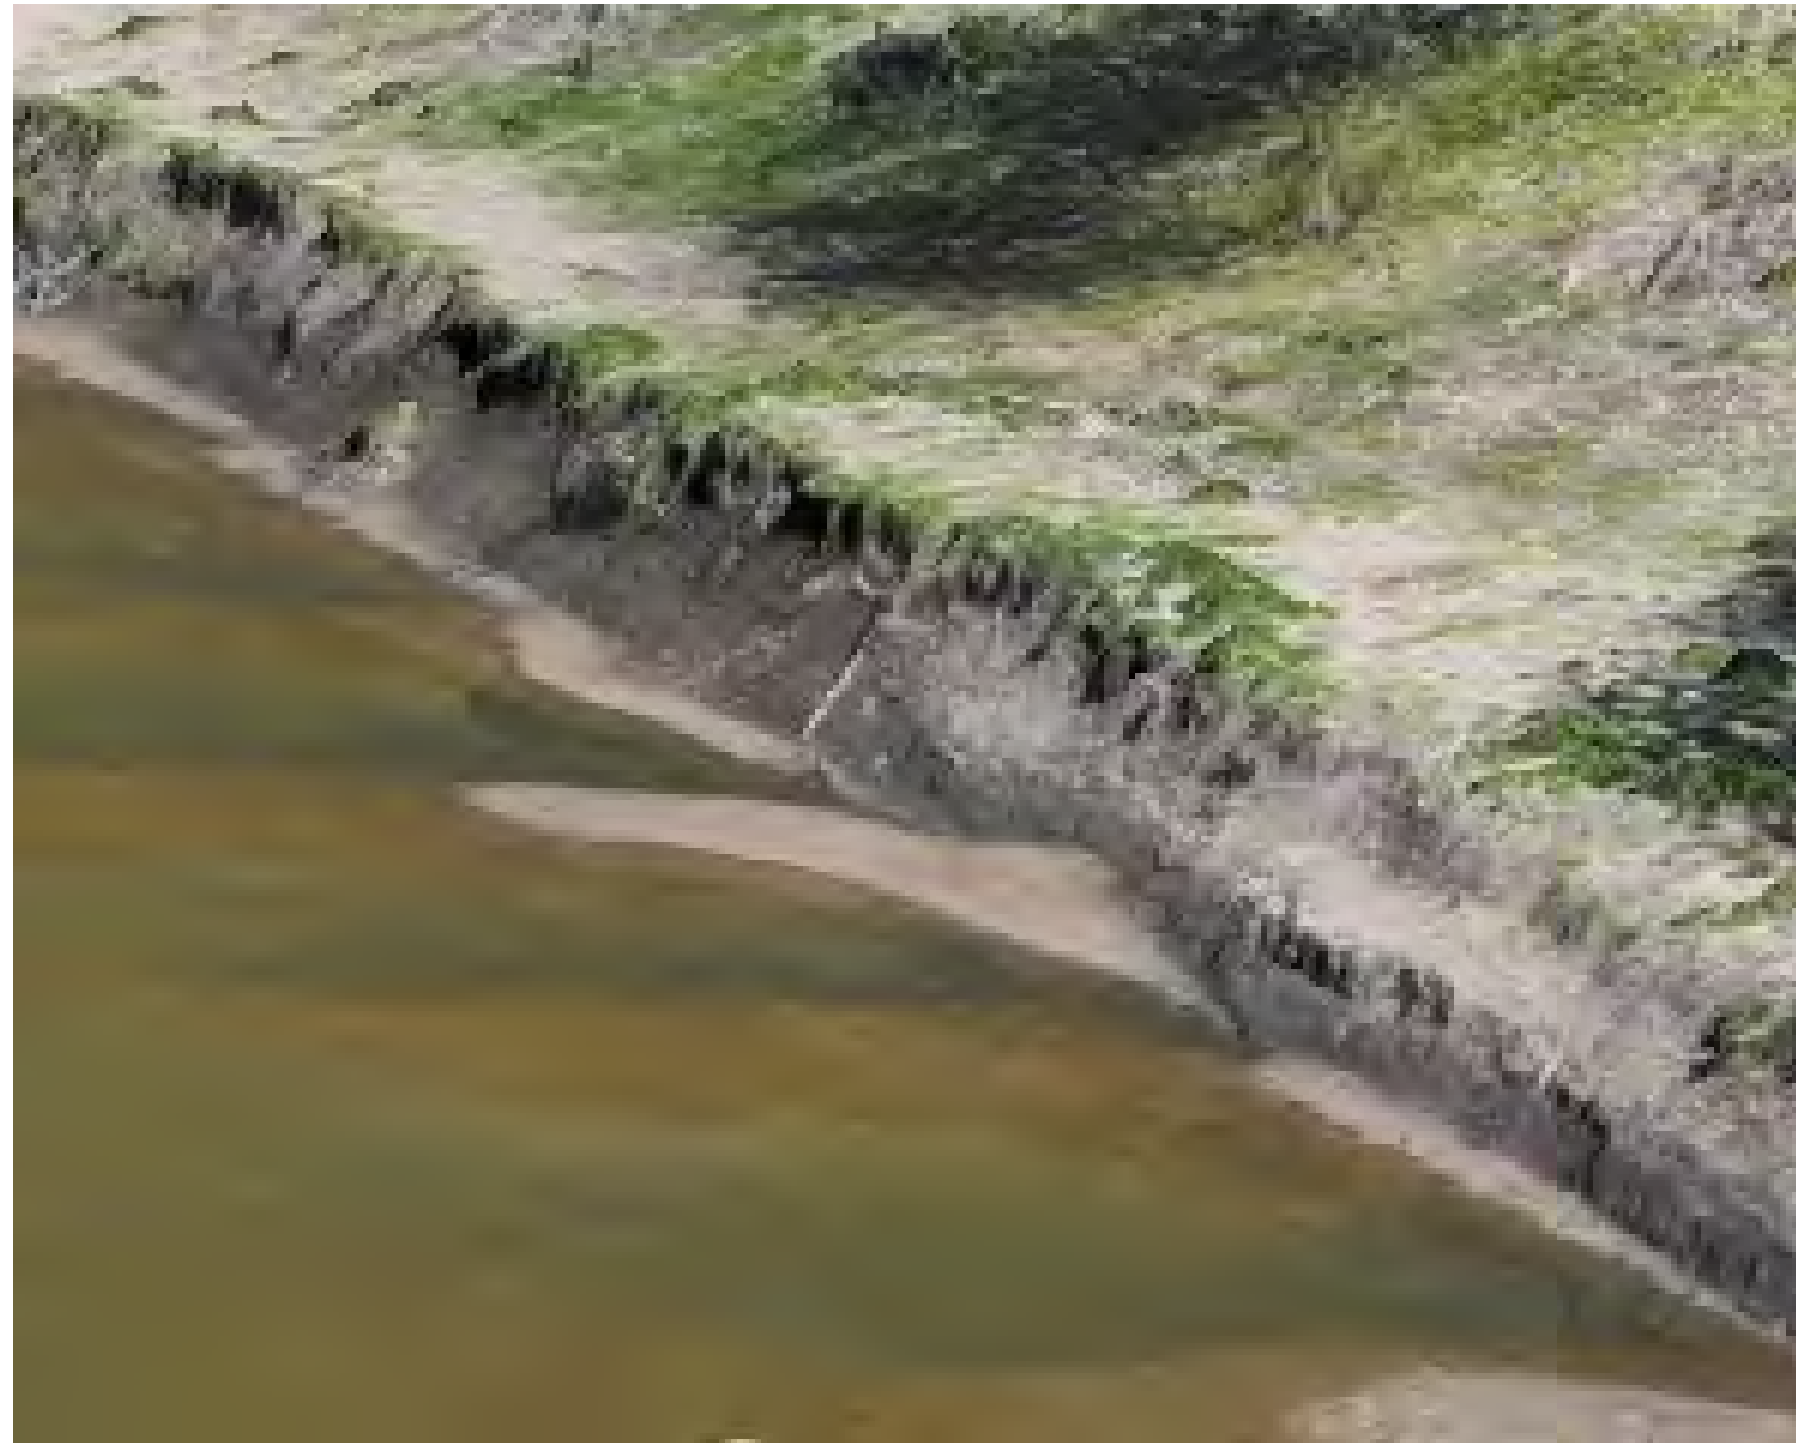
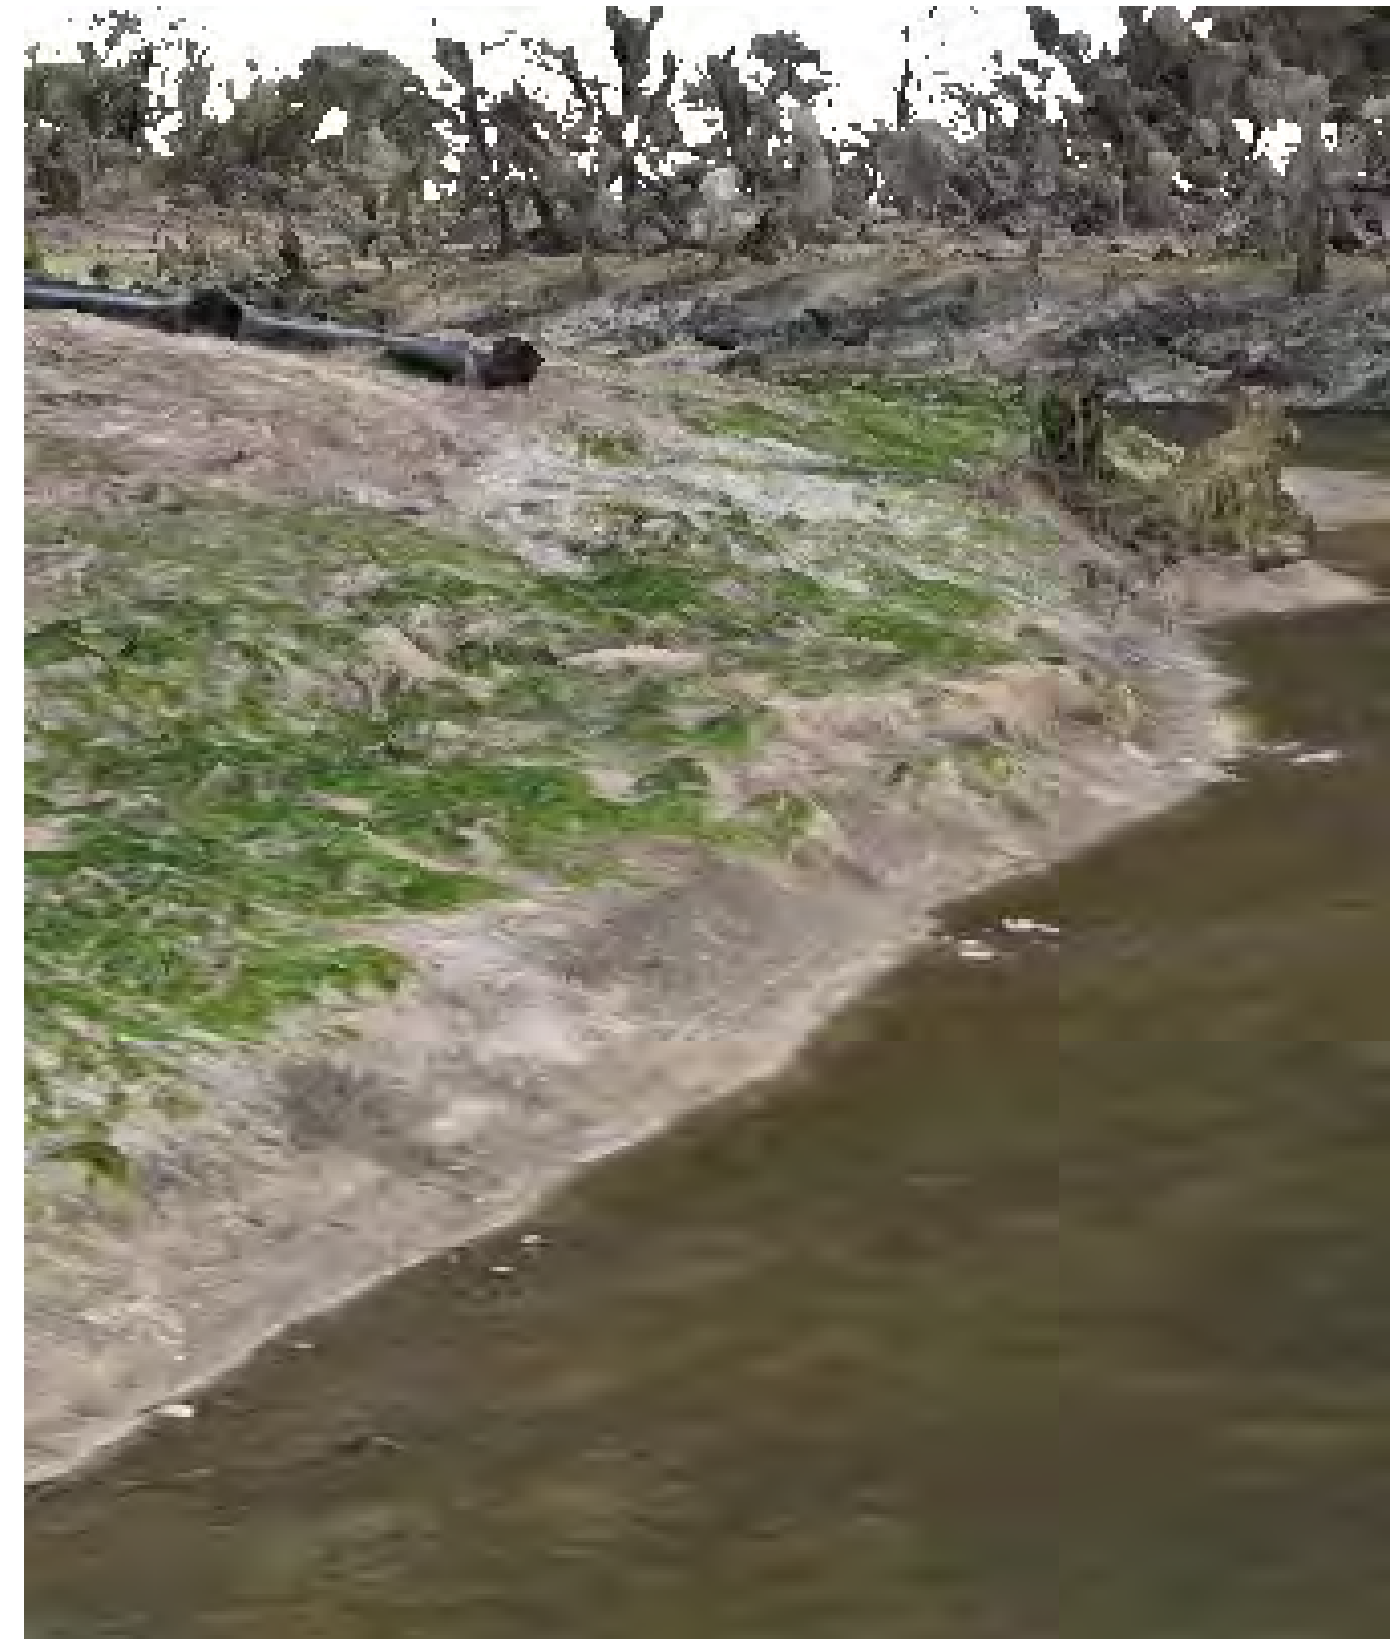
## **BANK CONDITION – Mild Erosion**

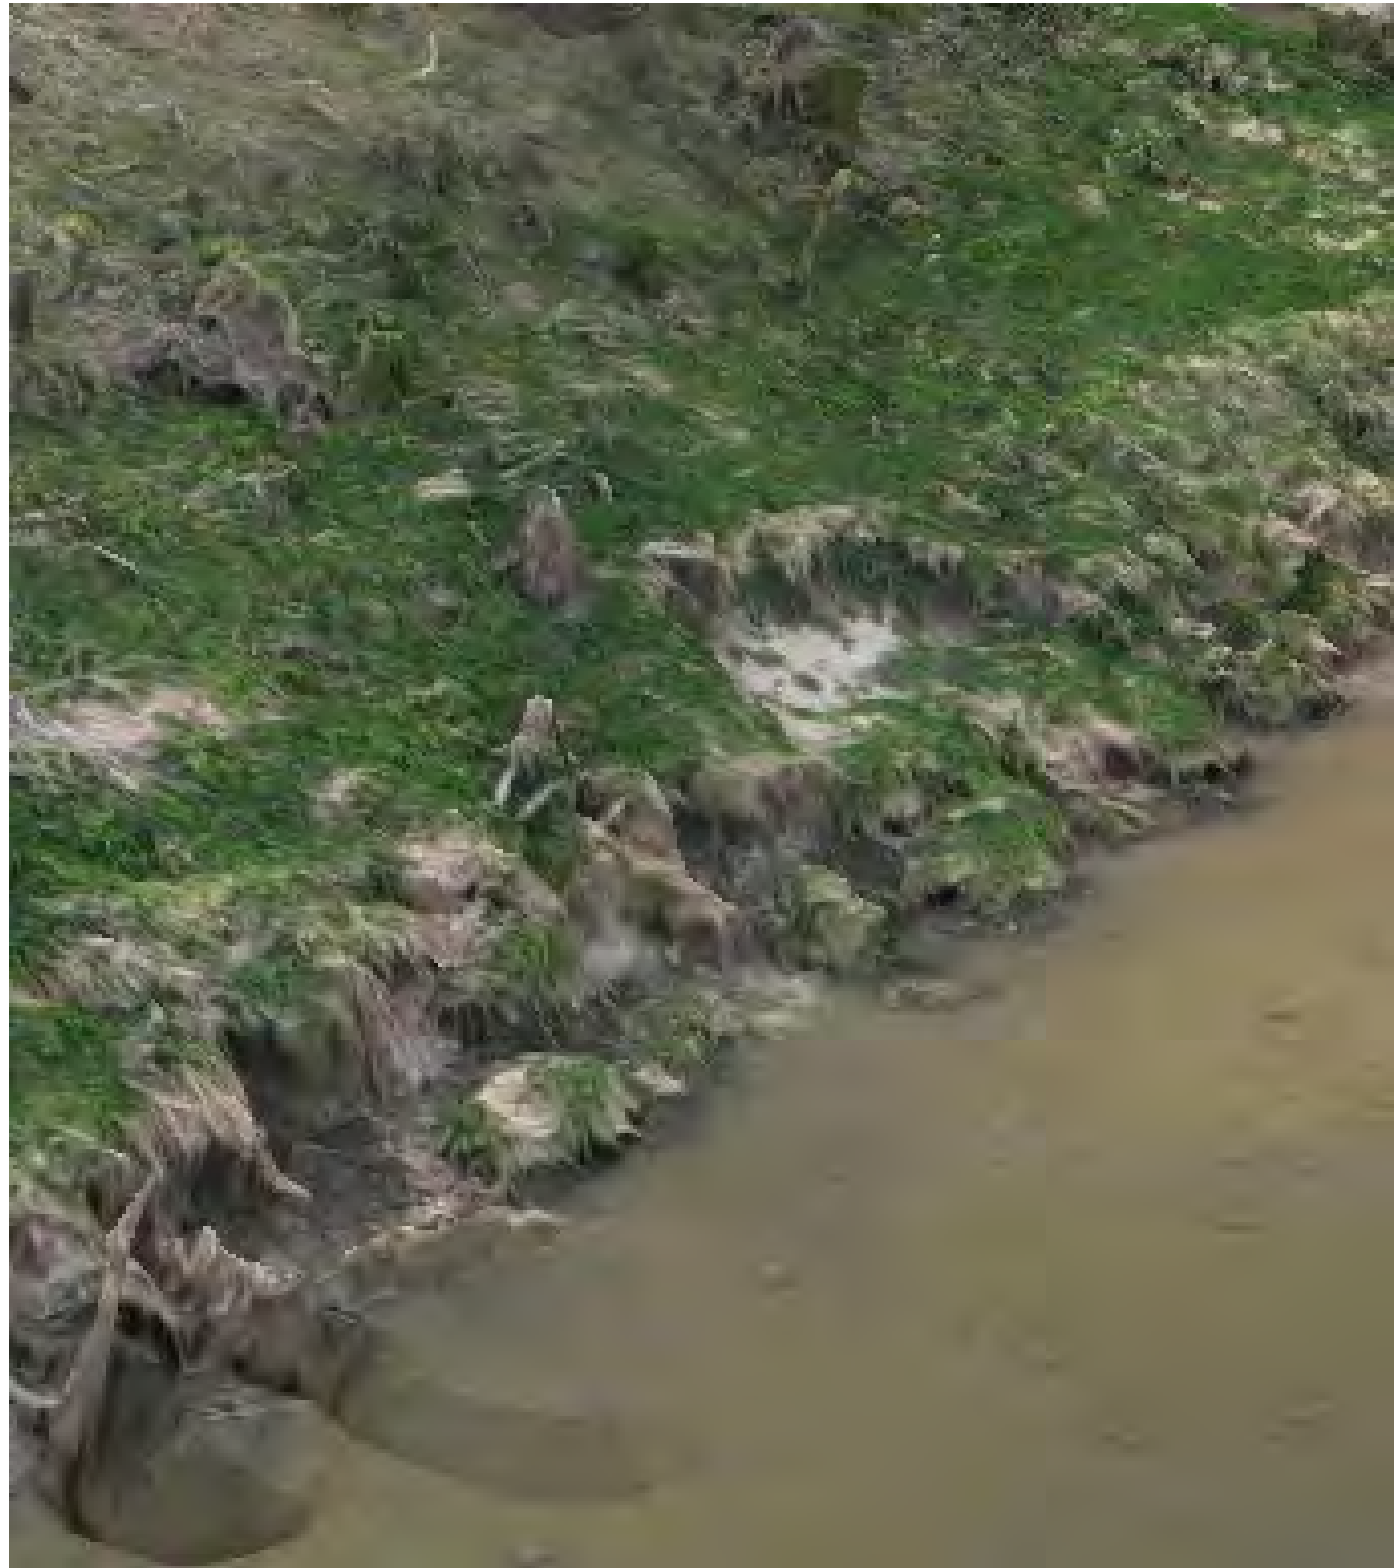
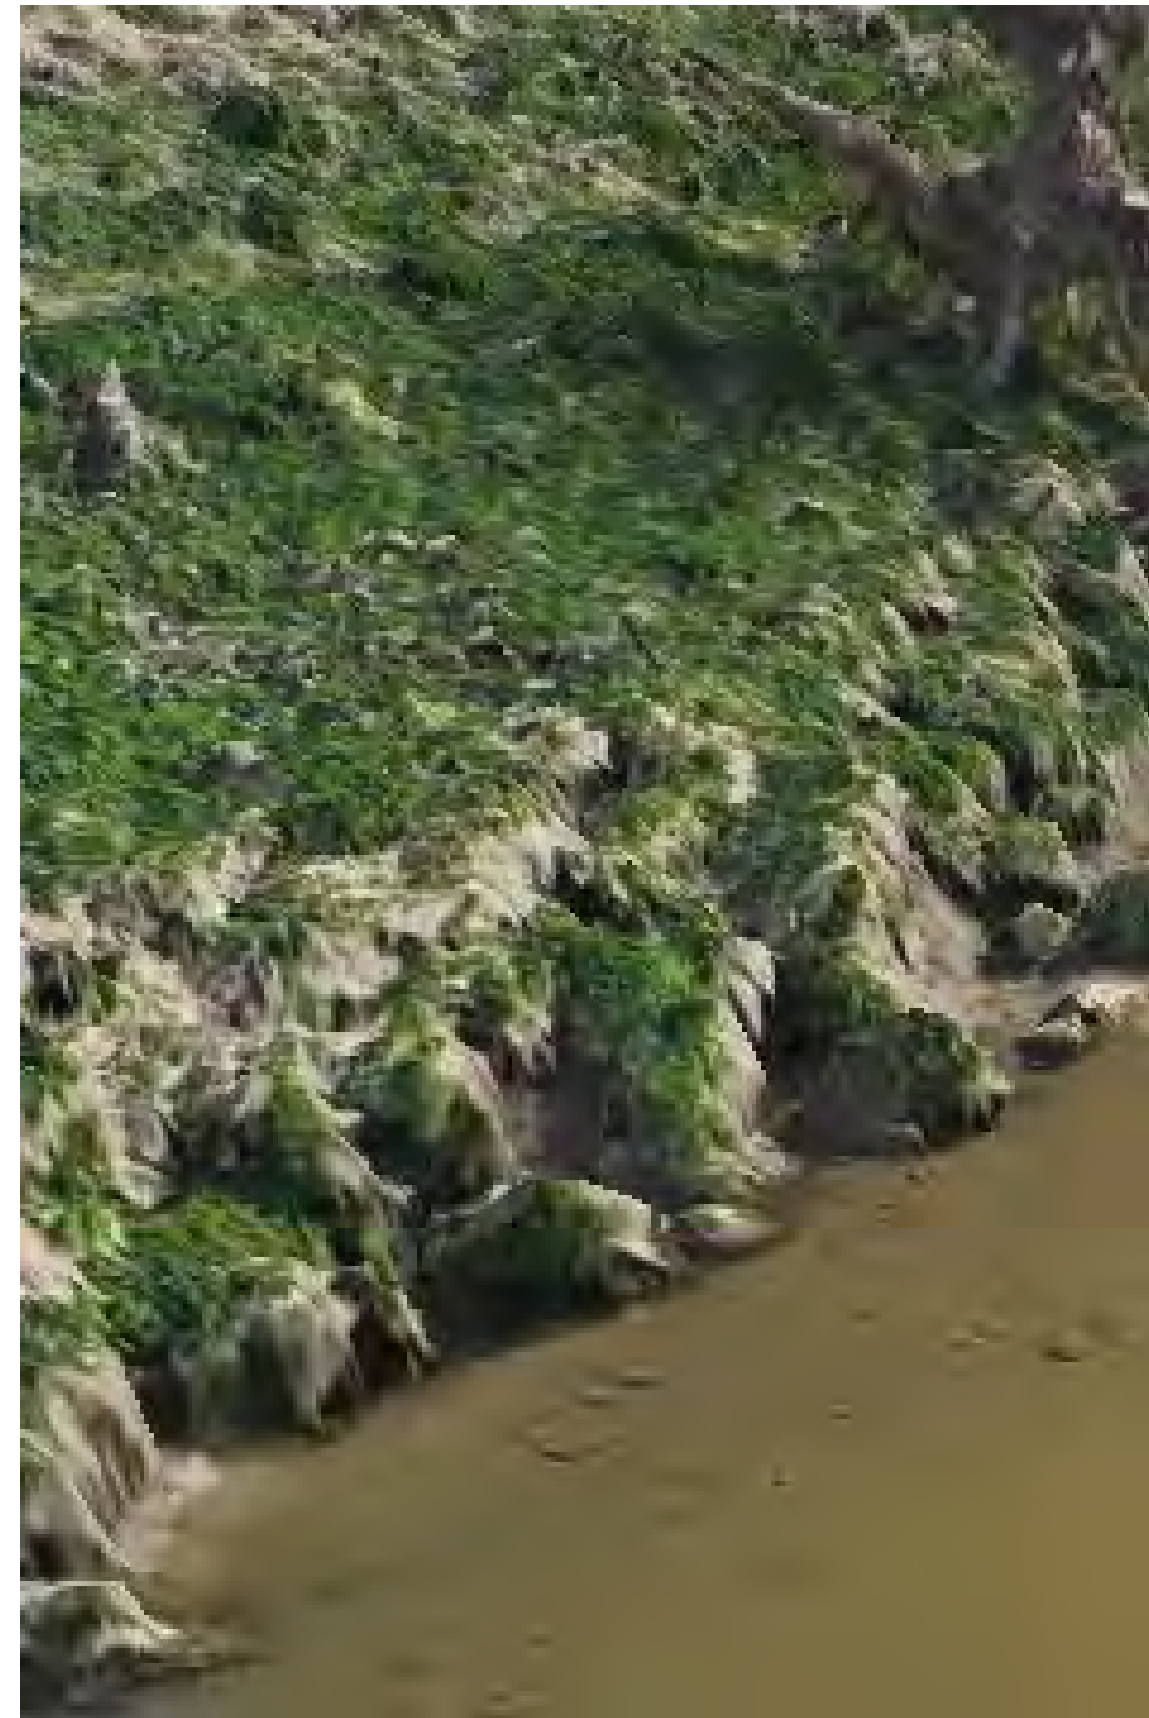
## **BANK CONDITION – Mild Erosion**
