Subject: GWK Permit – Red Run Drain Flooding

# **RED RUN INTERCOUNTY DRAIN**

UAS FLIGHT, PROCESS, AND BANK  
CONDITIONS

**Hubbell, Roth & Clark, Inc.**

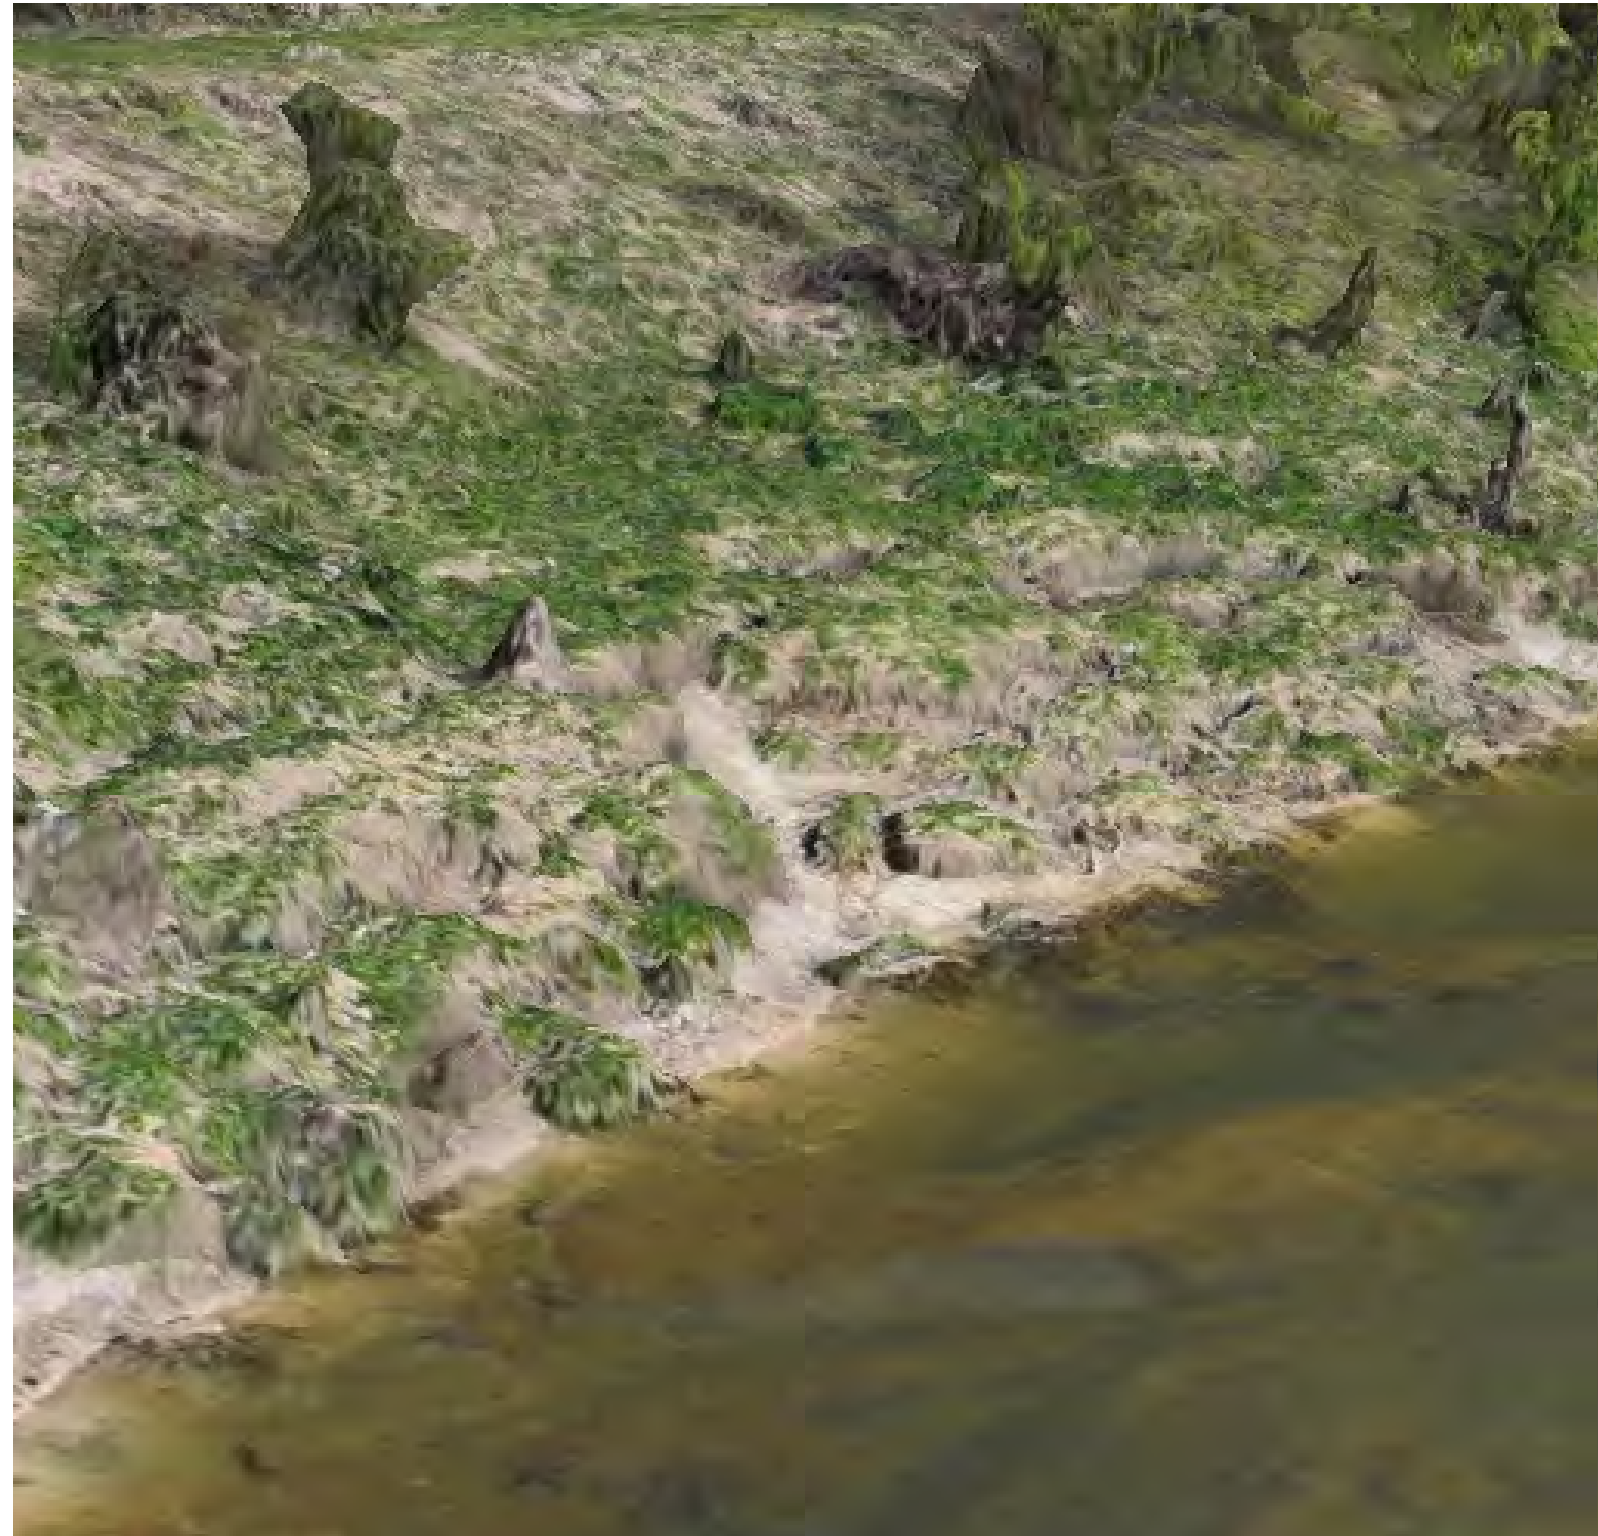
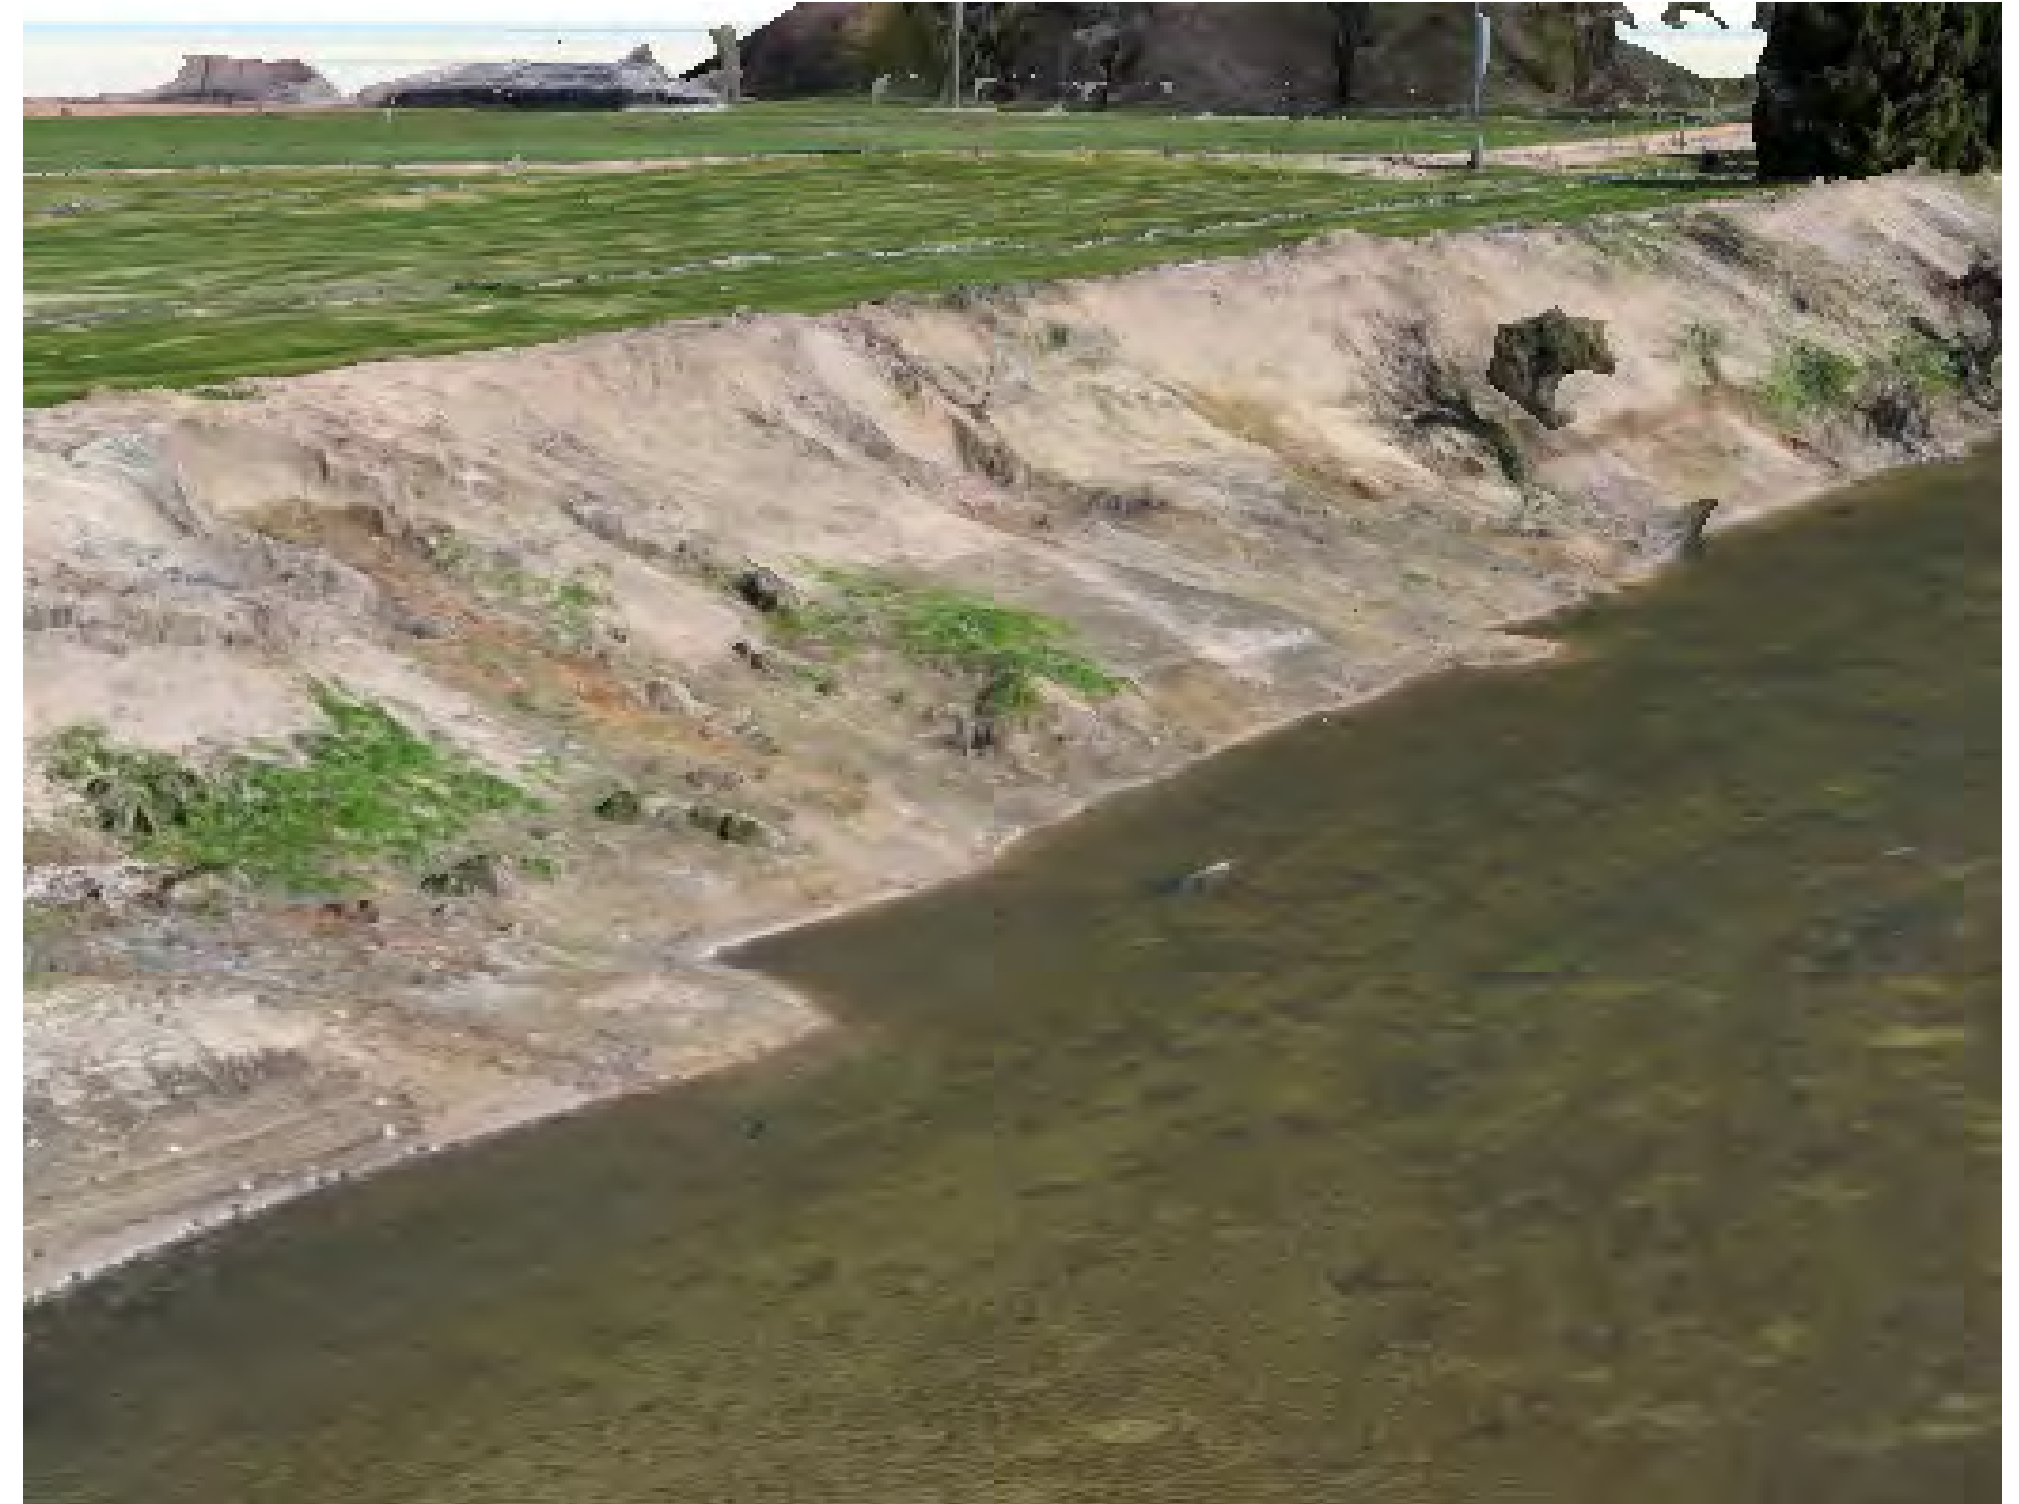
## **BANK CONDITION – Moderate Erosion**

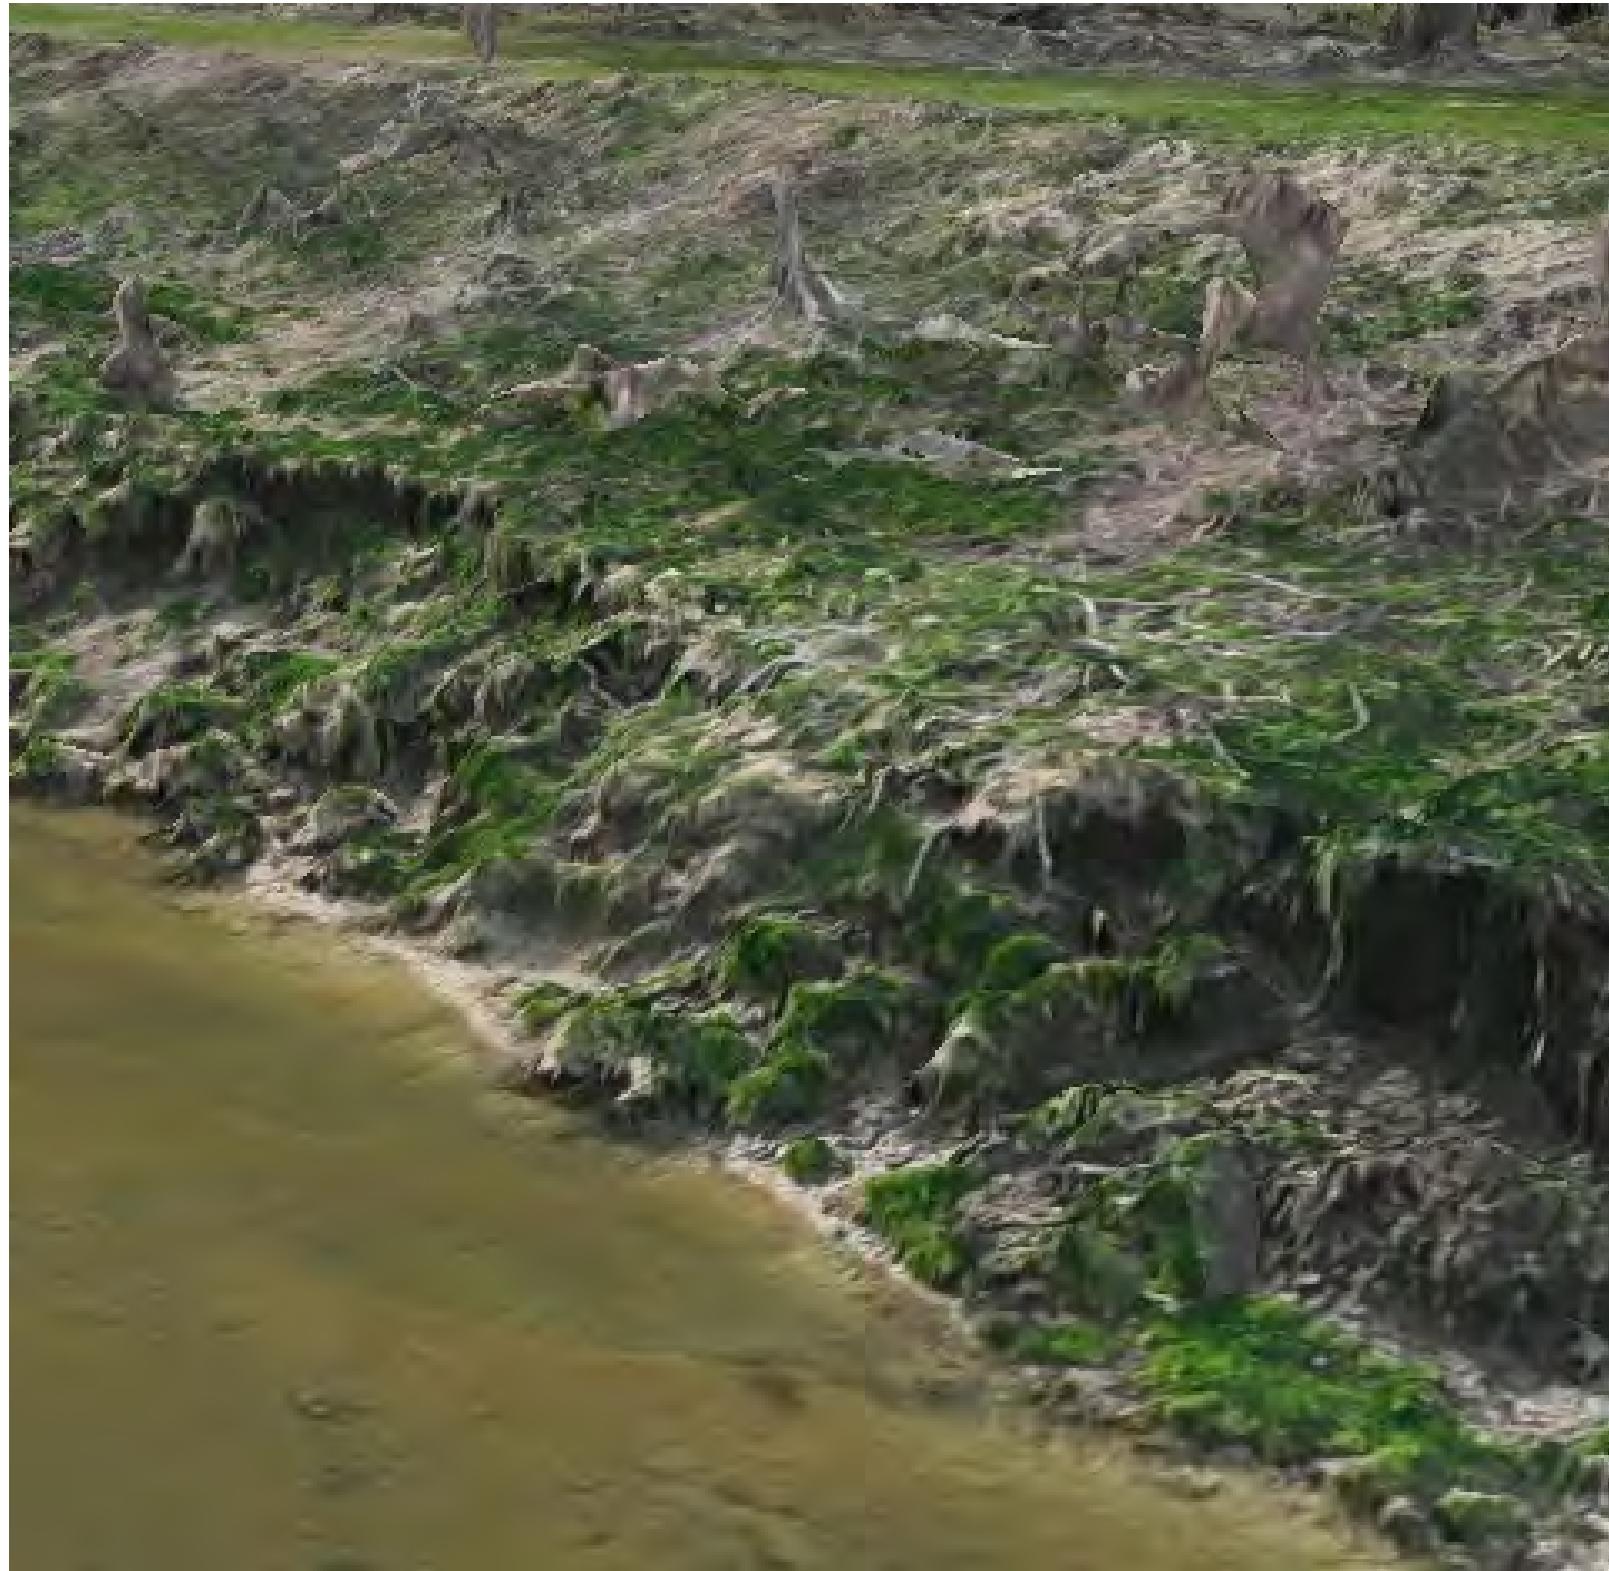
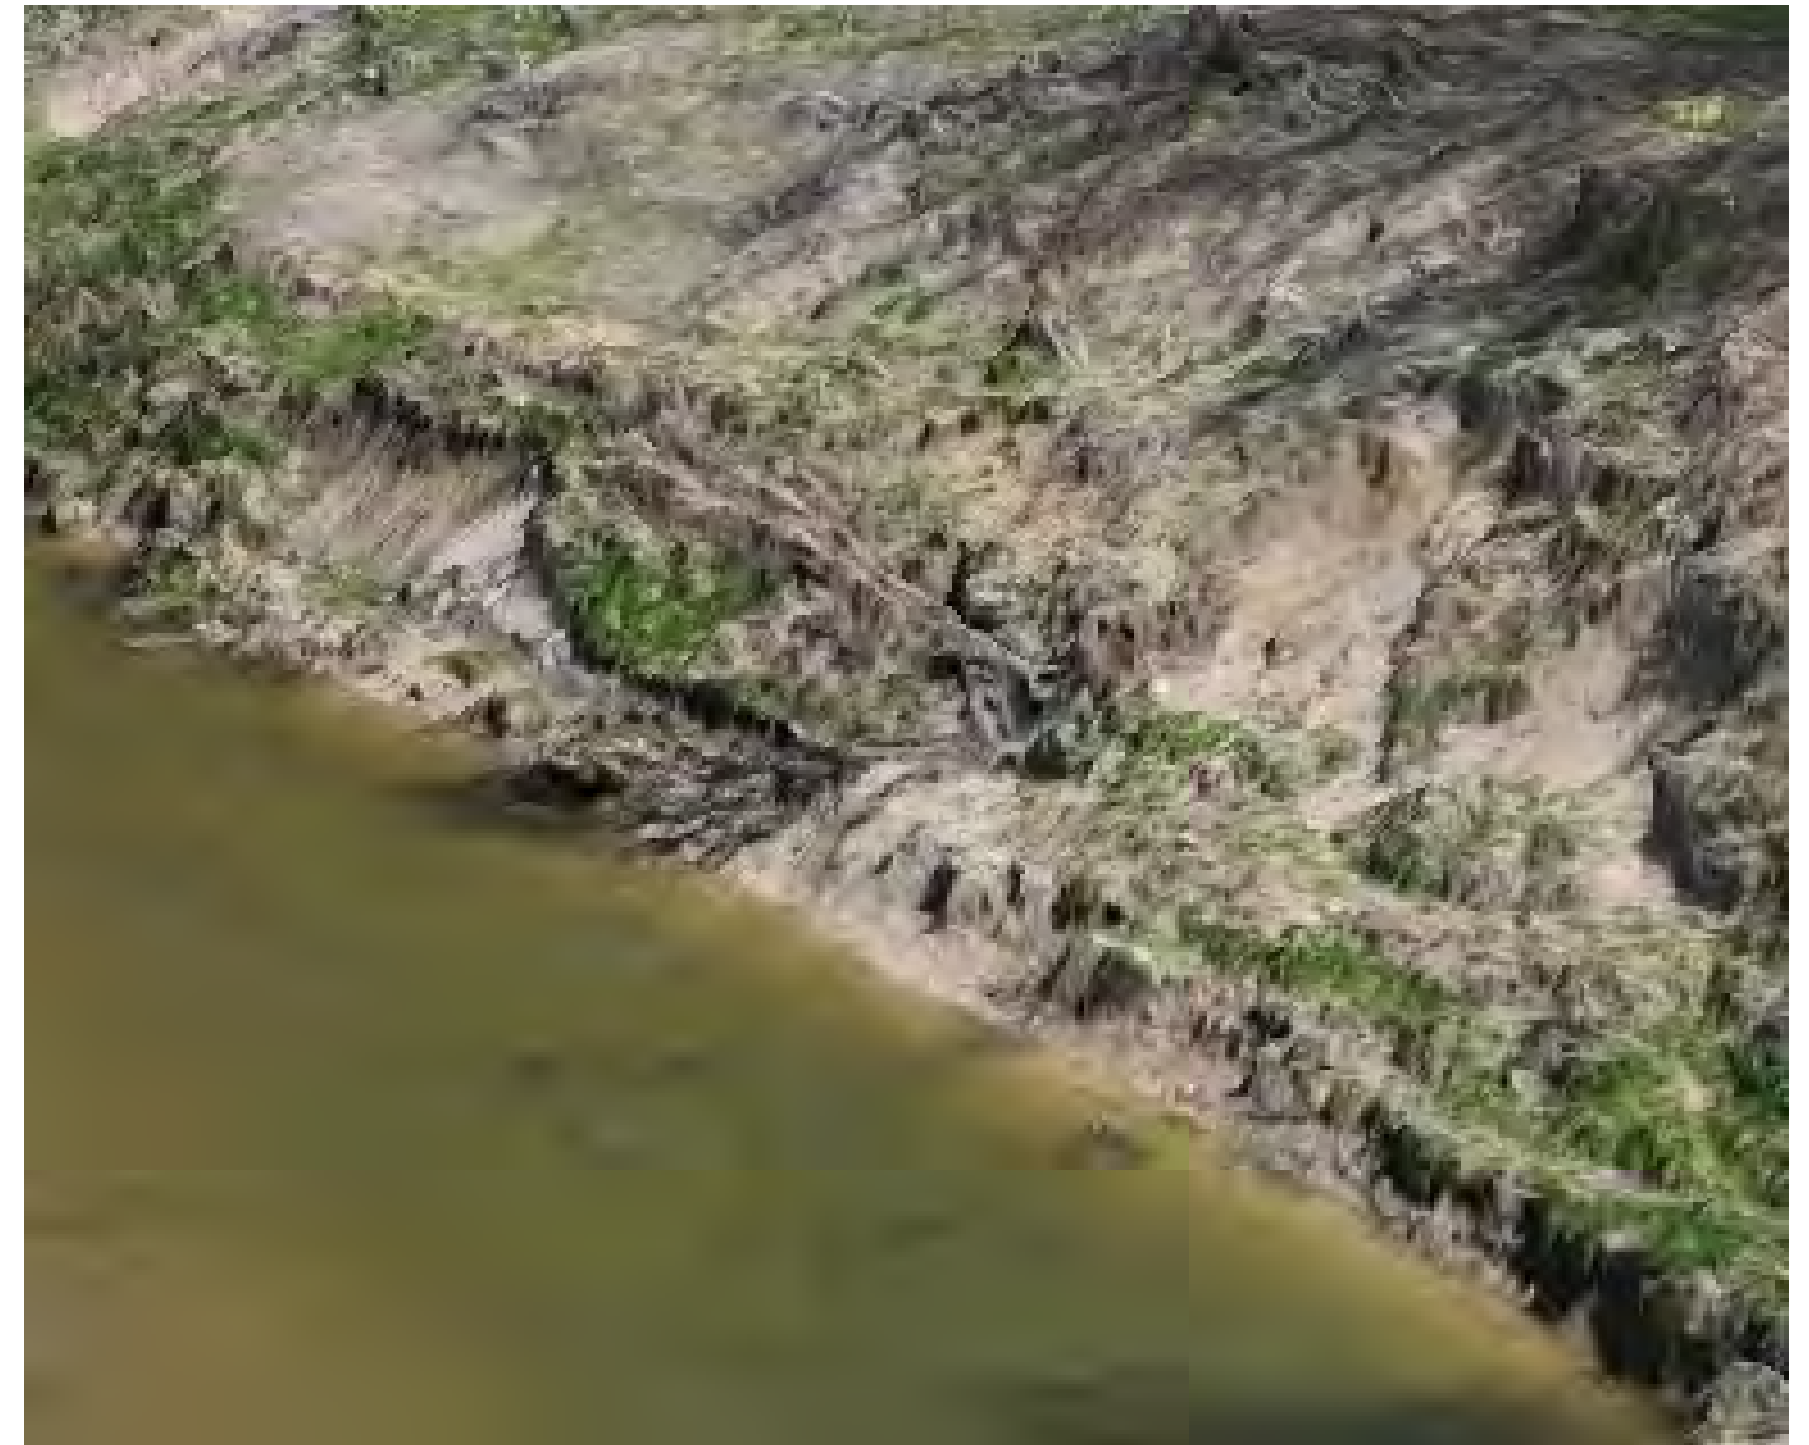
## **BANK CONDITION – Moderate Erosion**

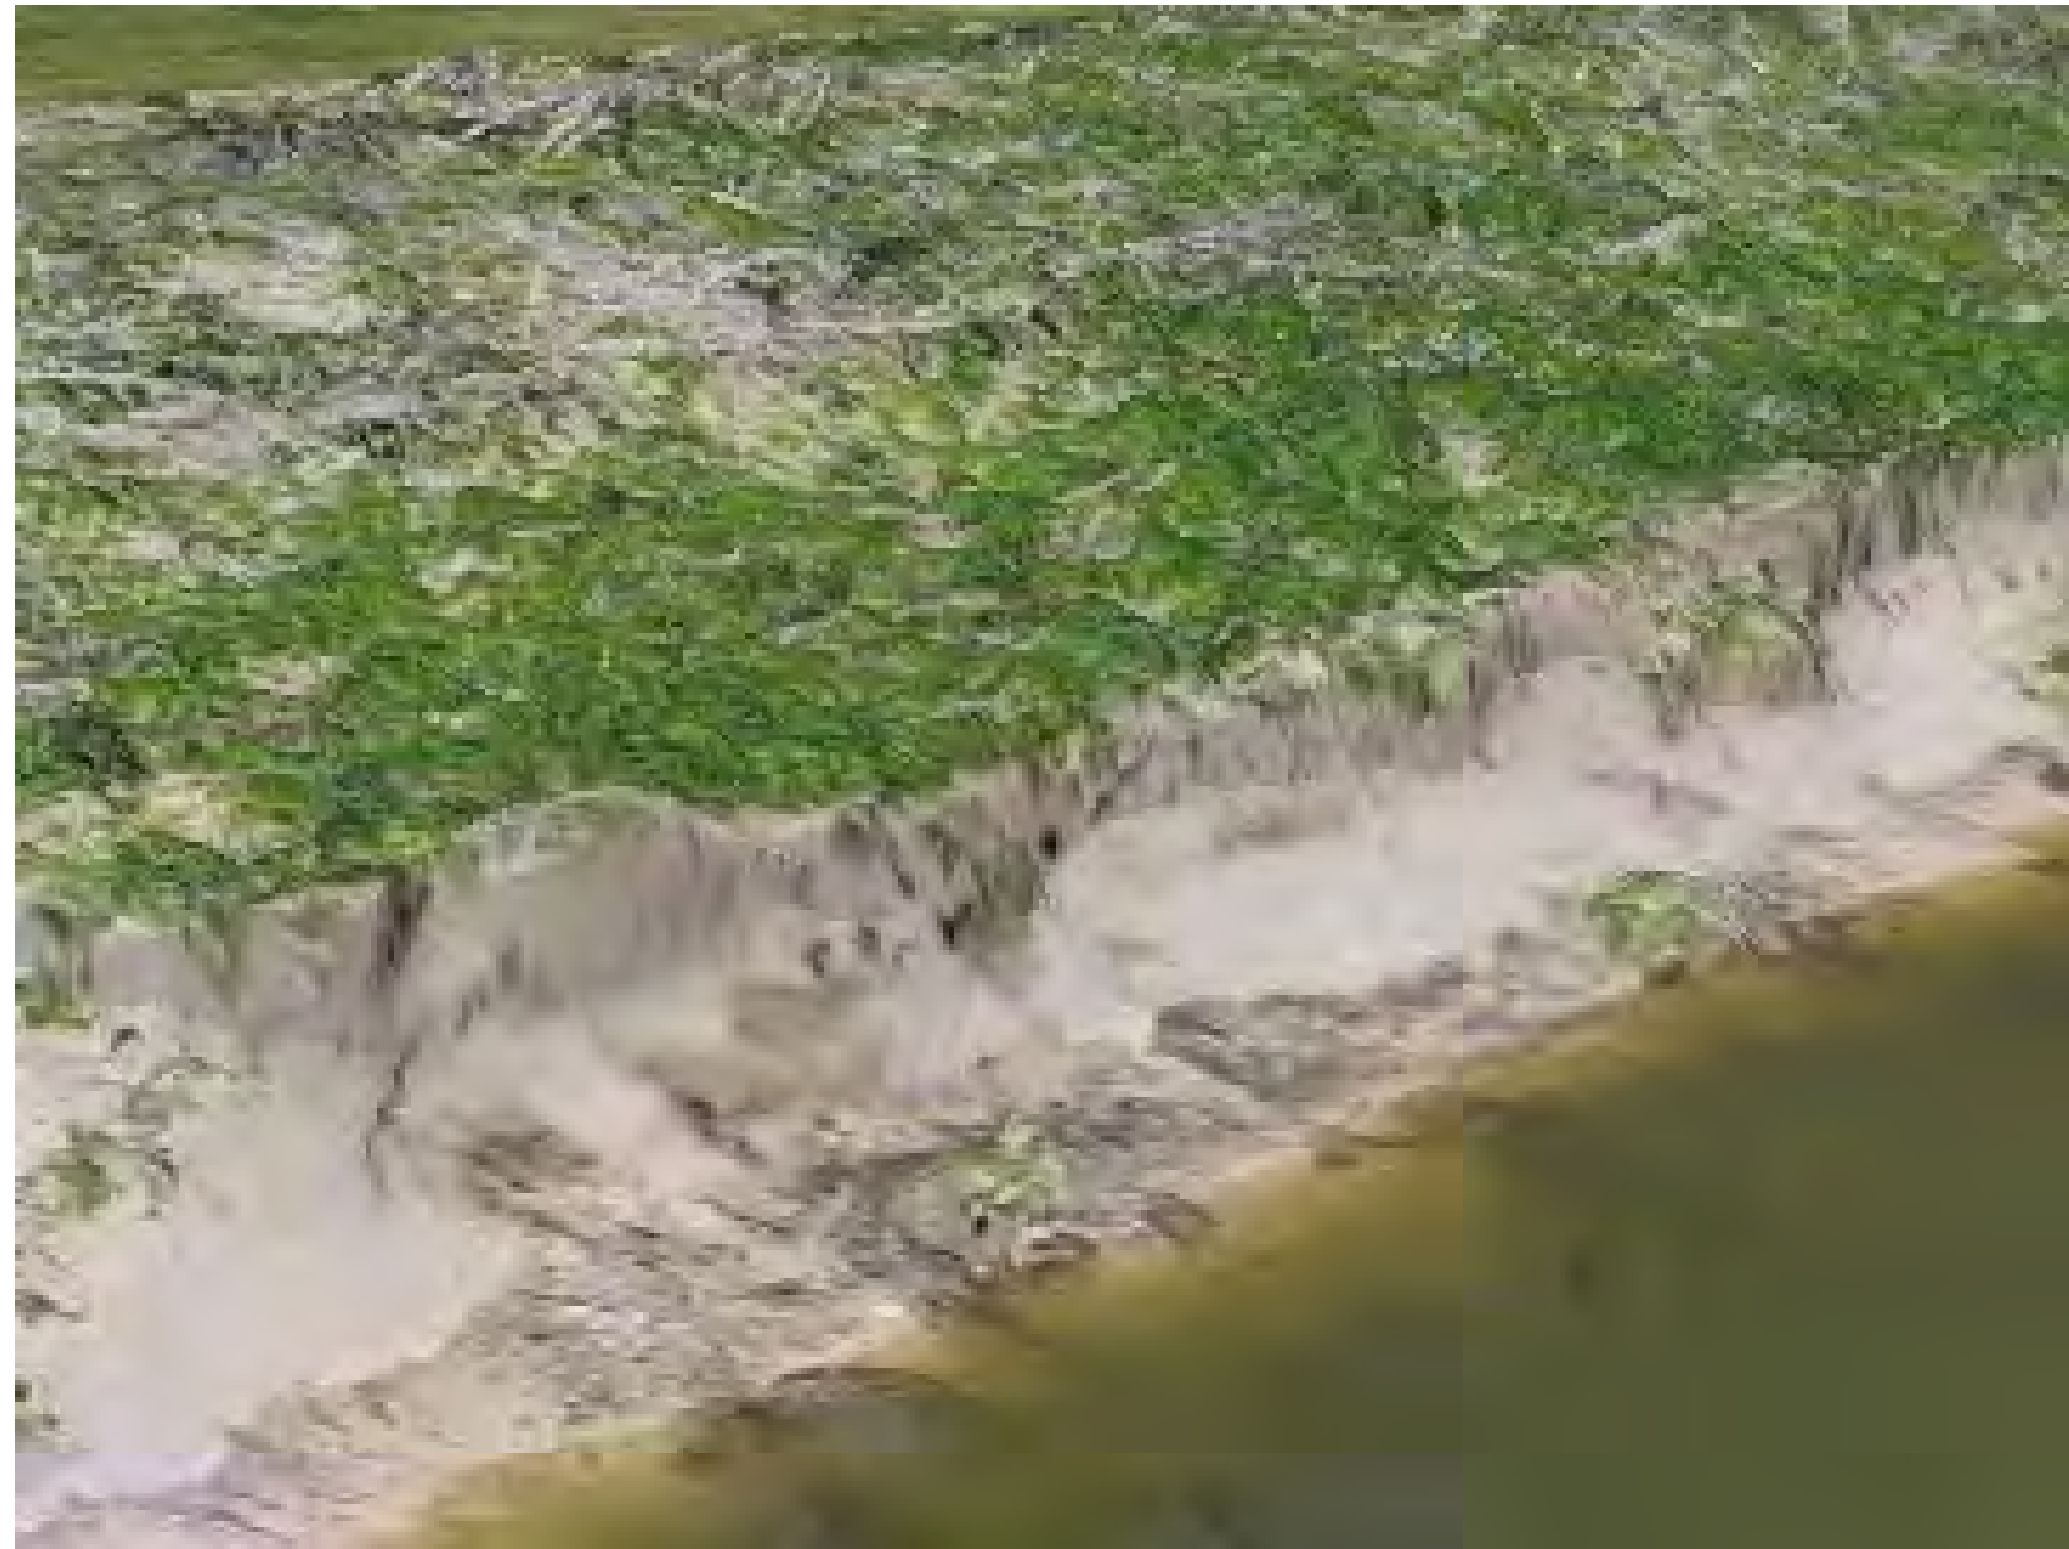
## **BANK CONDITION – Moderate Erosion**

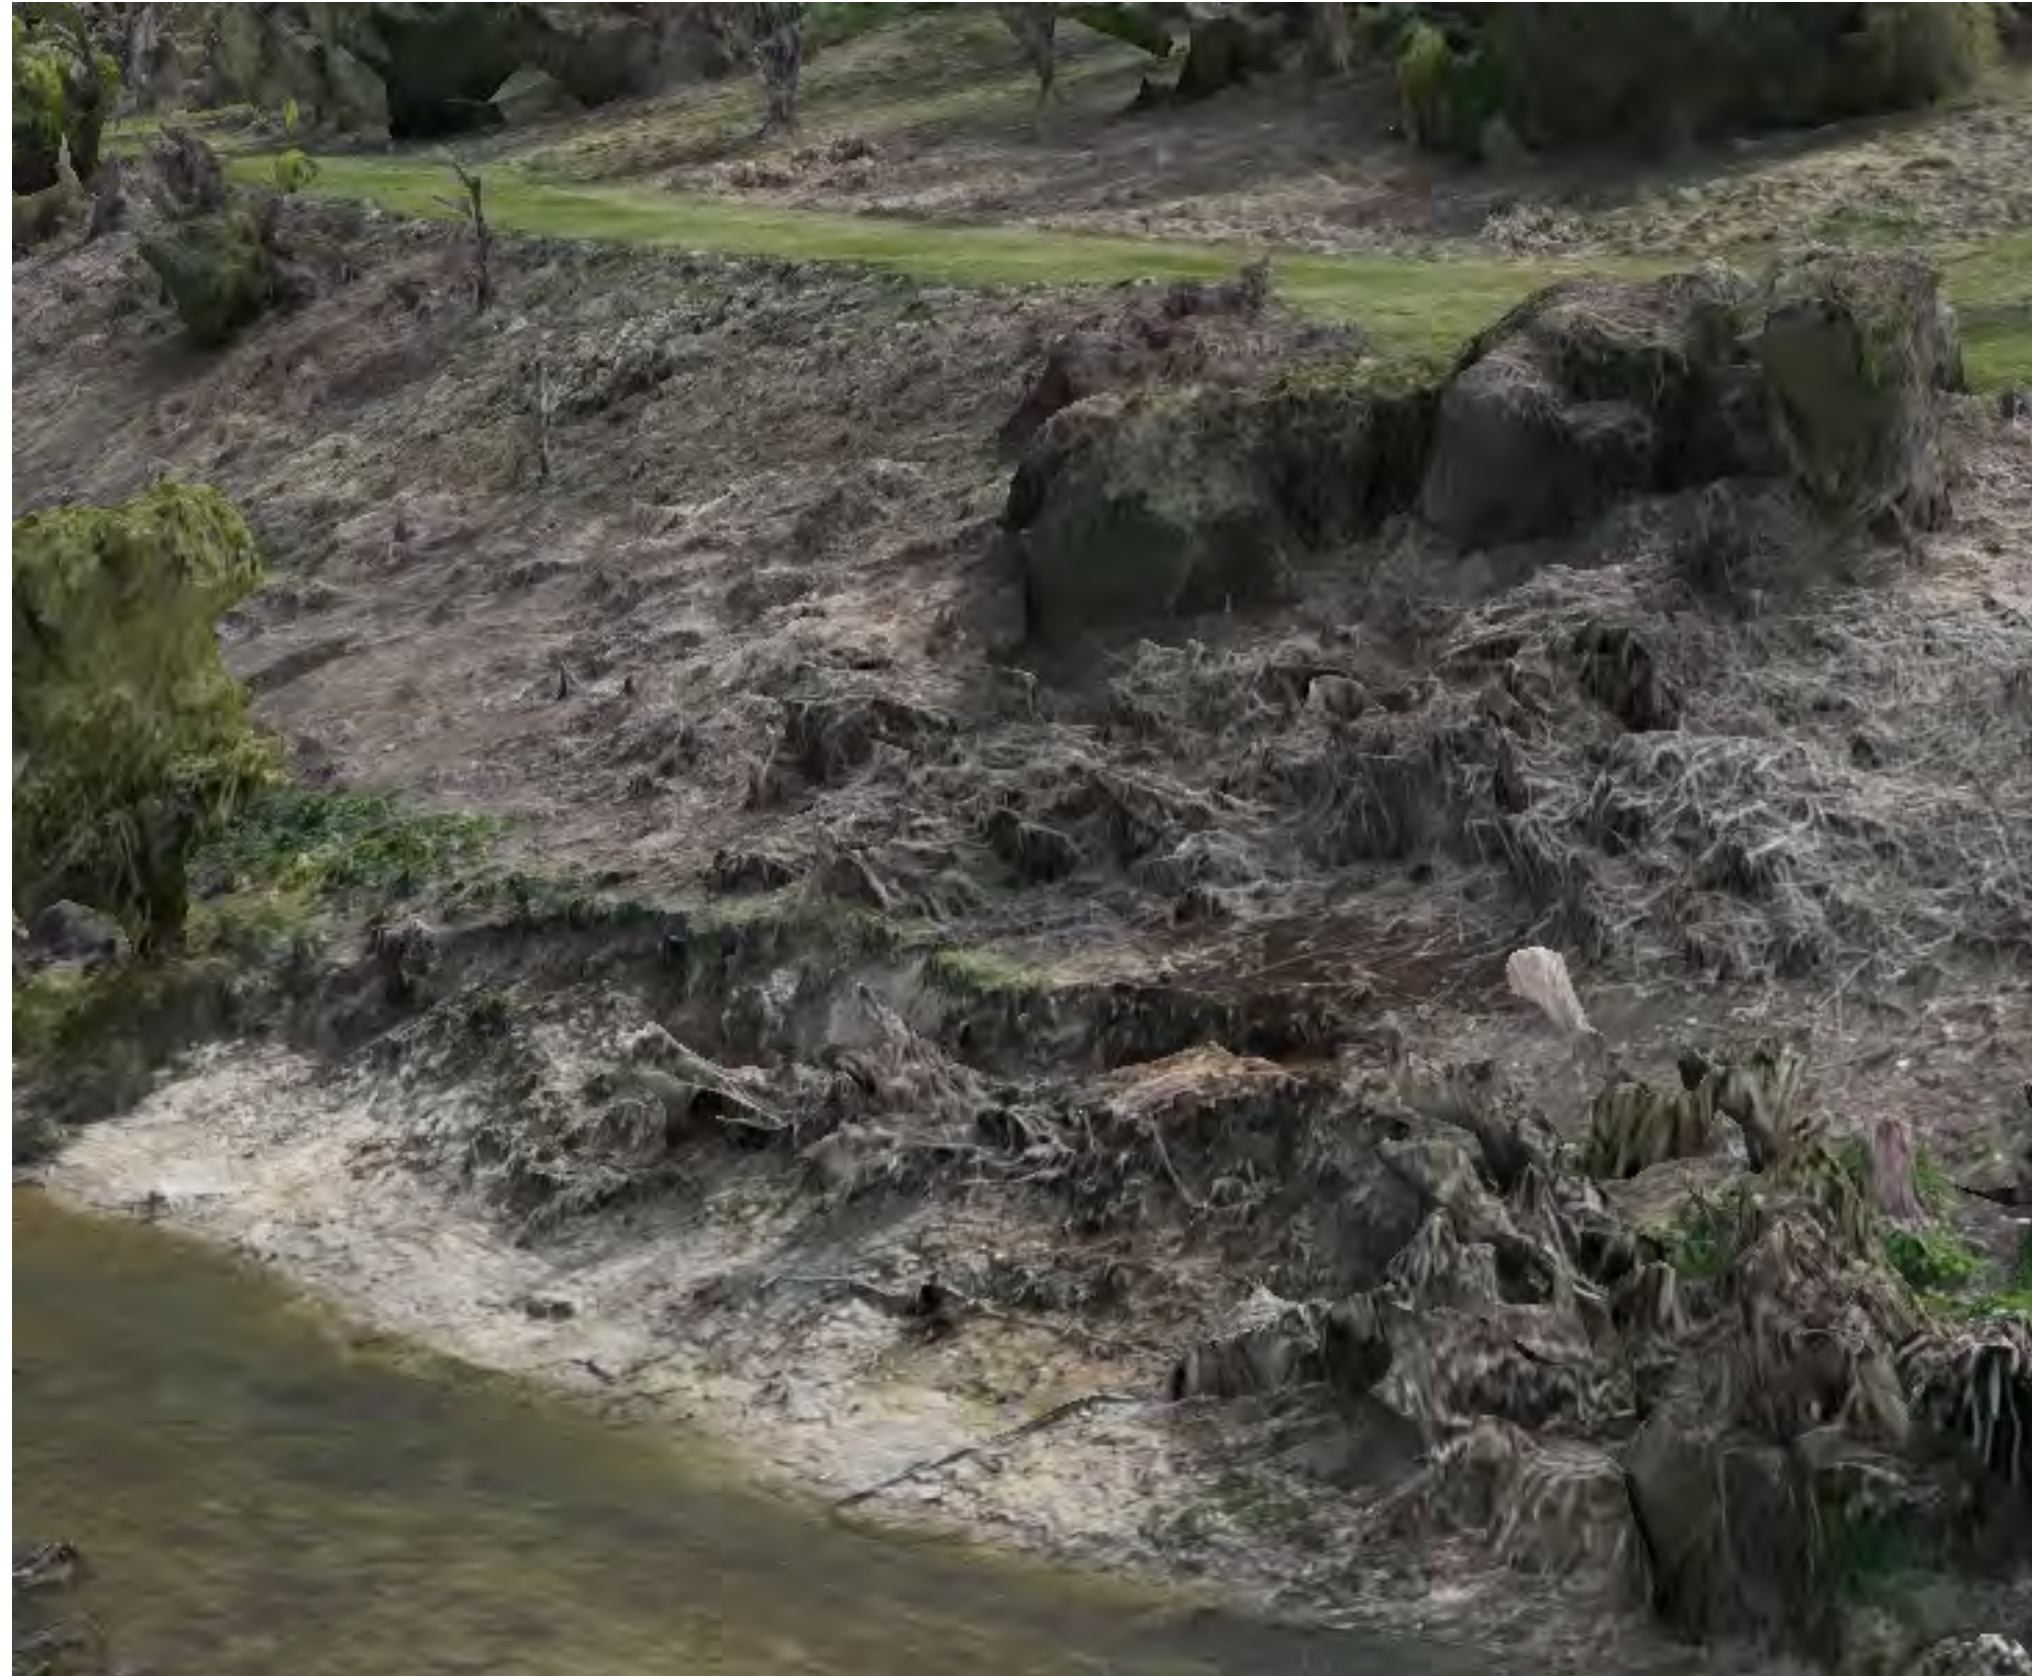
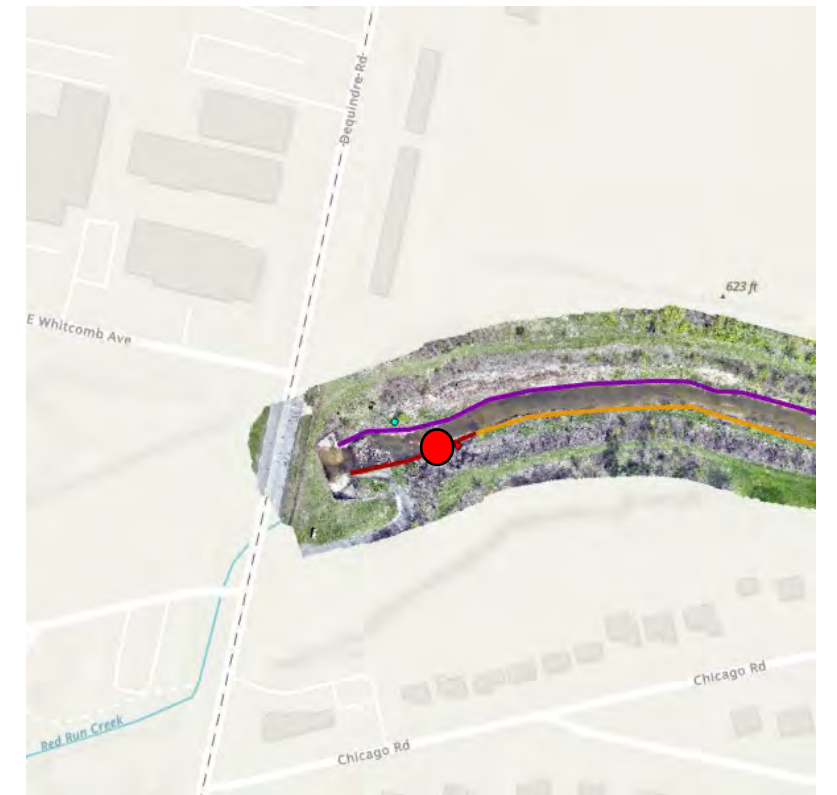
Object ID 11 – Point 8

# BANK CONDITION – Severe Erosion

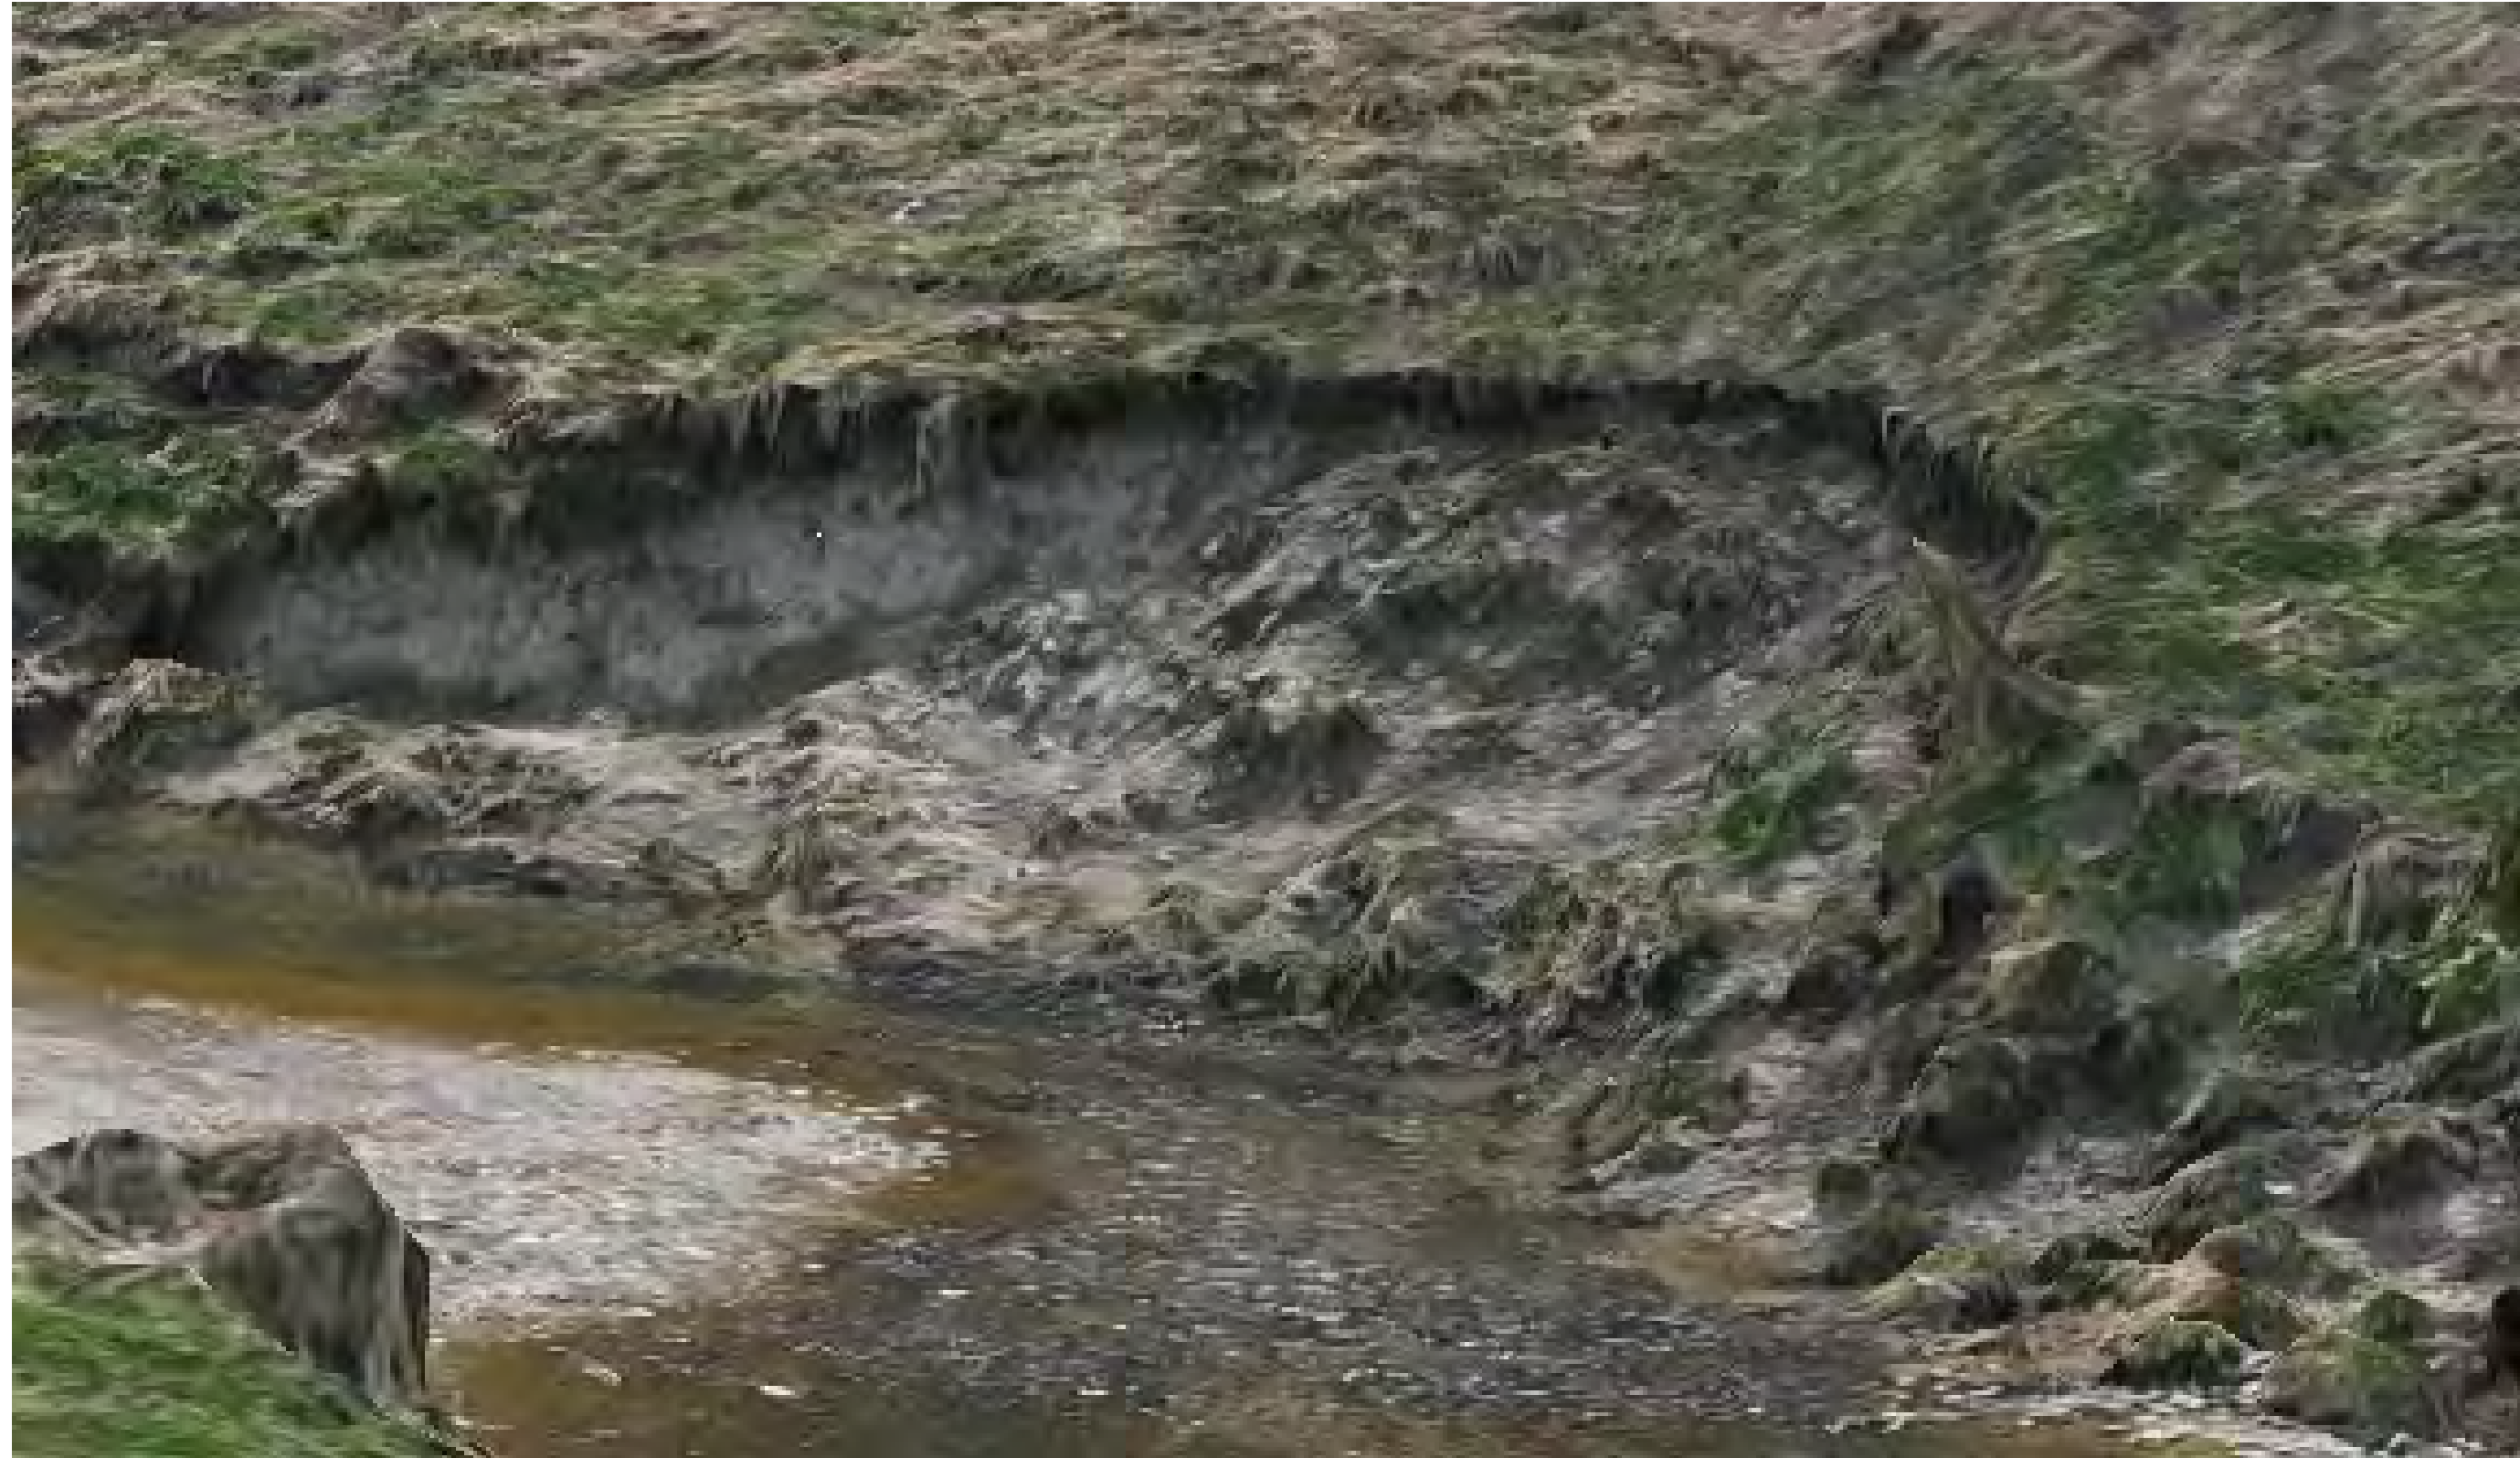
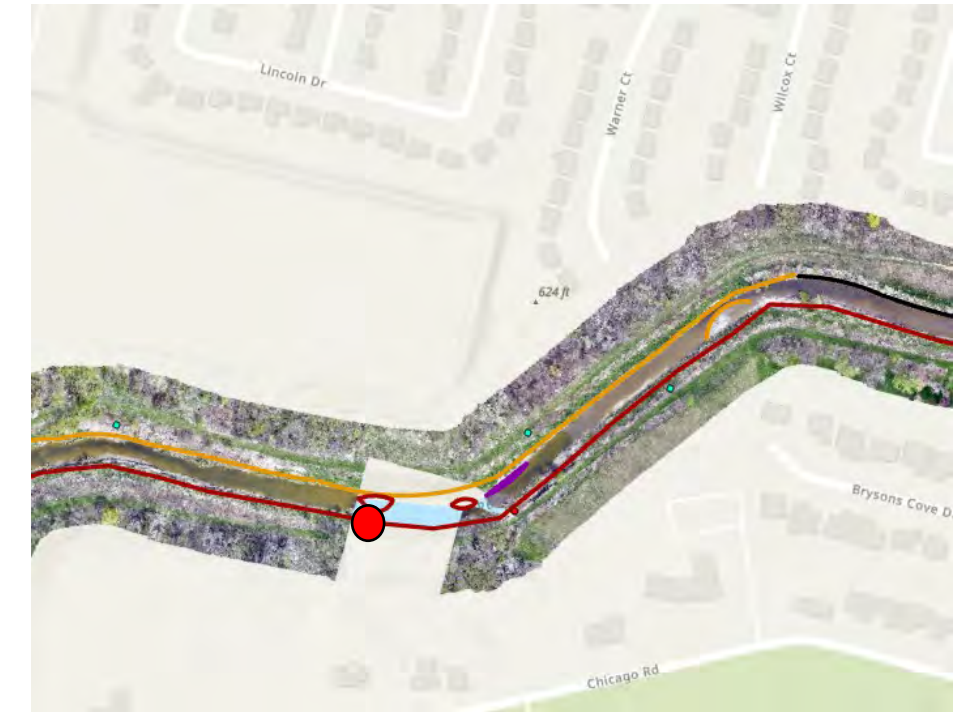
Object ID 9 – Point 7

# BANK CONDITION – Severe Erosion
