Subject: GWK Permit – Red Run Drain Flooding

# **RED RUN INTERCOUNTY DRAIN**

UAS FLIGHT, PROCESS, AND BANK  
CONDITIONS

**Hubbell, Roth & Clark, Inc.**

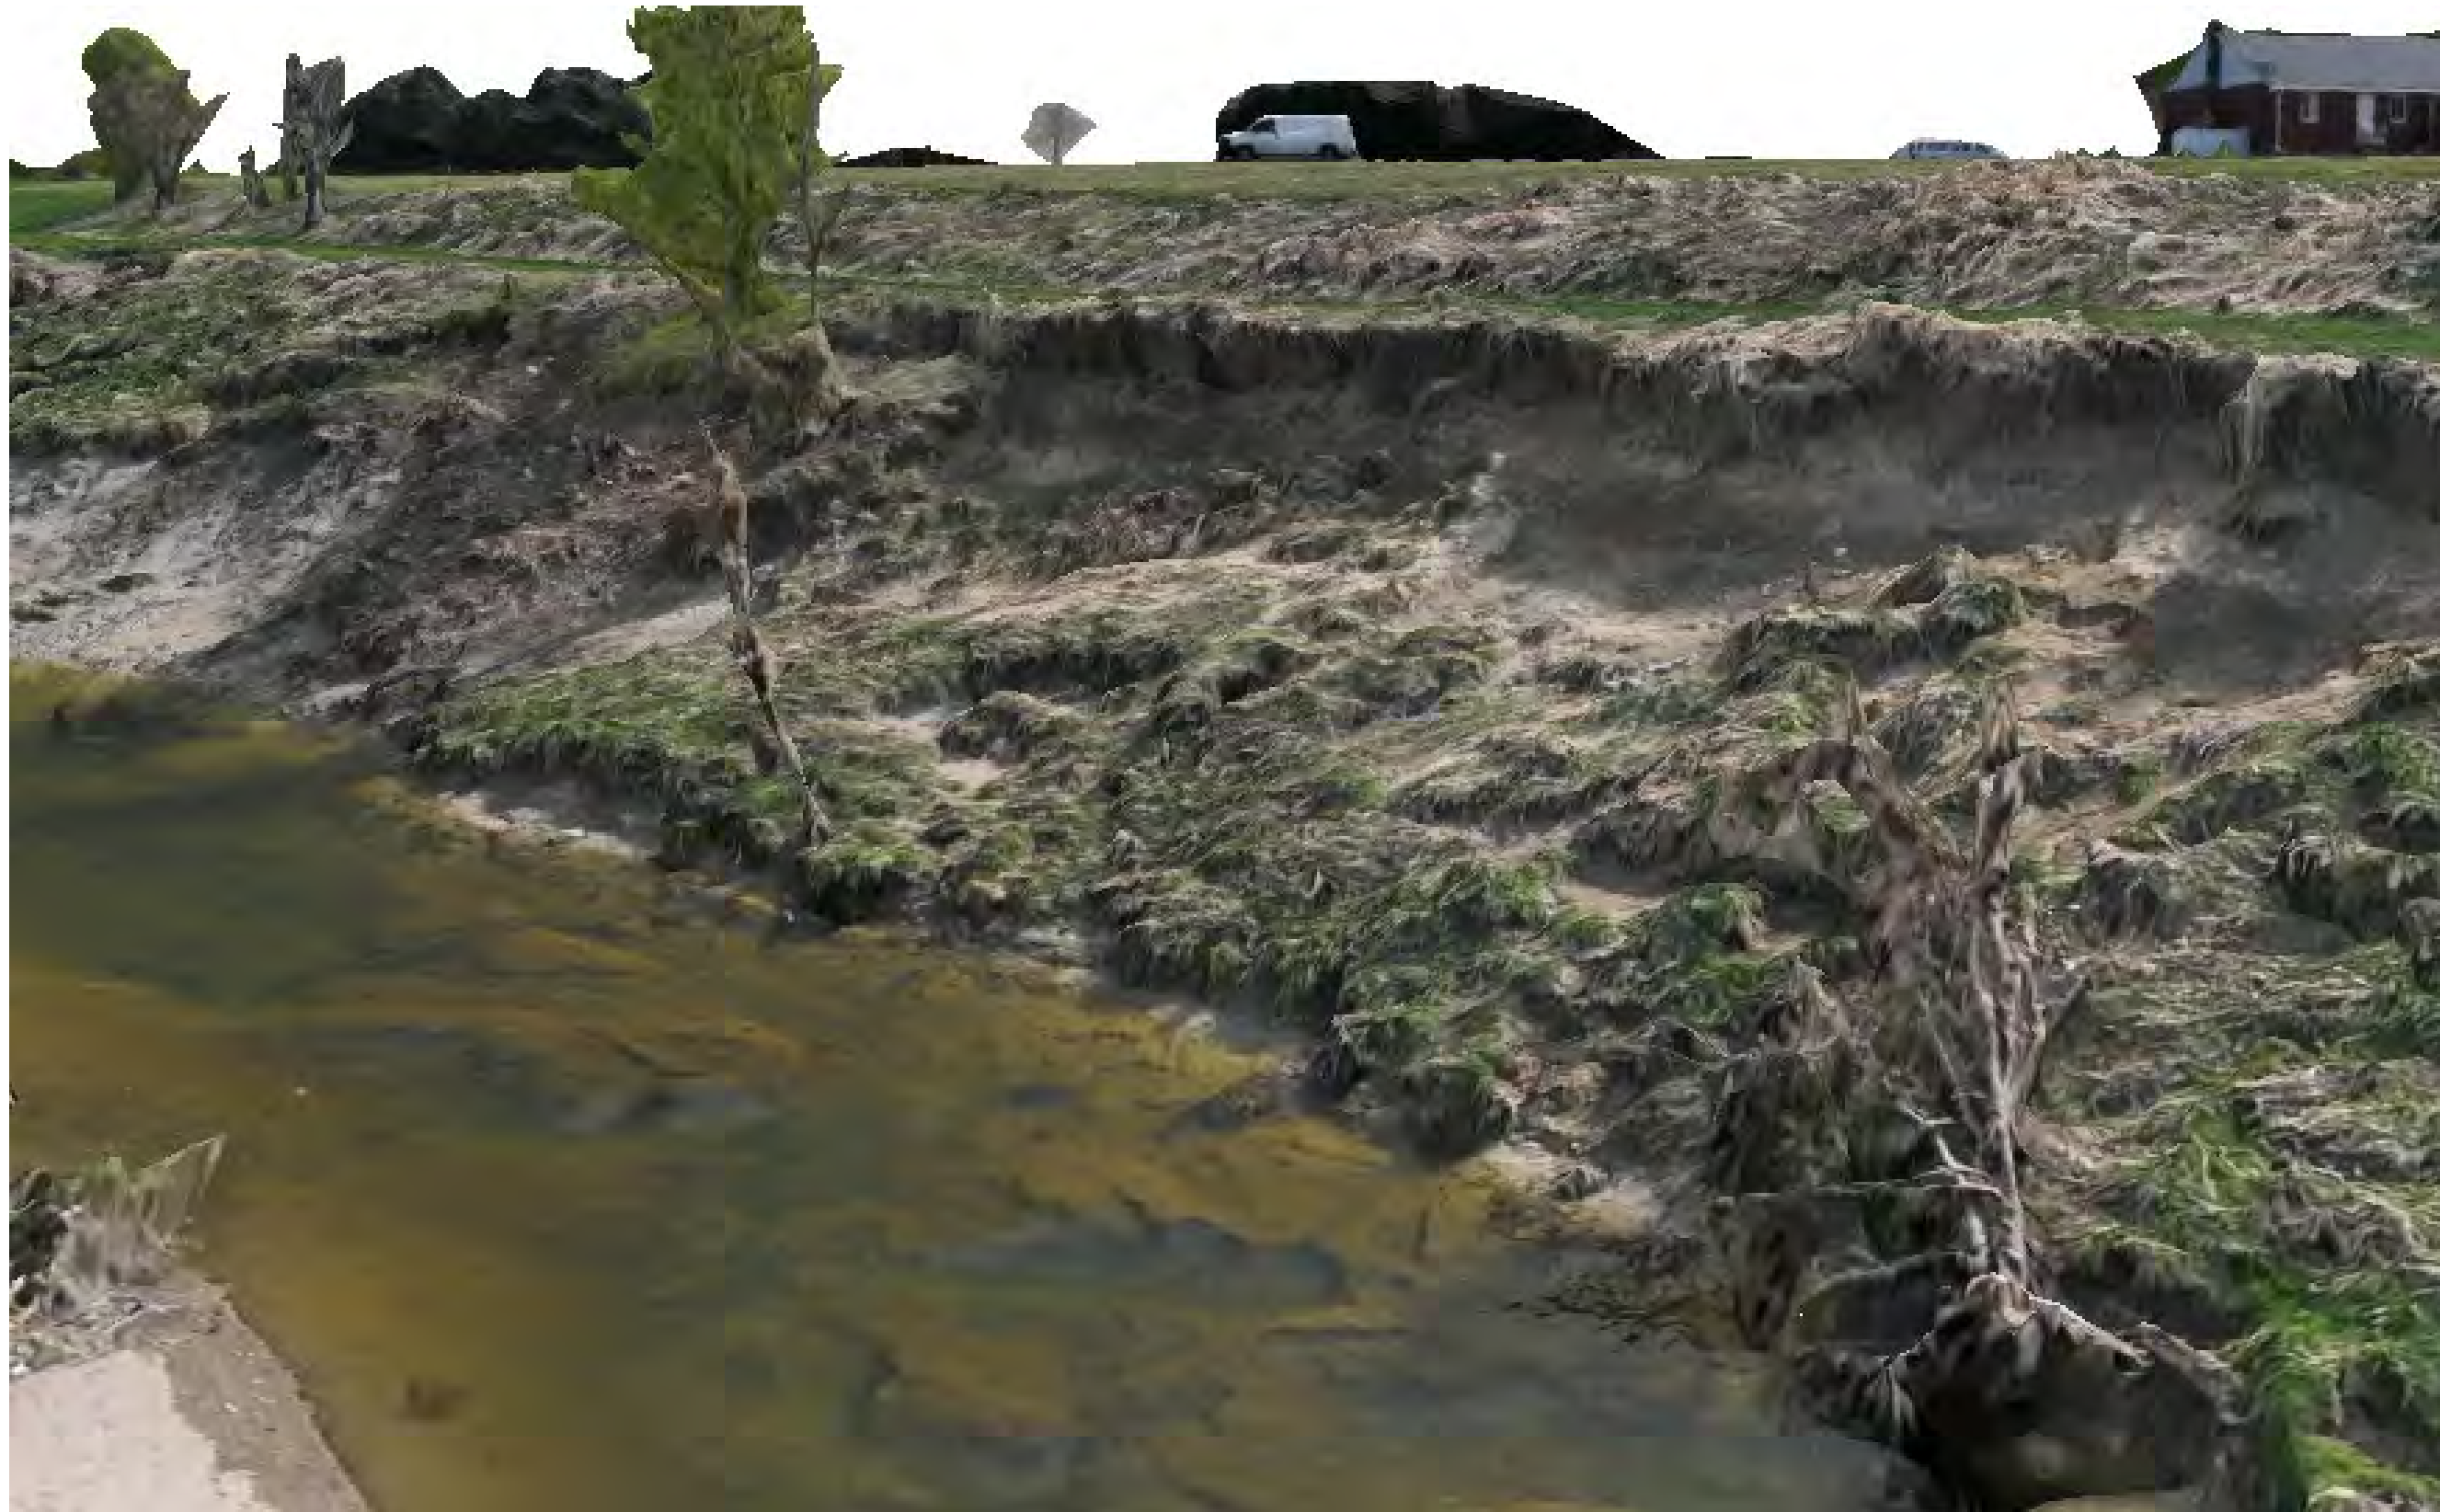
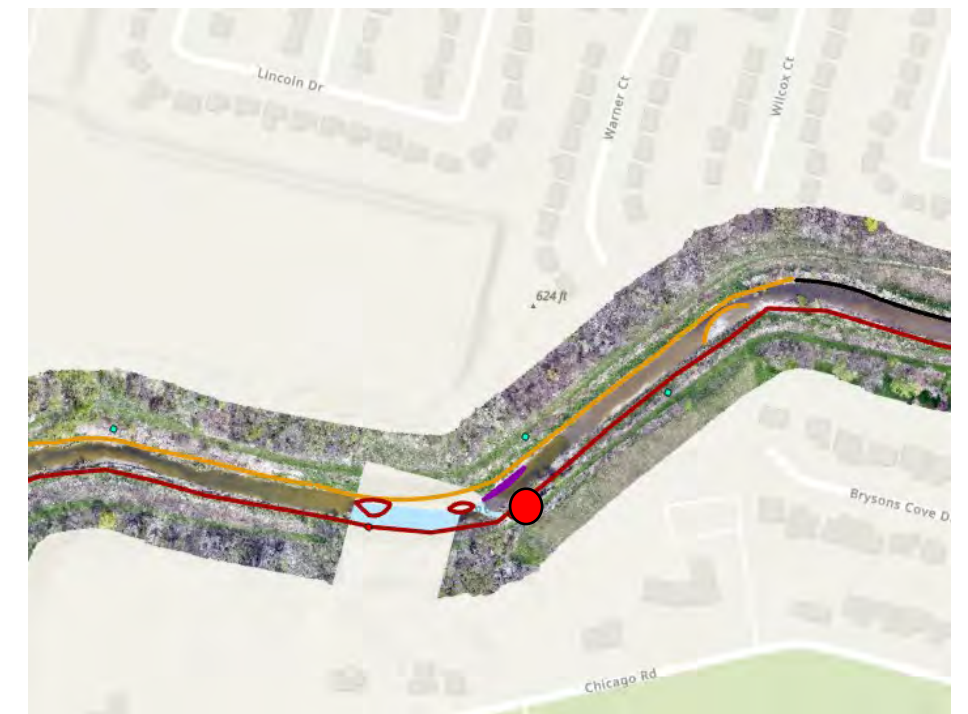
Object ID 15 – Point 3

# BANK CONDITION – Severe Erosion

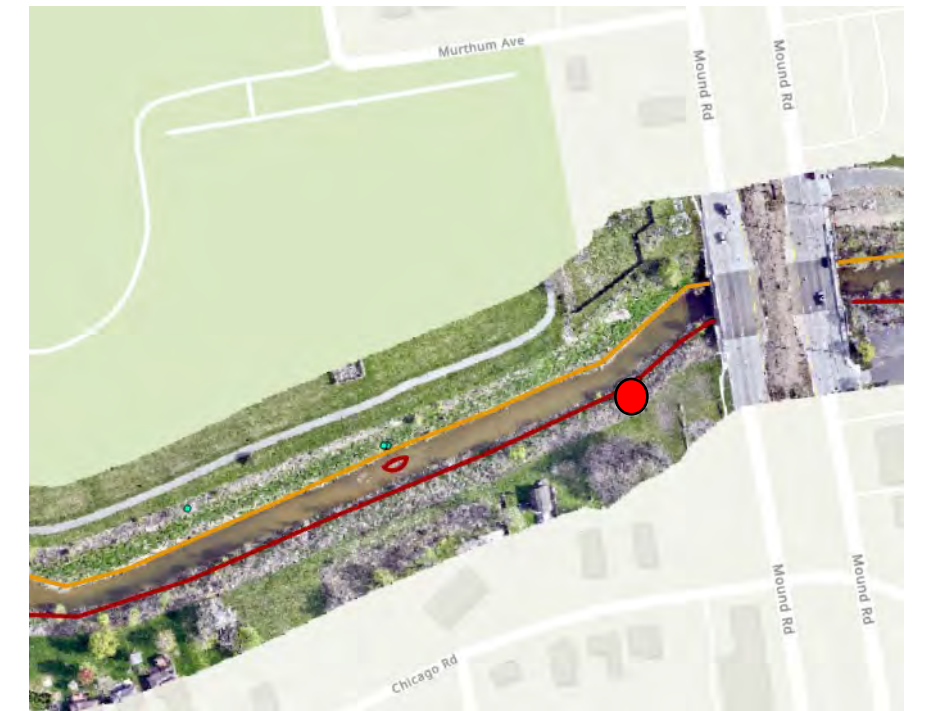
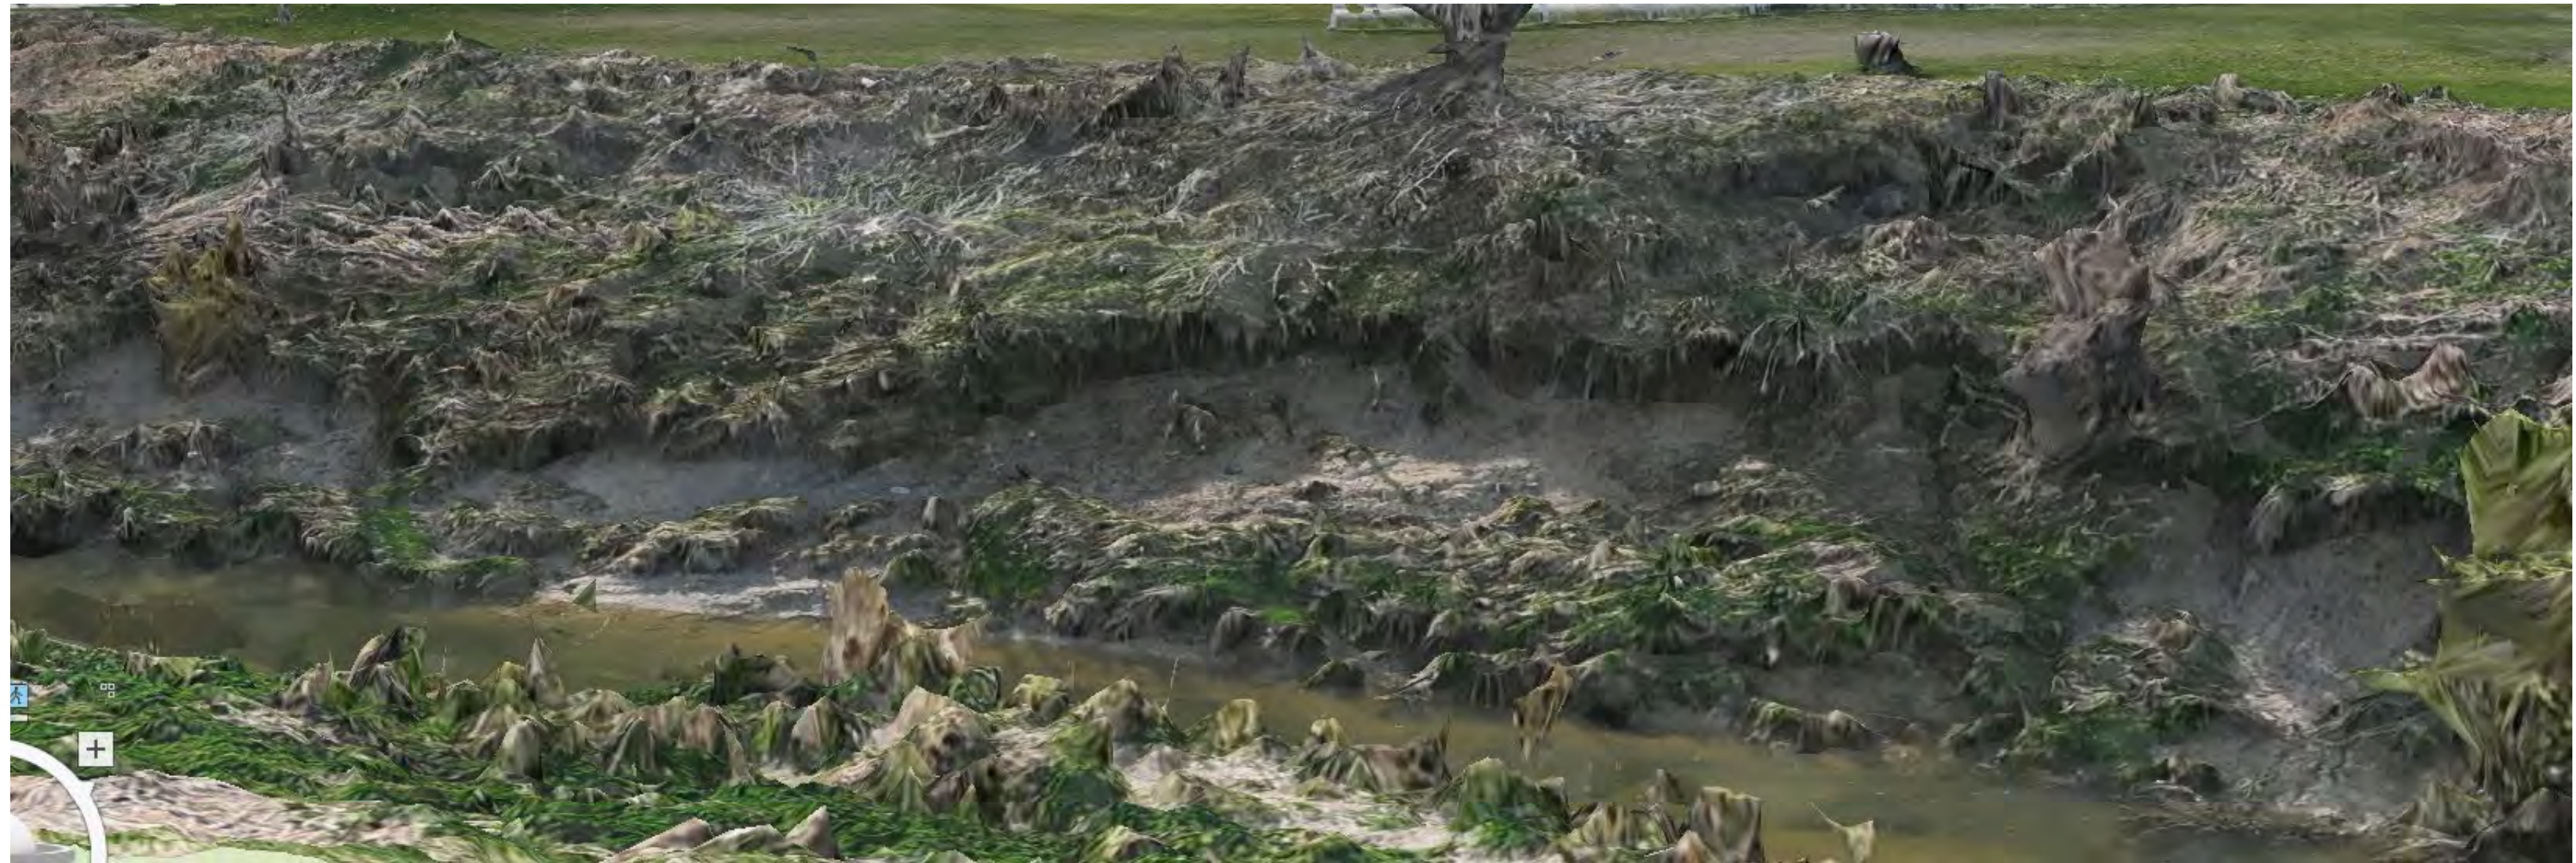
Object ID 34 – Point 5

# BANK CONDITION – Severe Erosion

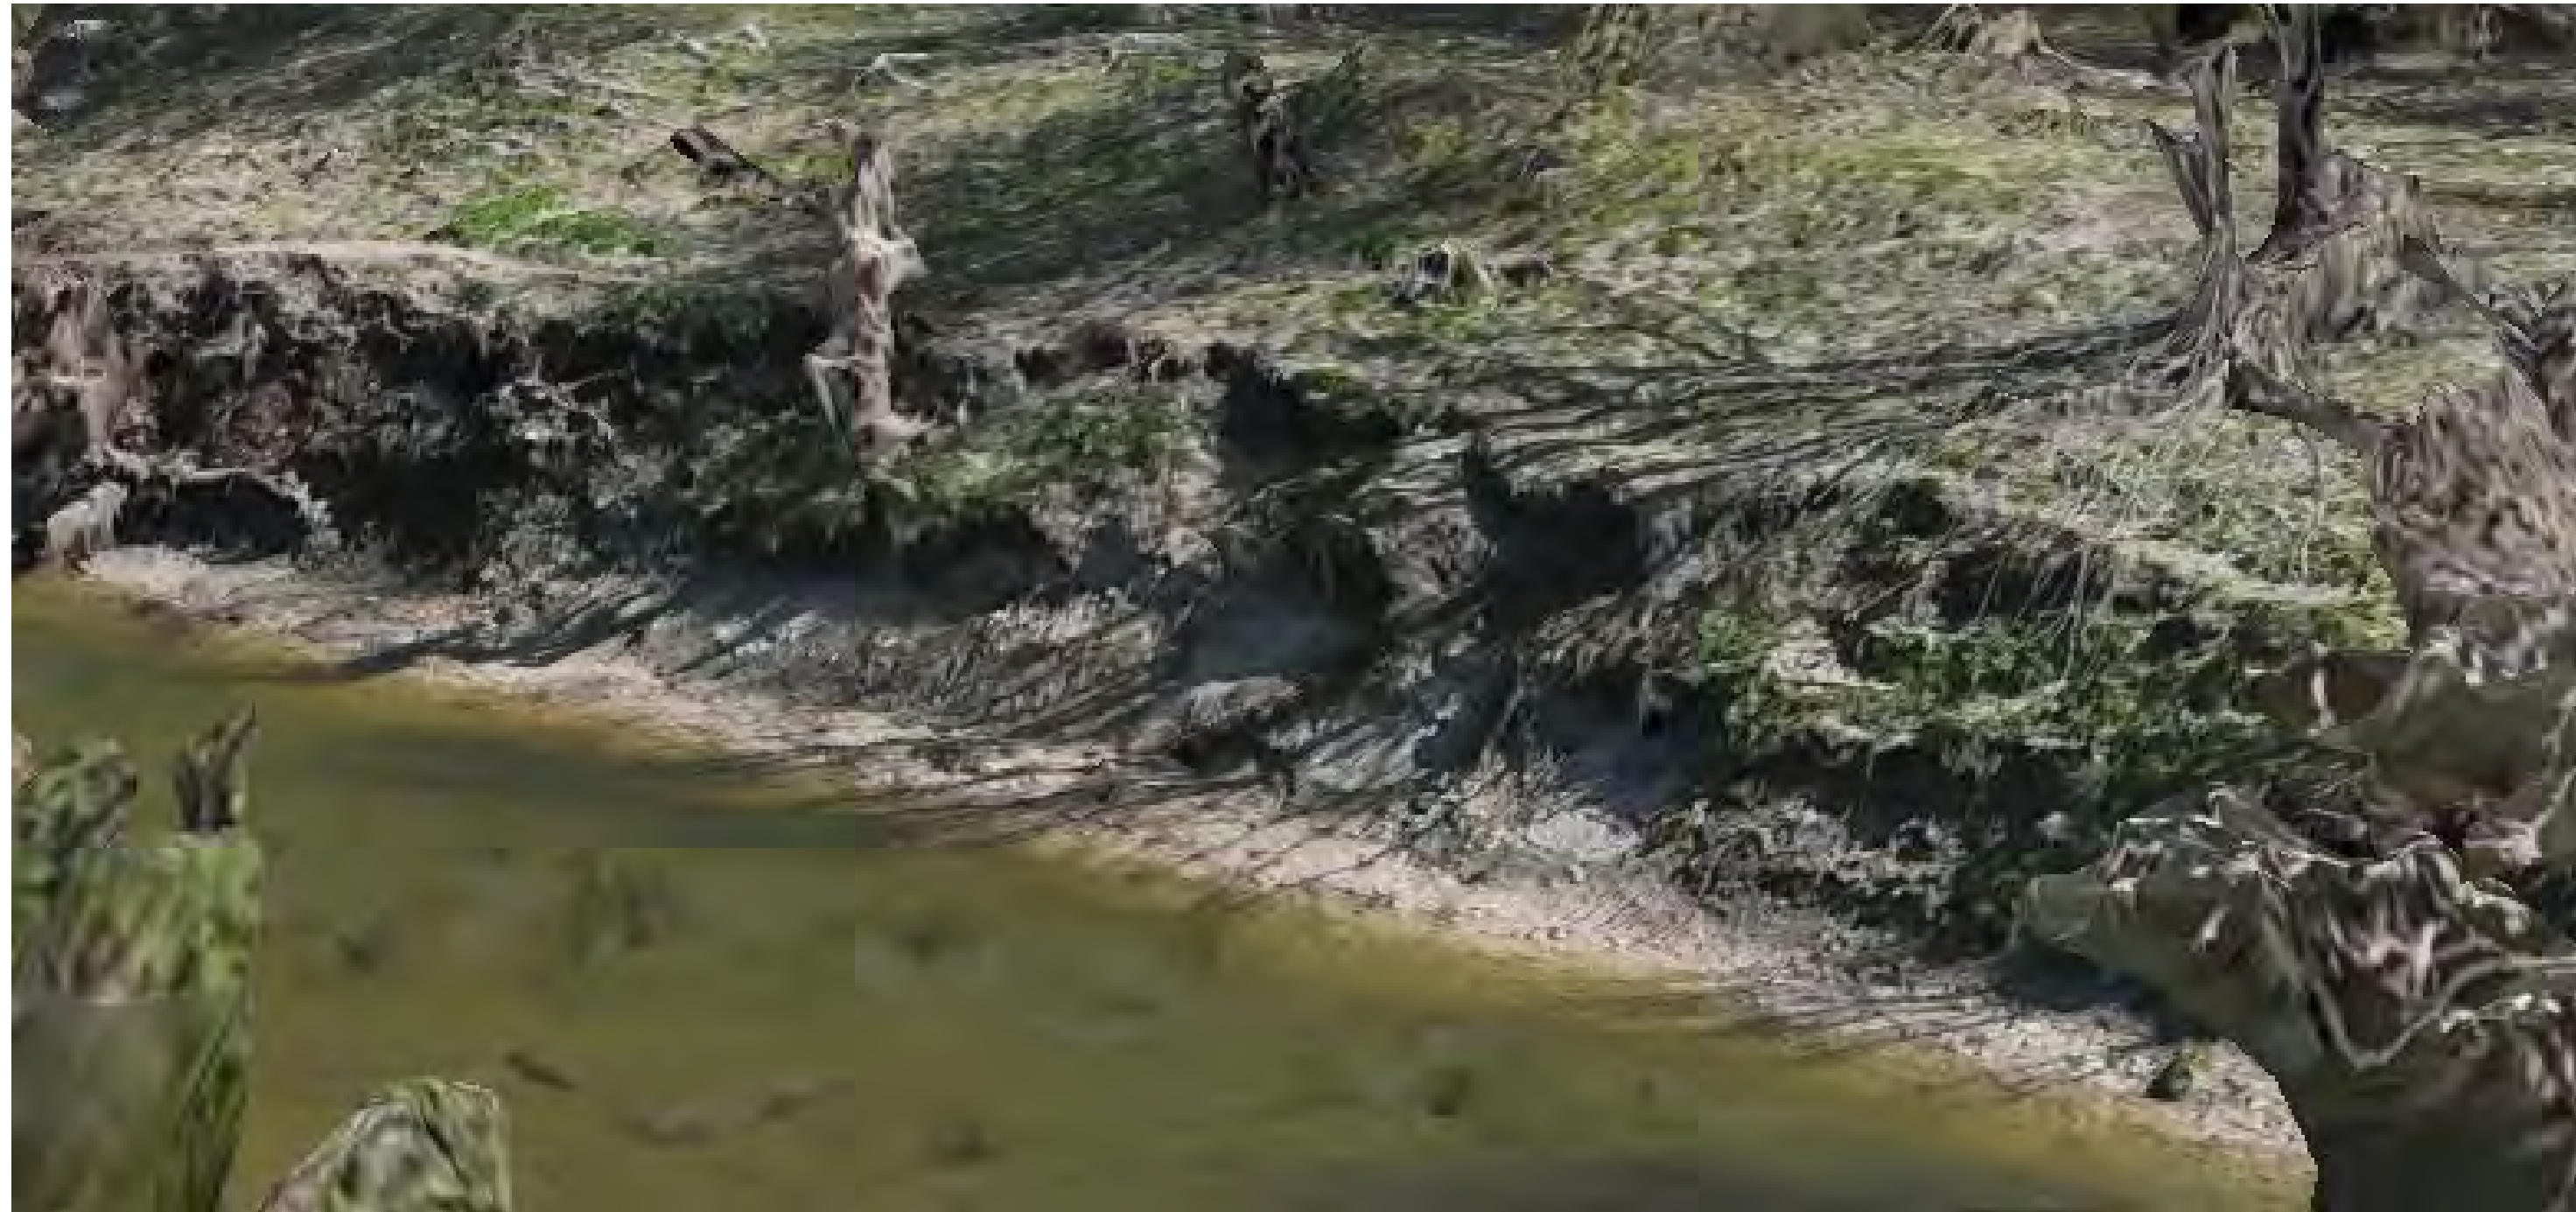
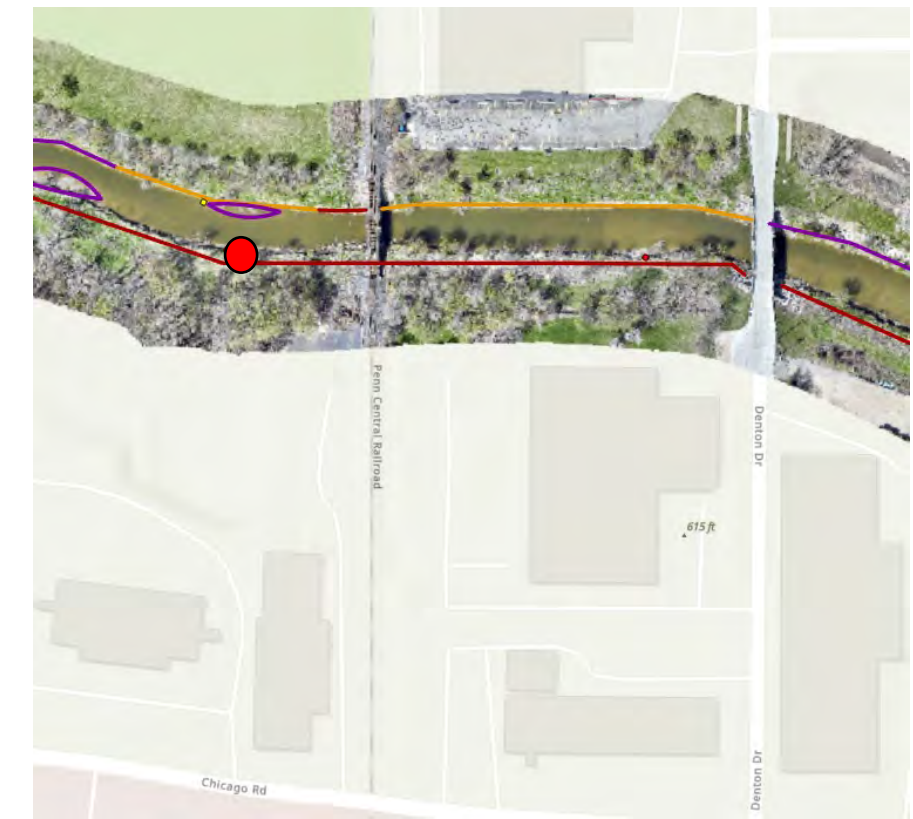
Object ID 33 – Point 6

# BANK CONDITION – Severe Erosion

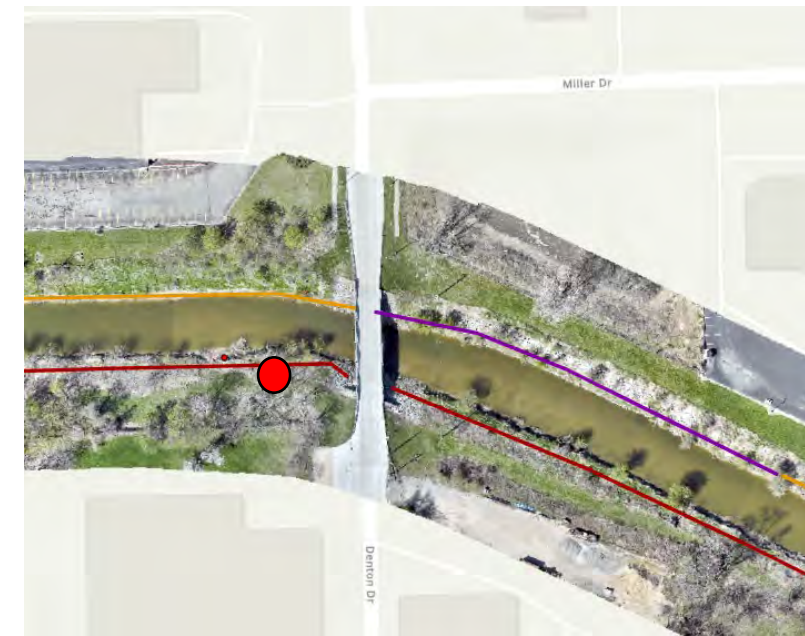
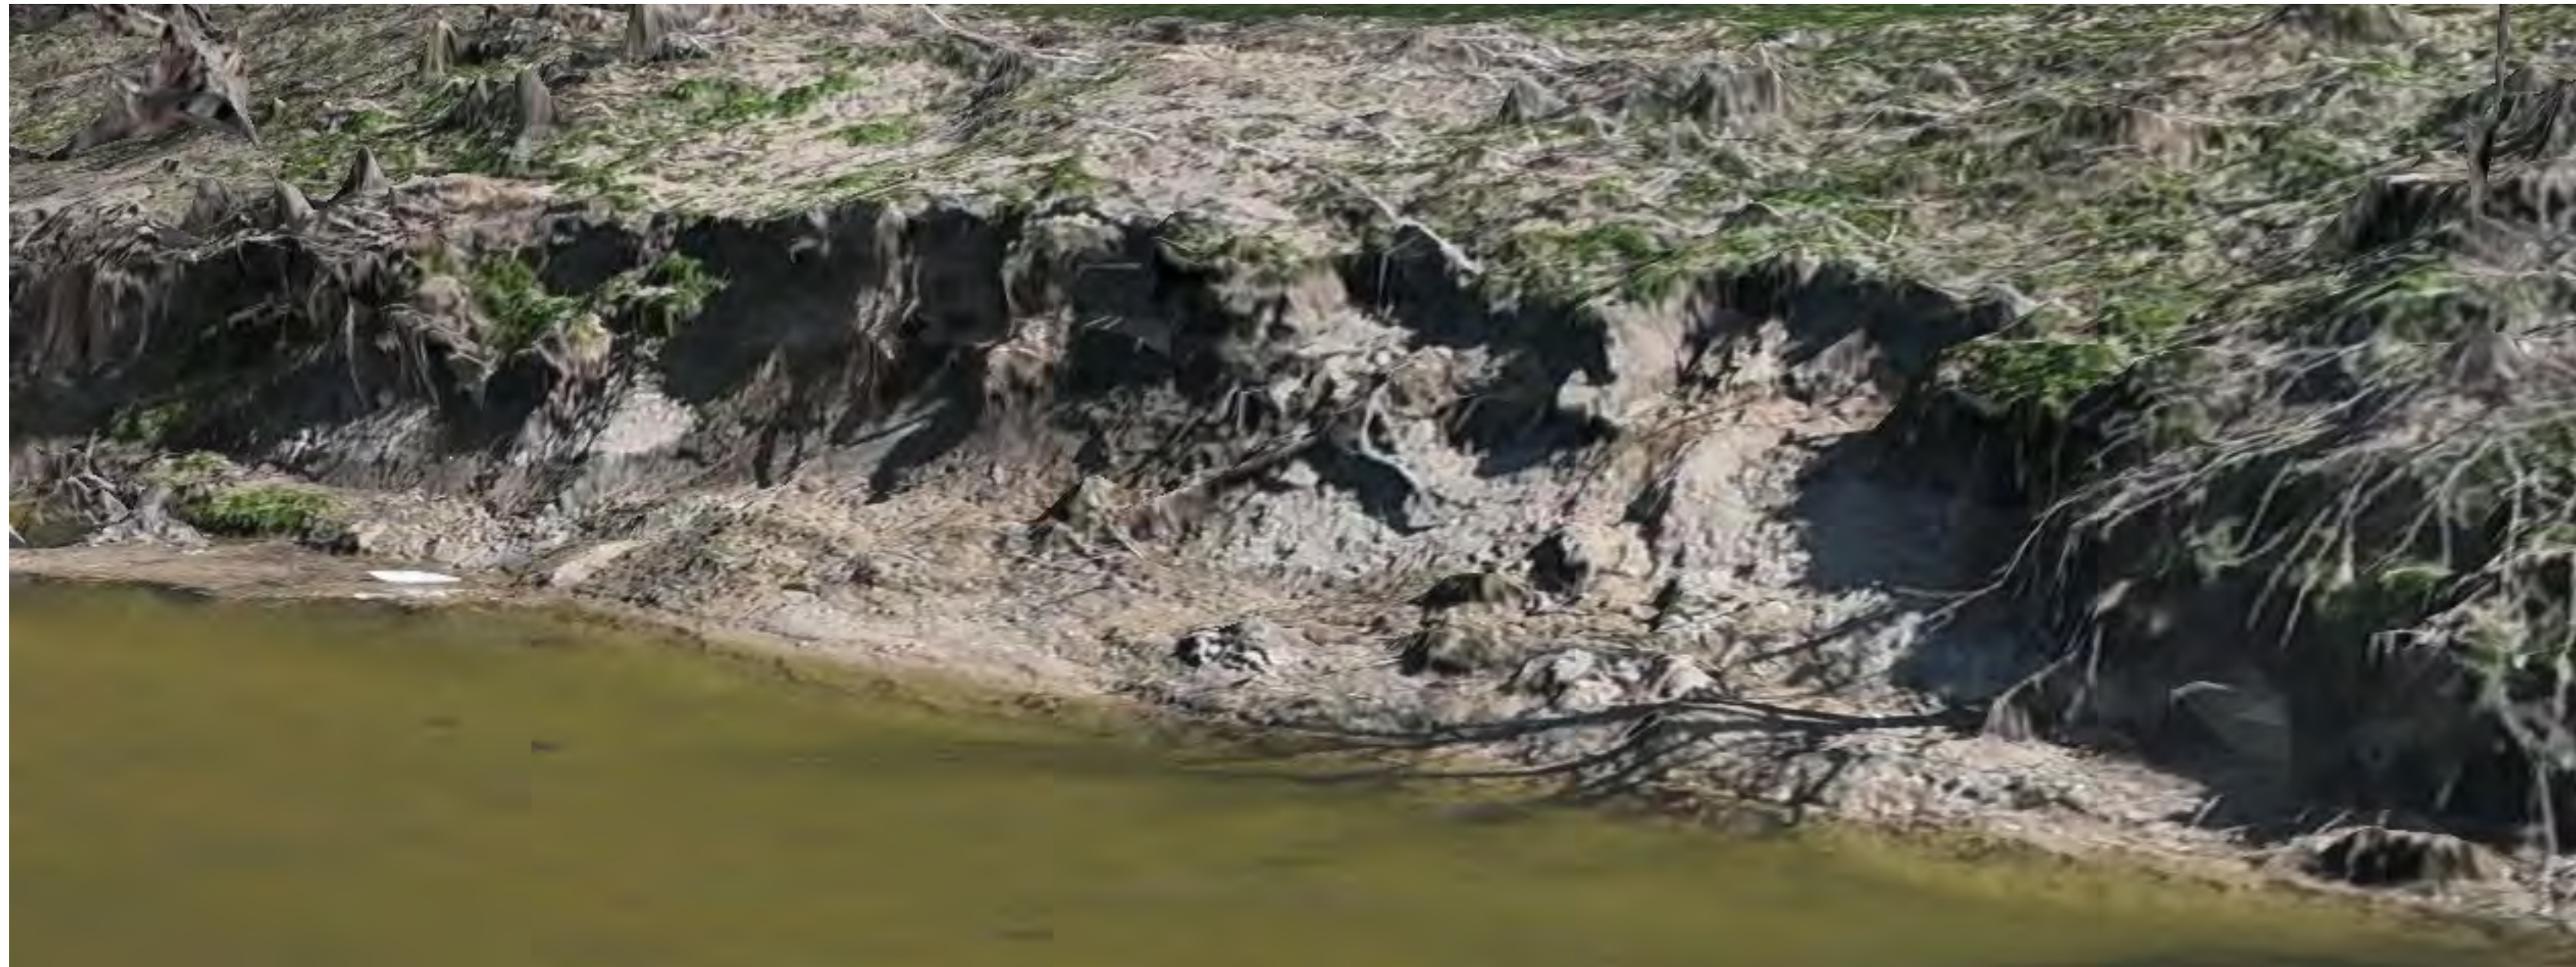
Object ID 35 – Point 1

# BANK CONDITION – Severe Erosion

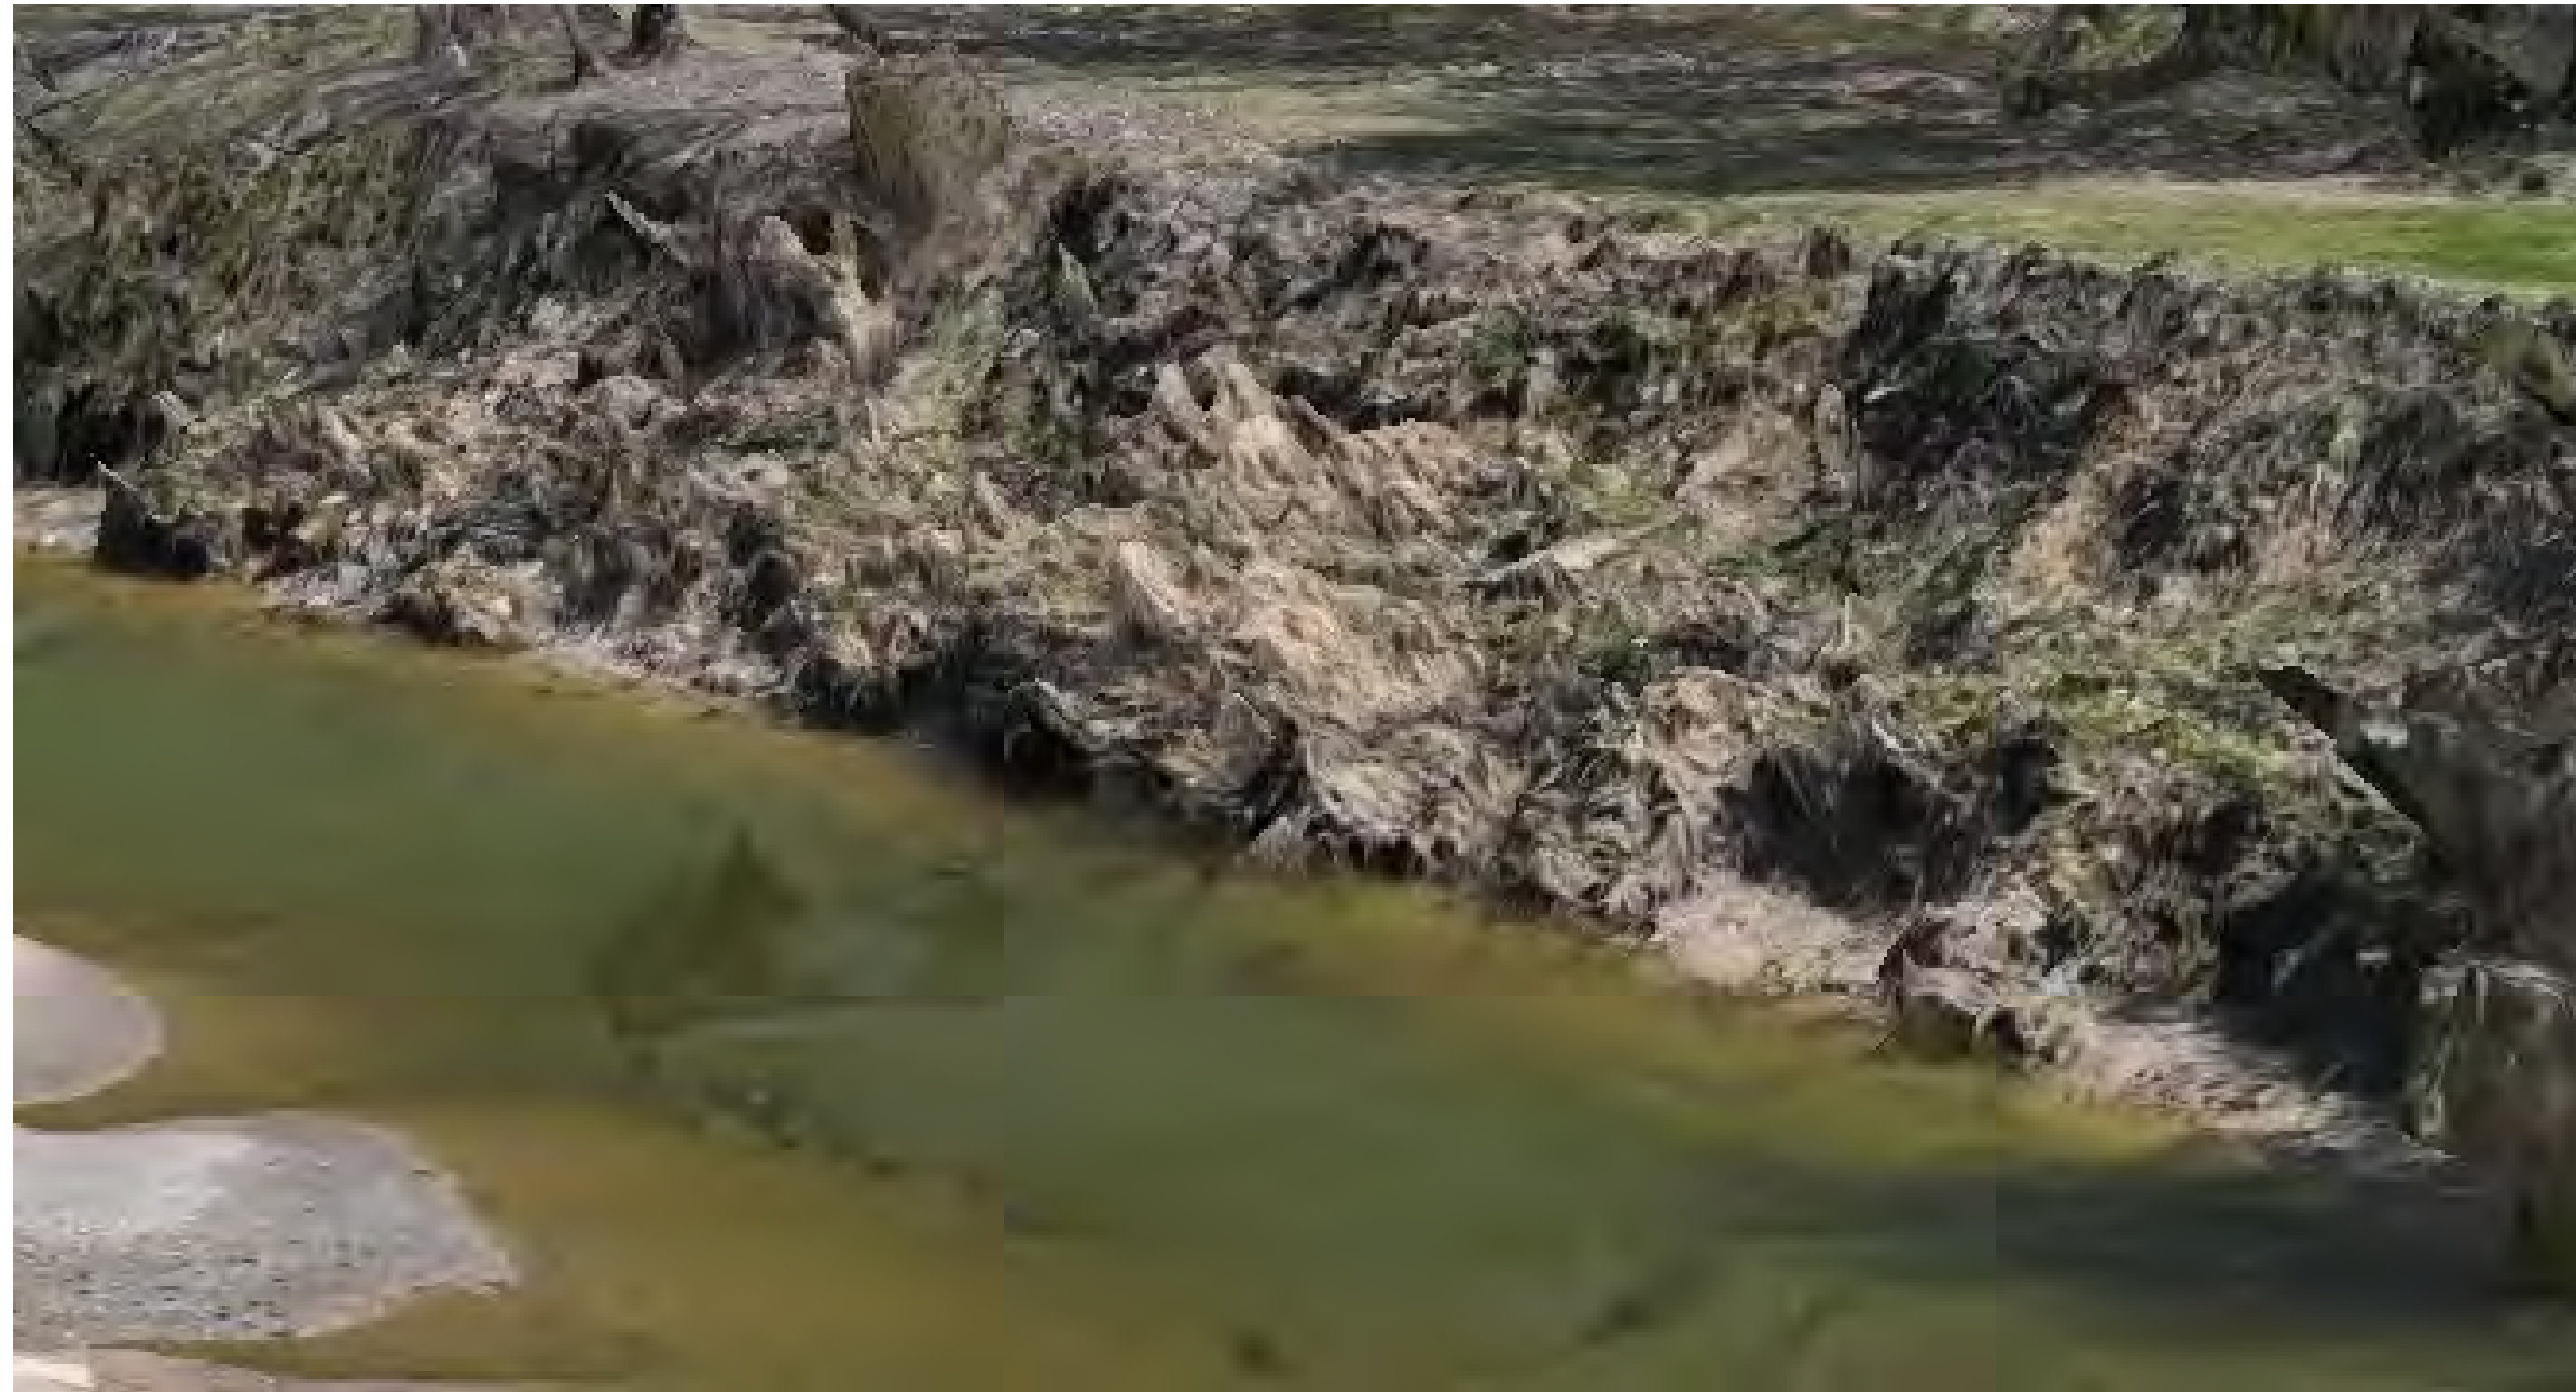
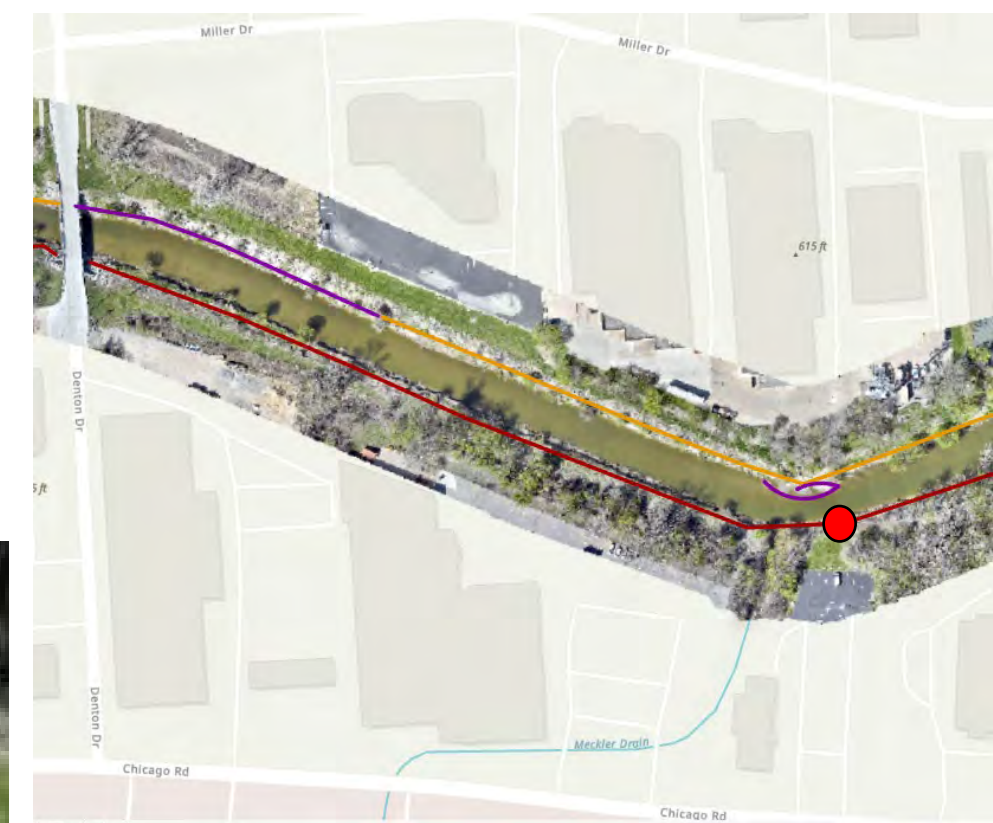
Object ID 19 – Point 10

# BANK CONDITION – Severe Erosion

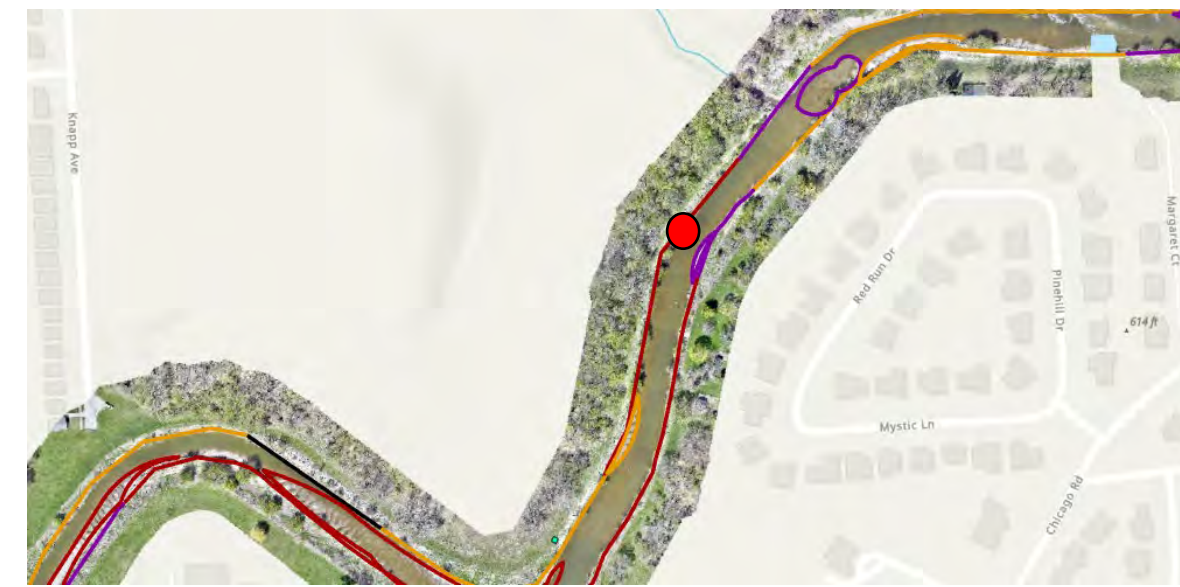
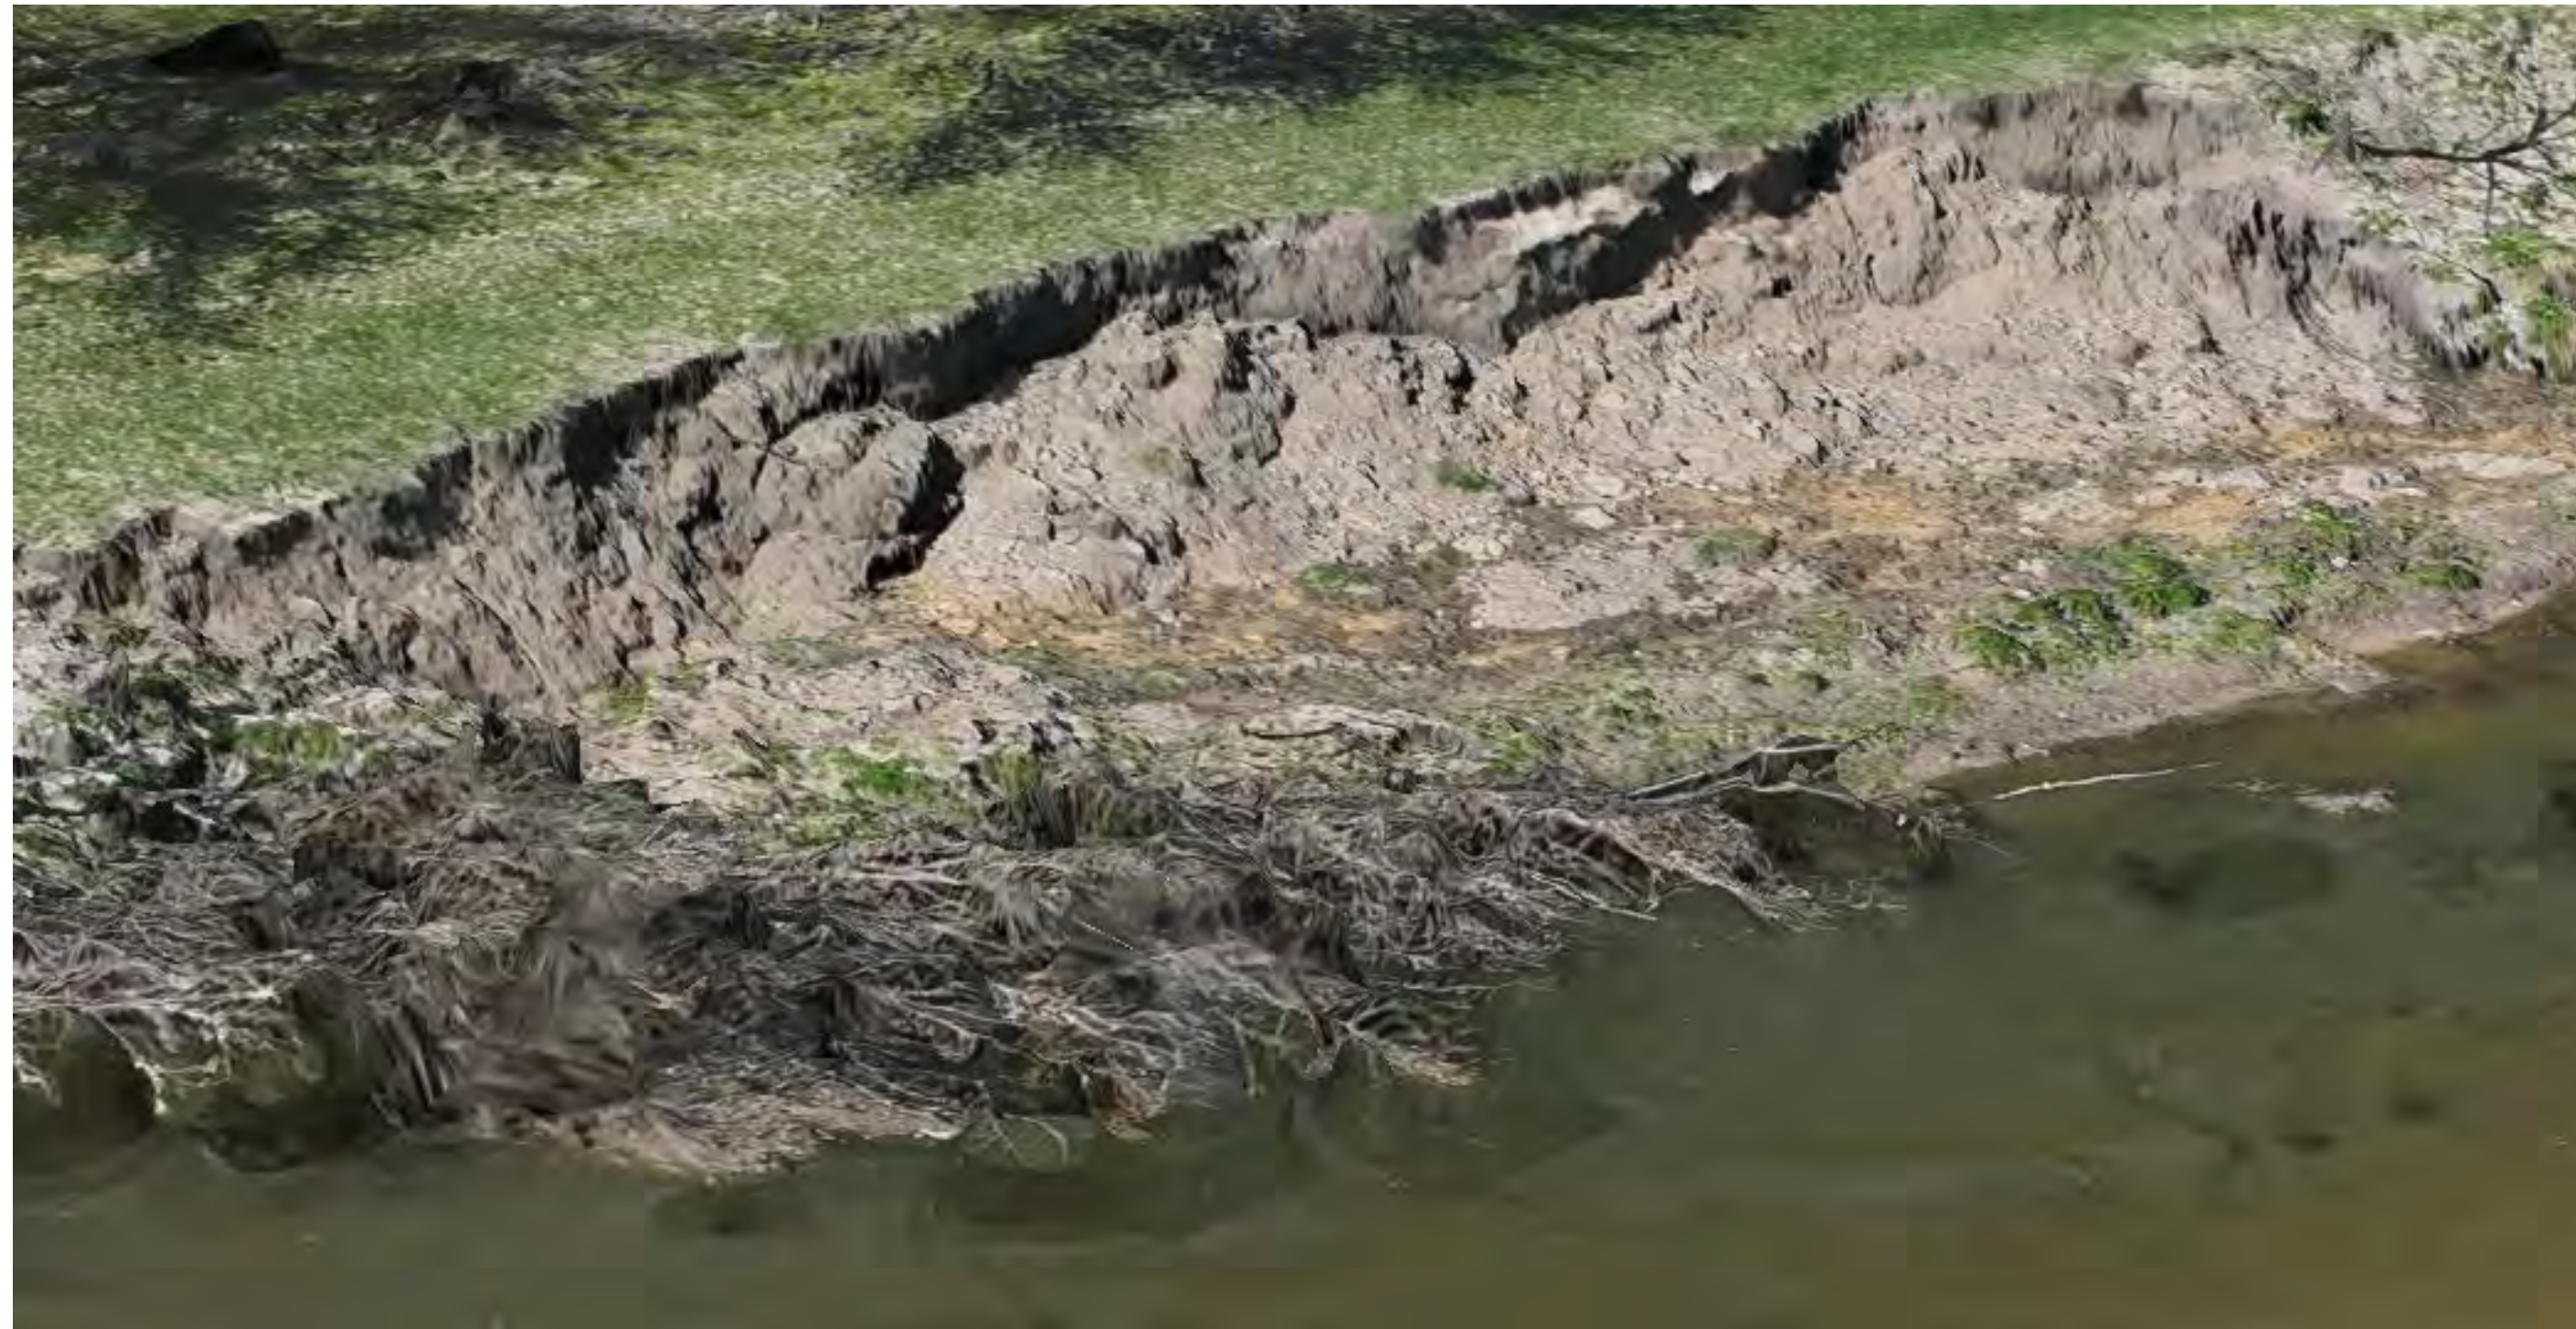
Object ID 30 – Point 2

# BANK CONDITION – Severe Erosion
