Subject: GWK Permit – Red Run Drain Flooding

# **RED RUN INTERCOUNTY DRAIN**

UAS FLIGHT, PROCESS, AND BANK  
CONDITIONS

**Hubbell, Roth & Clark, Inc.**

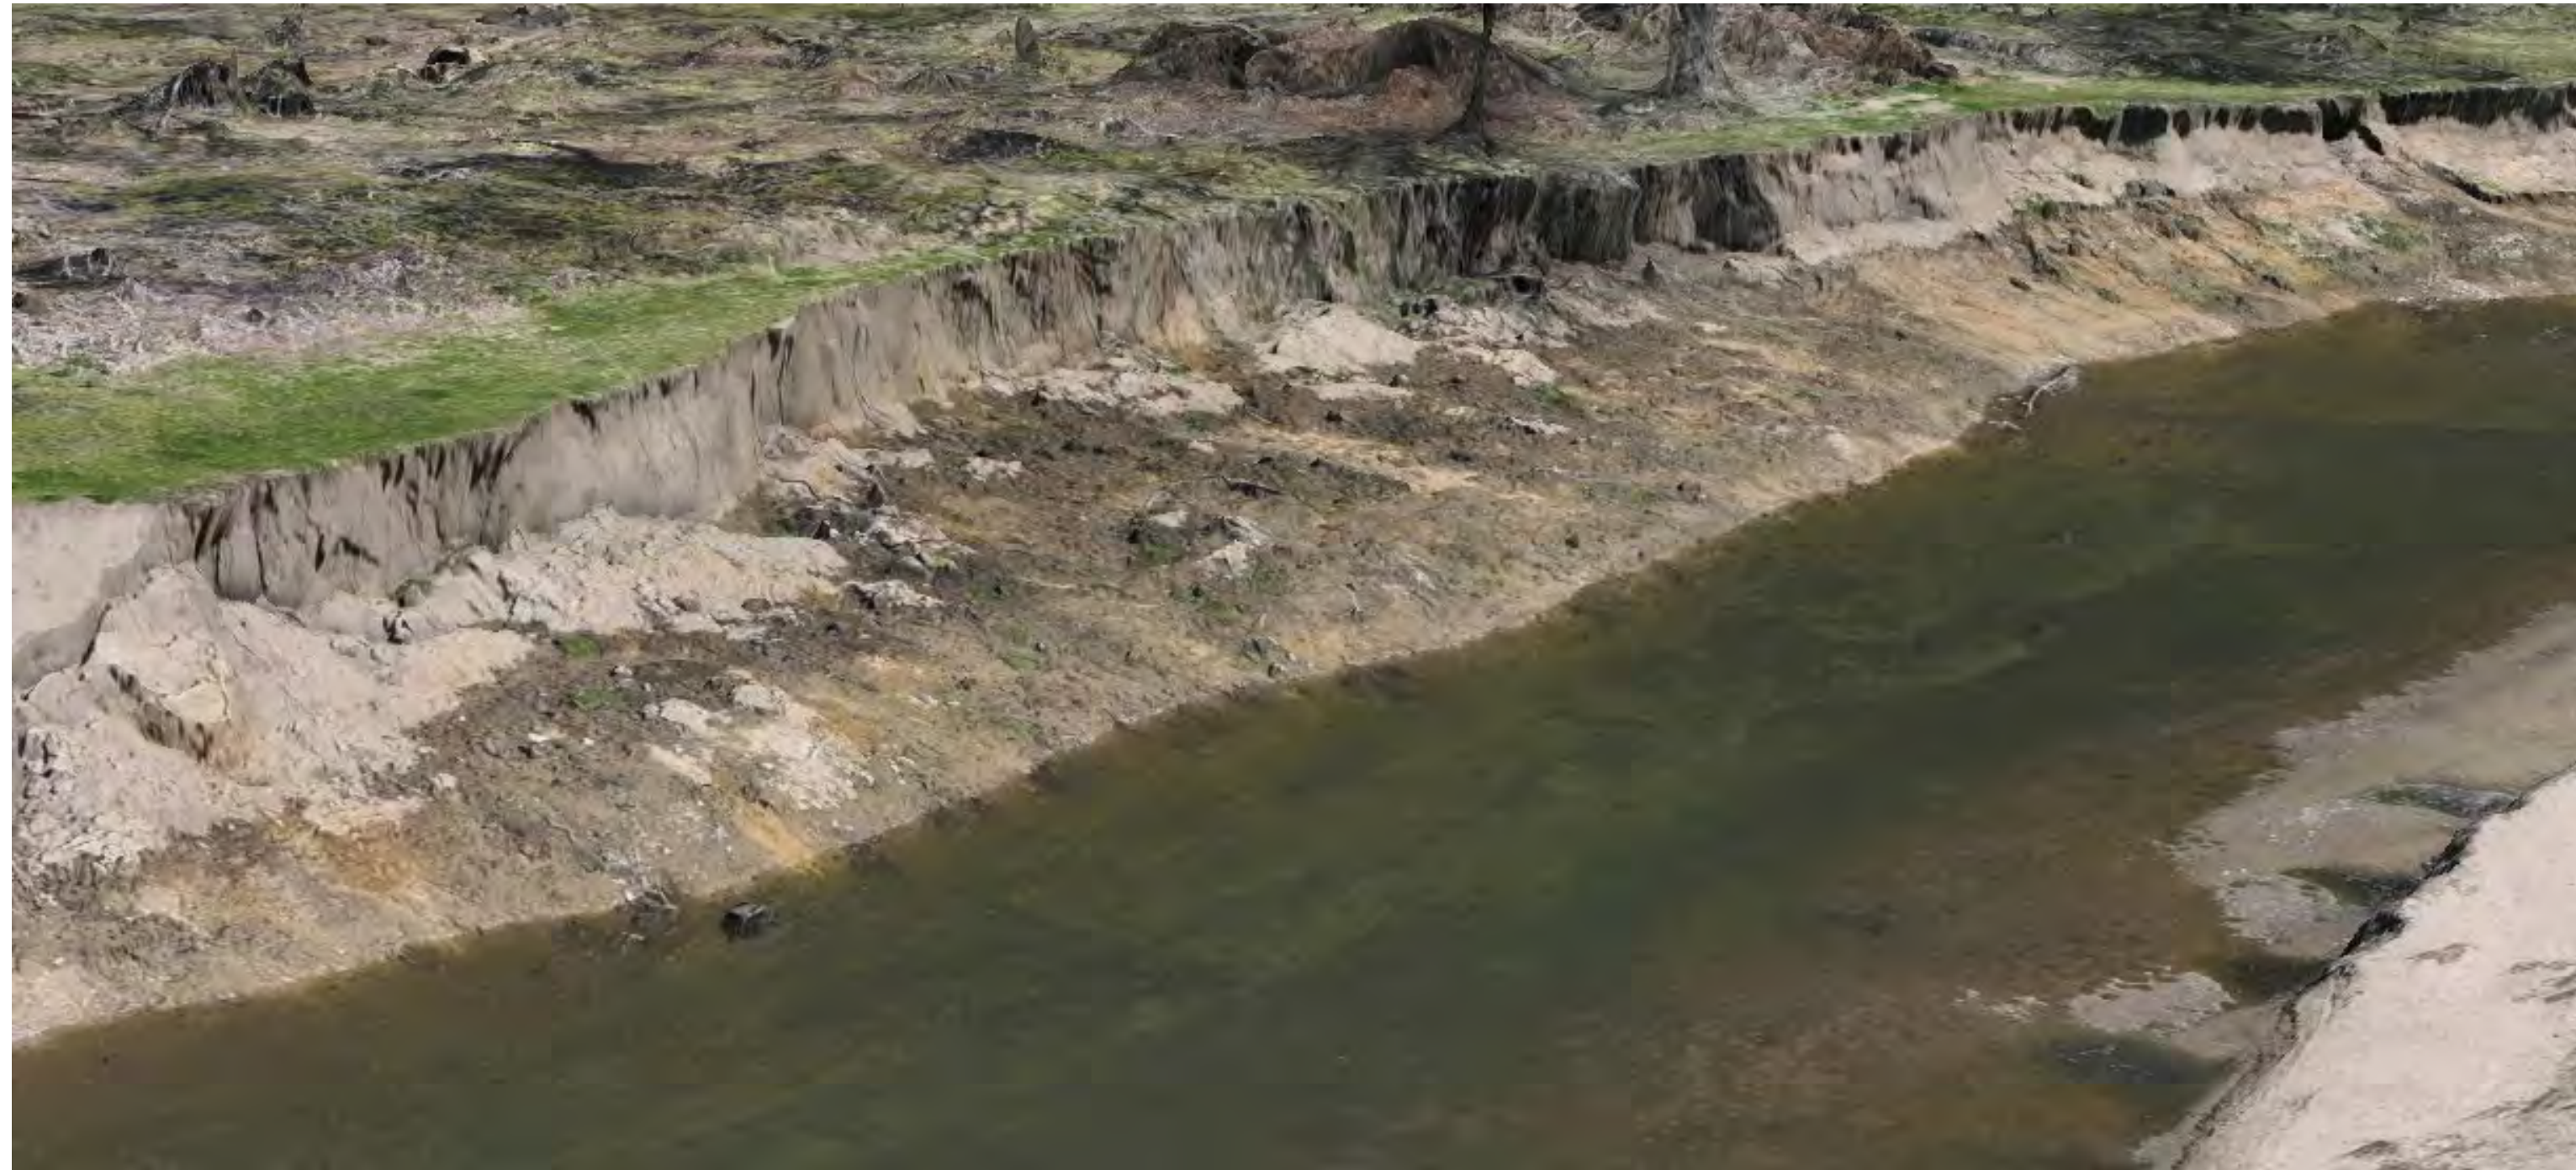
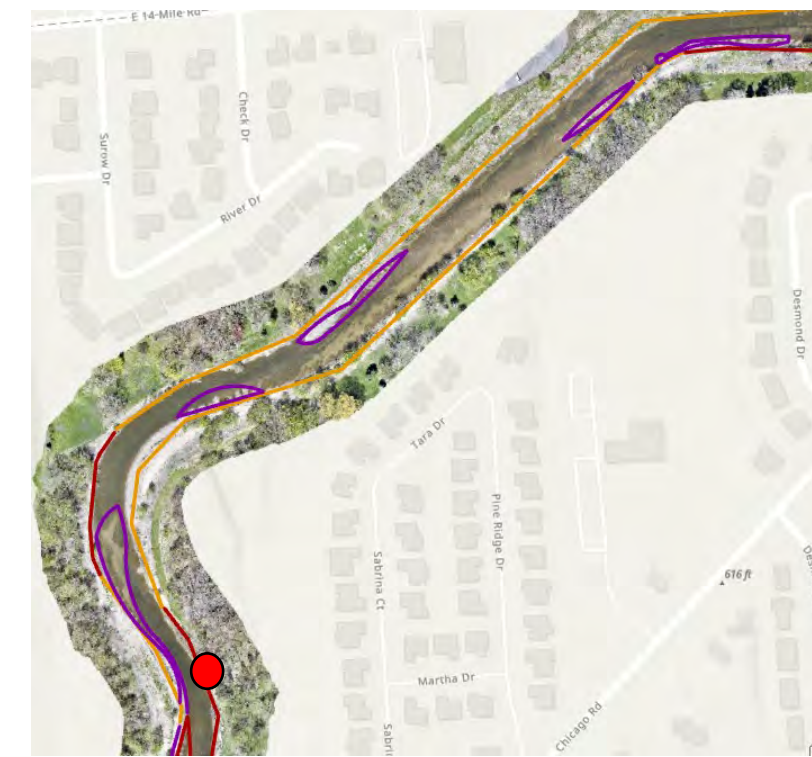
Object ID 24 – Point 4

# BANK CONDITION – Severe Erosion

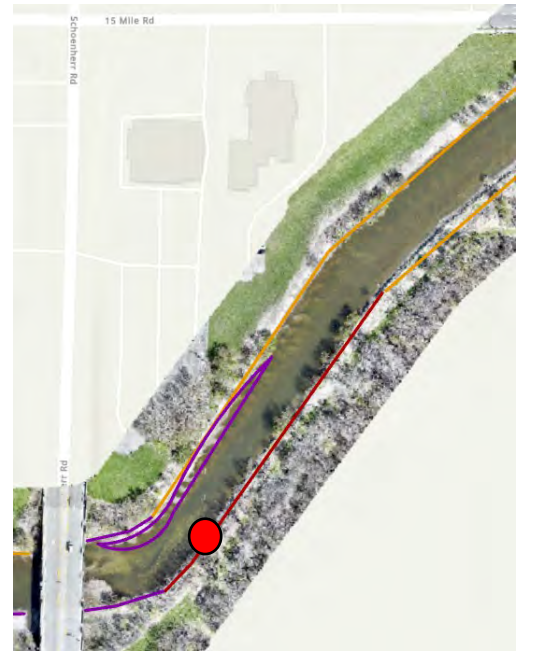
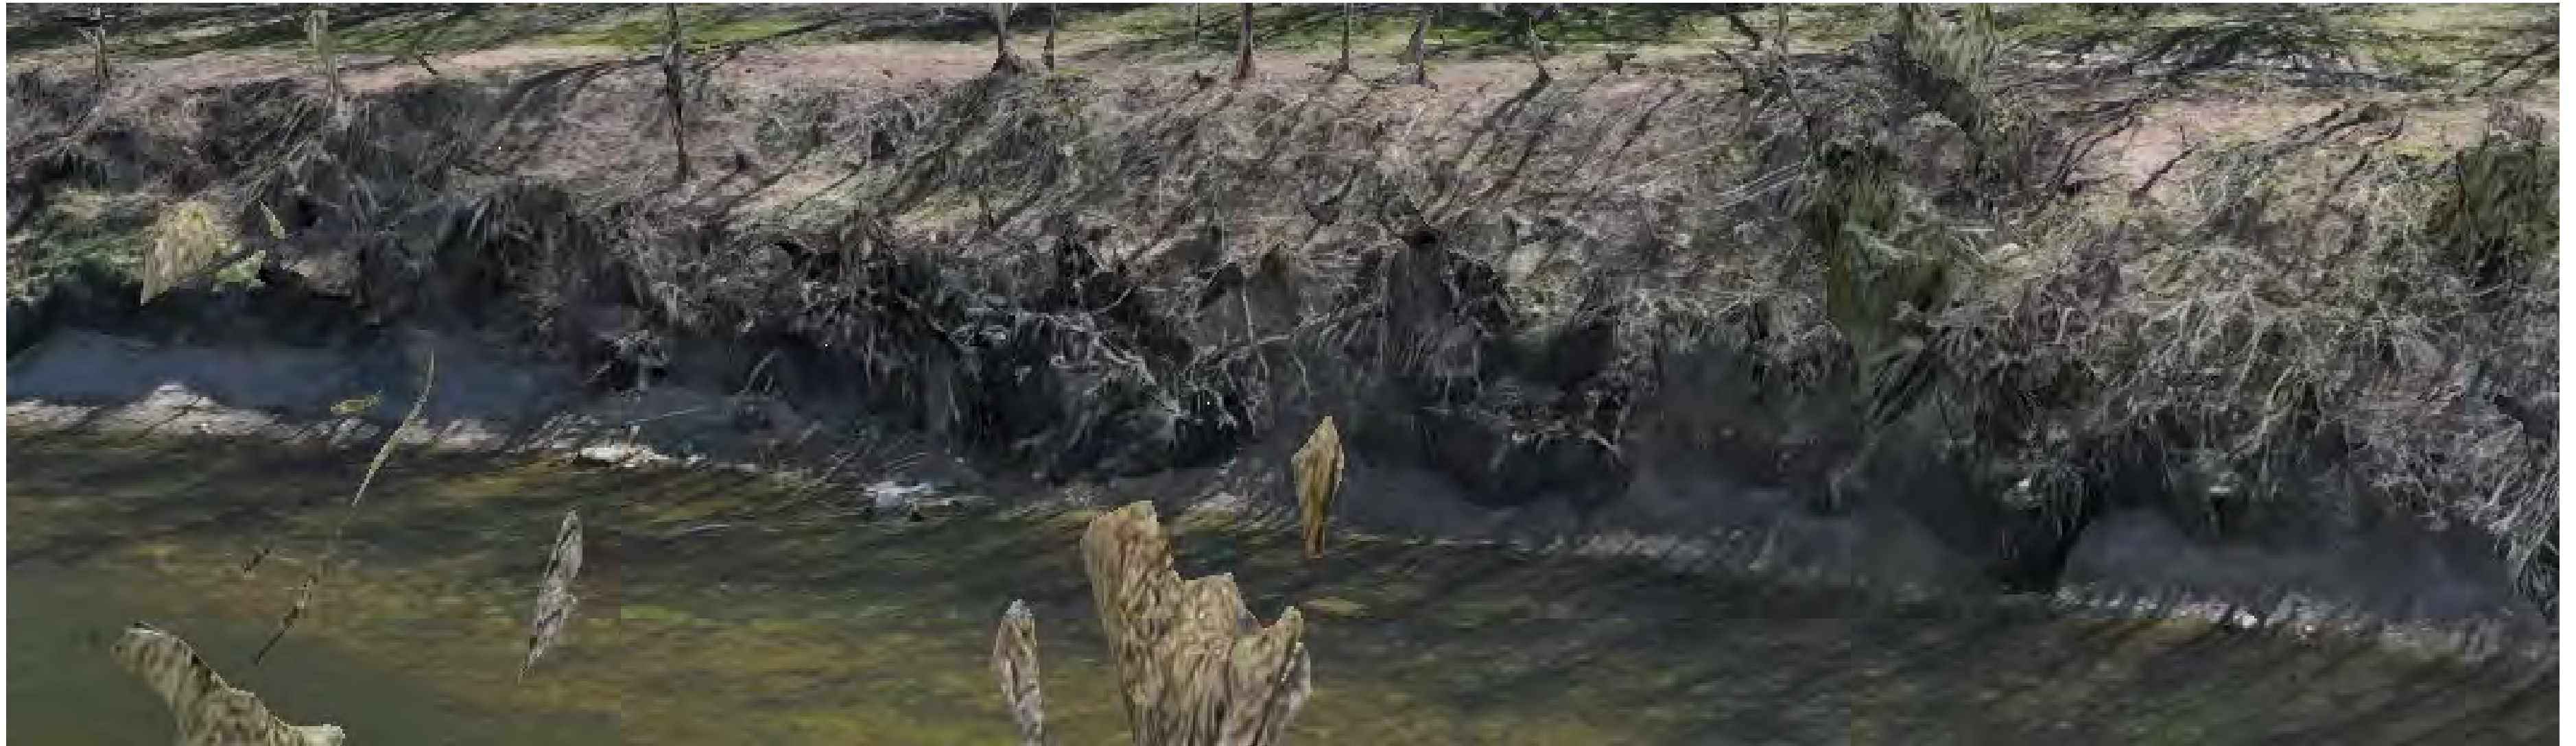
Object ID 27 – Point 9

# BANK CONDITION – Severe Erosion

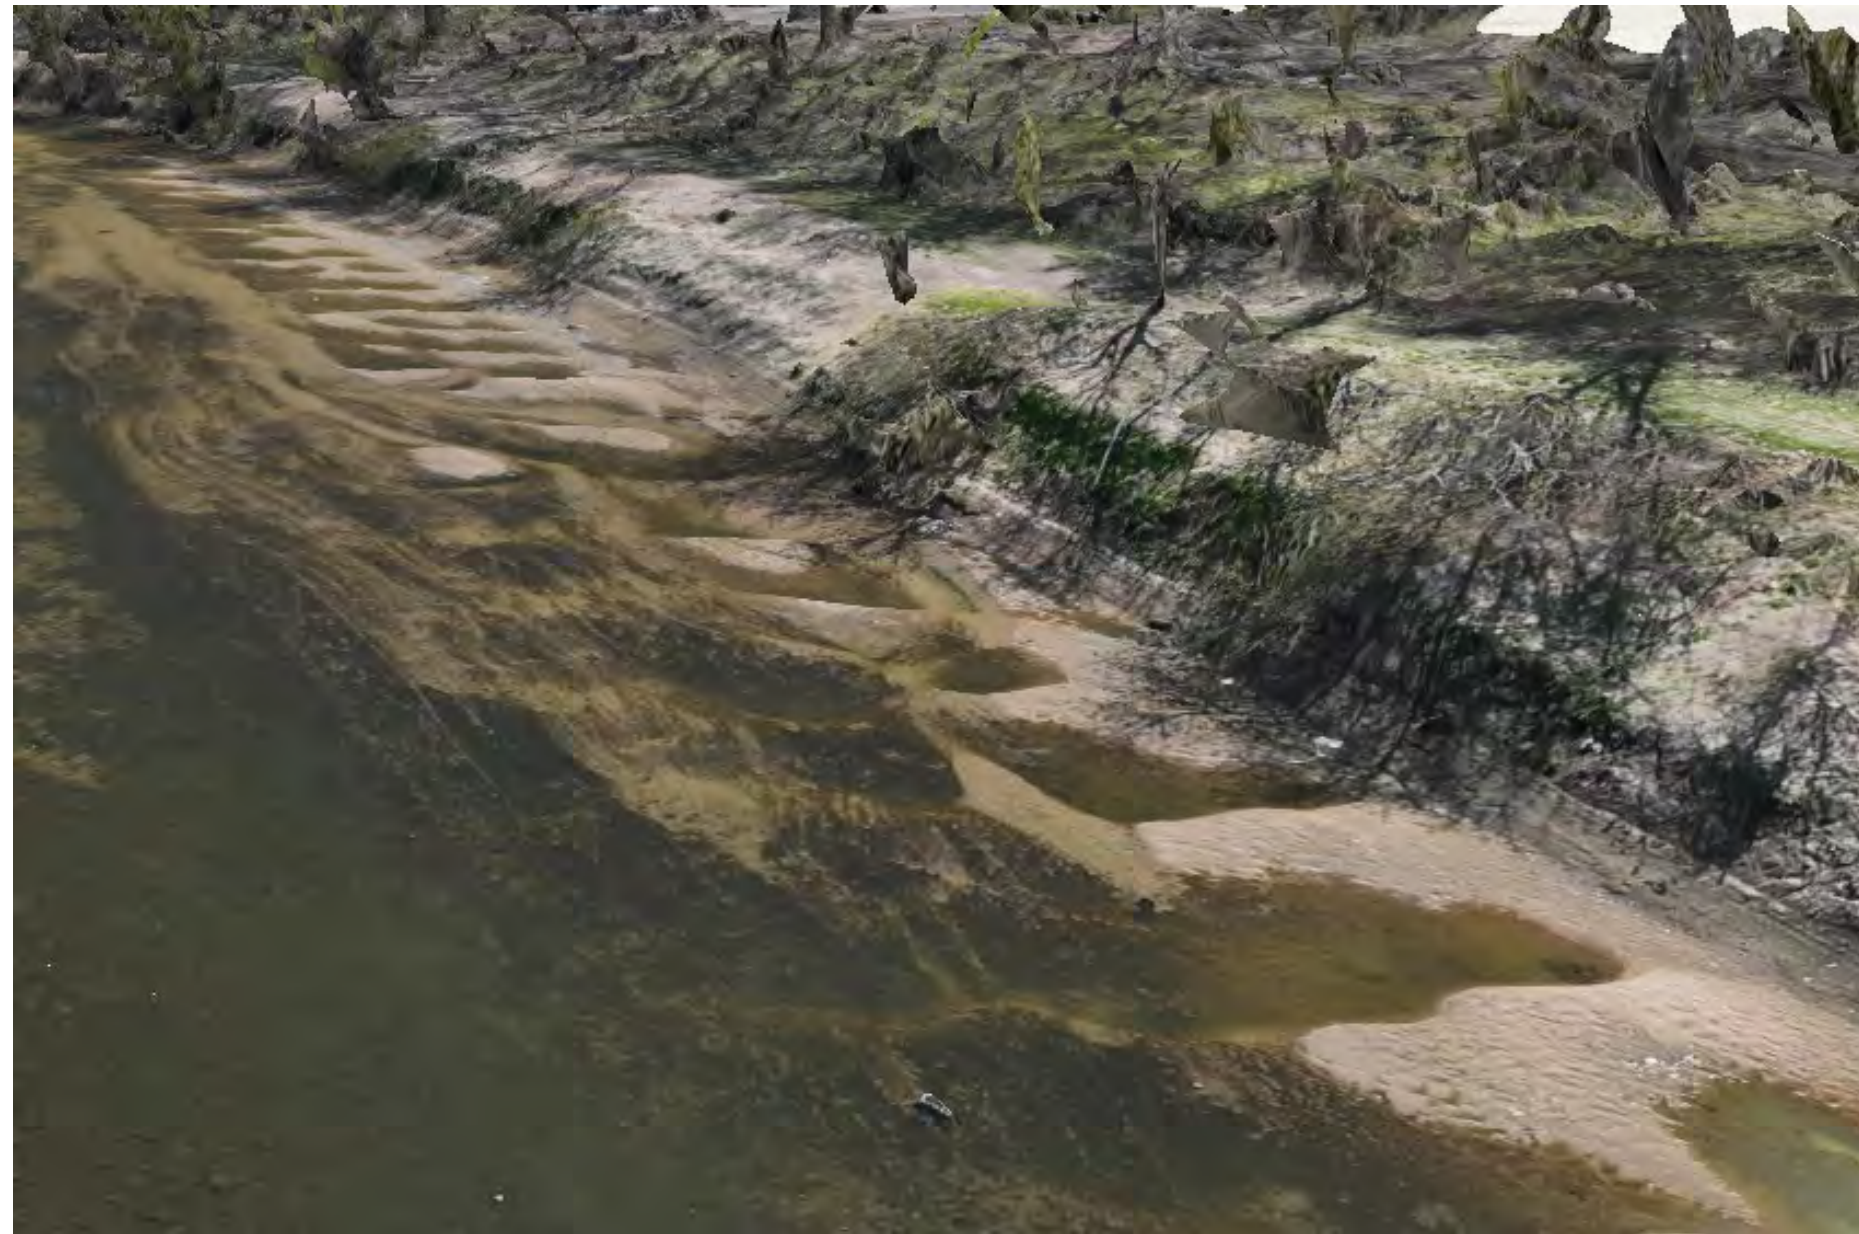
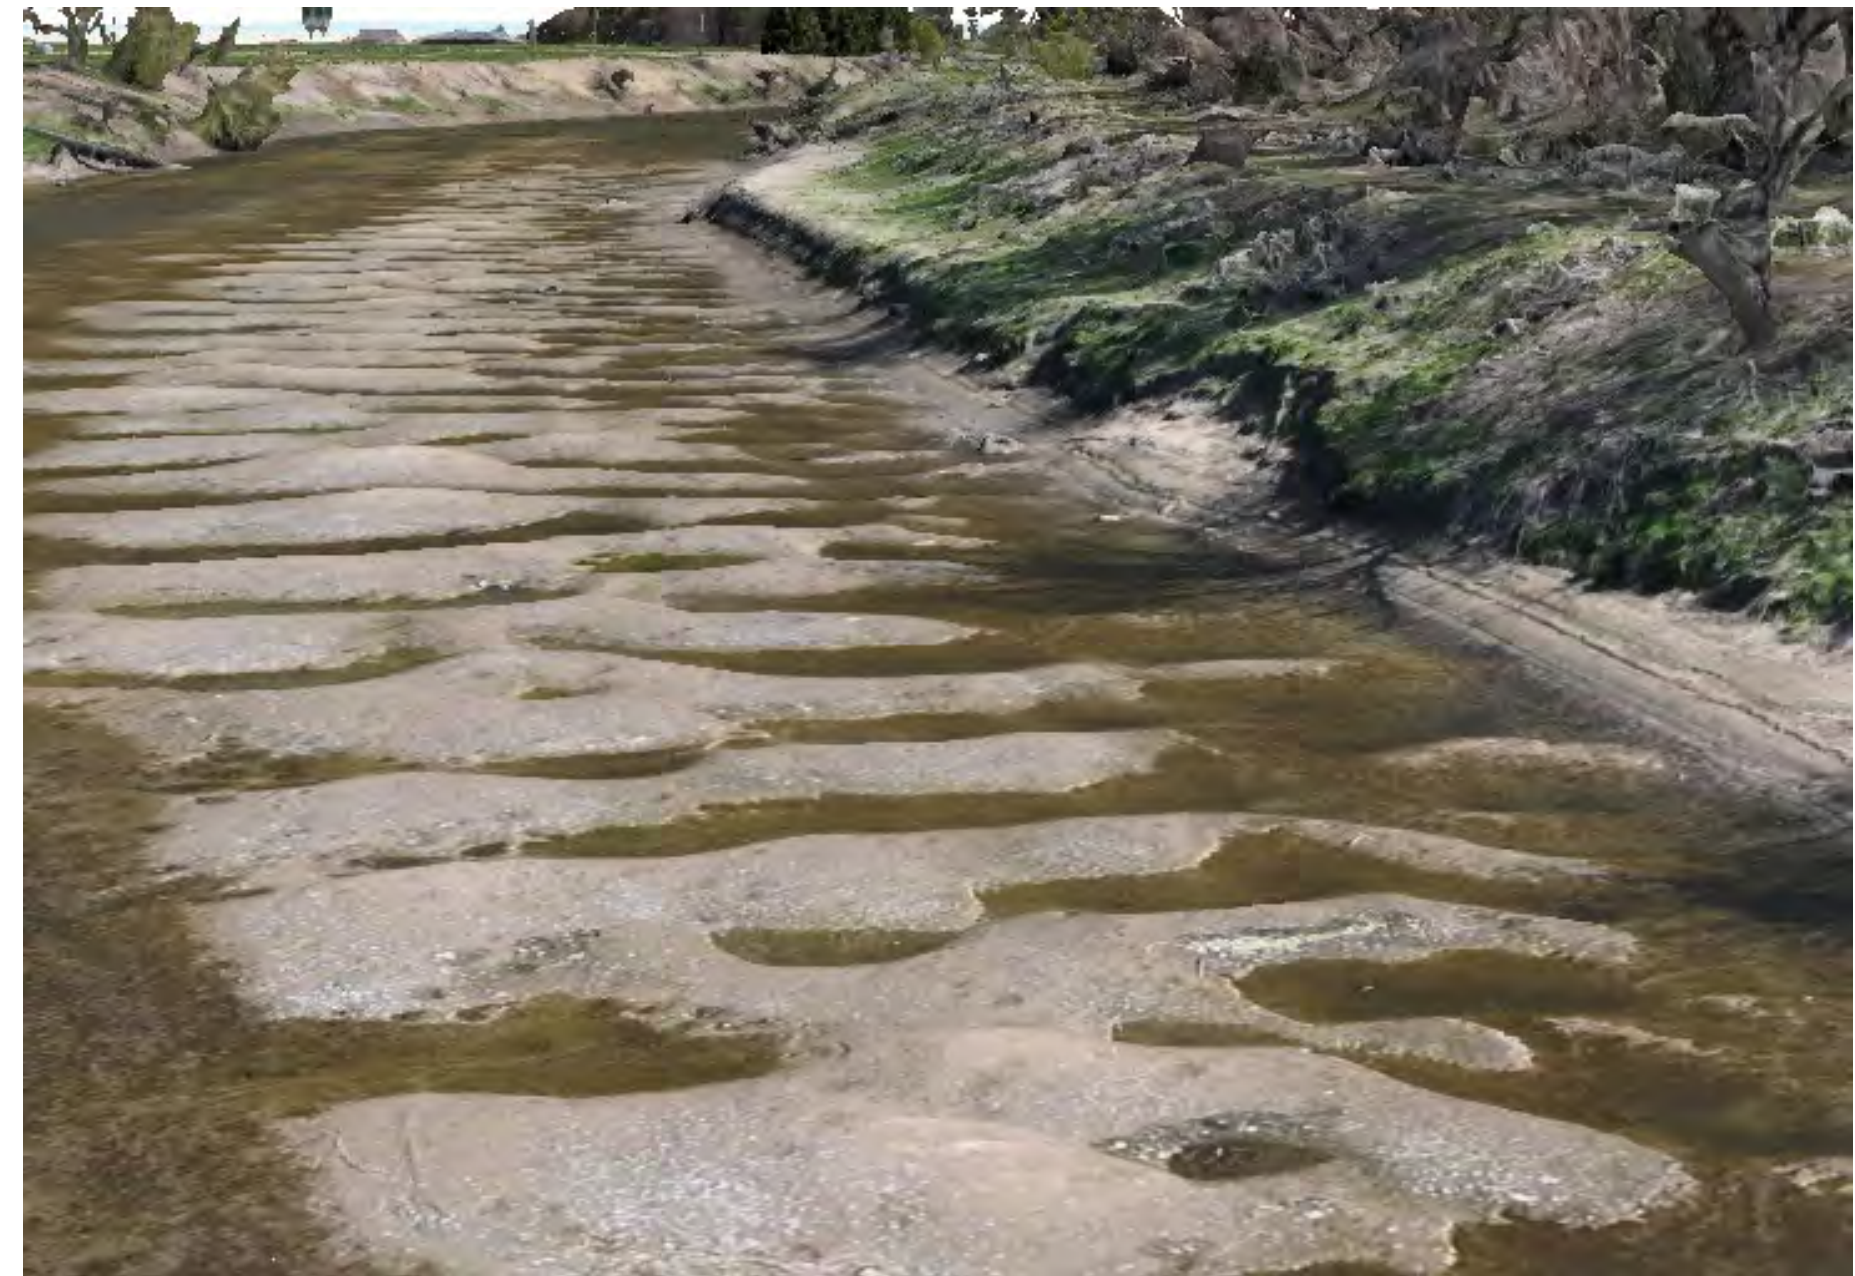
# BANK CONDITION - Shoaling

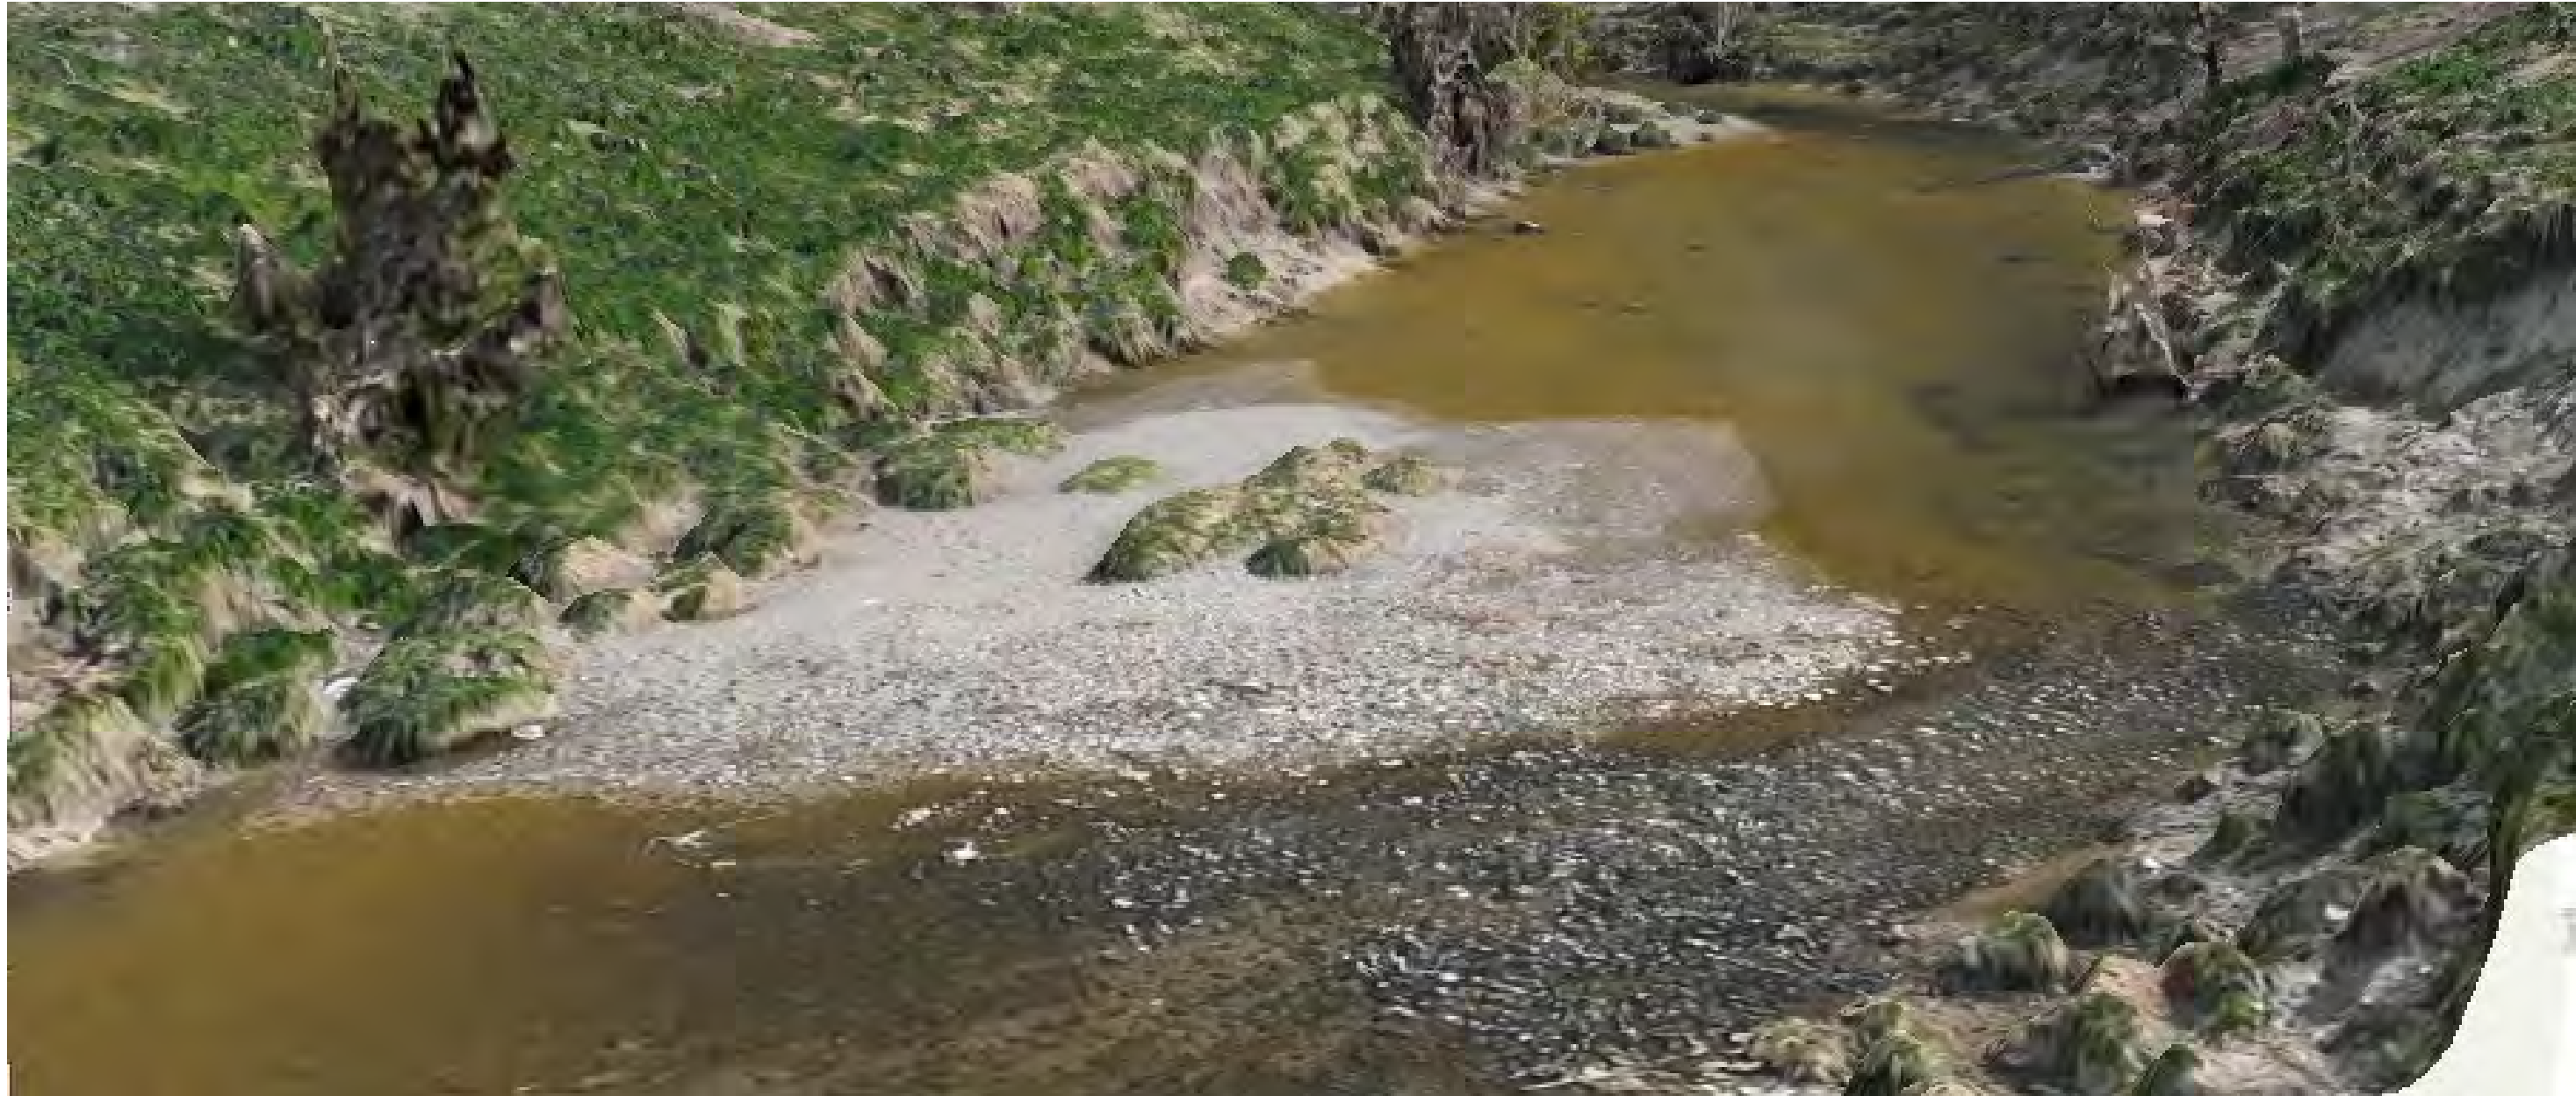
## **BANK CONDITION - Shoaling**

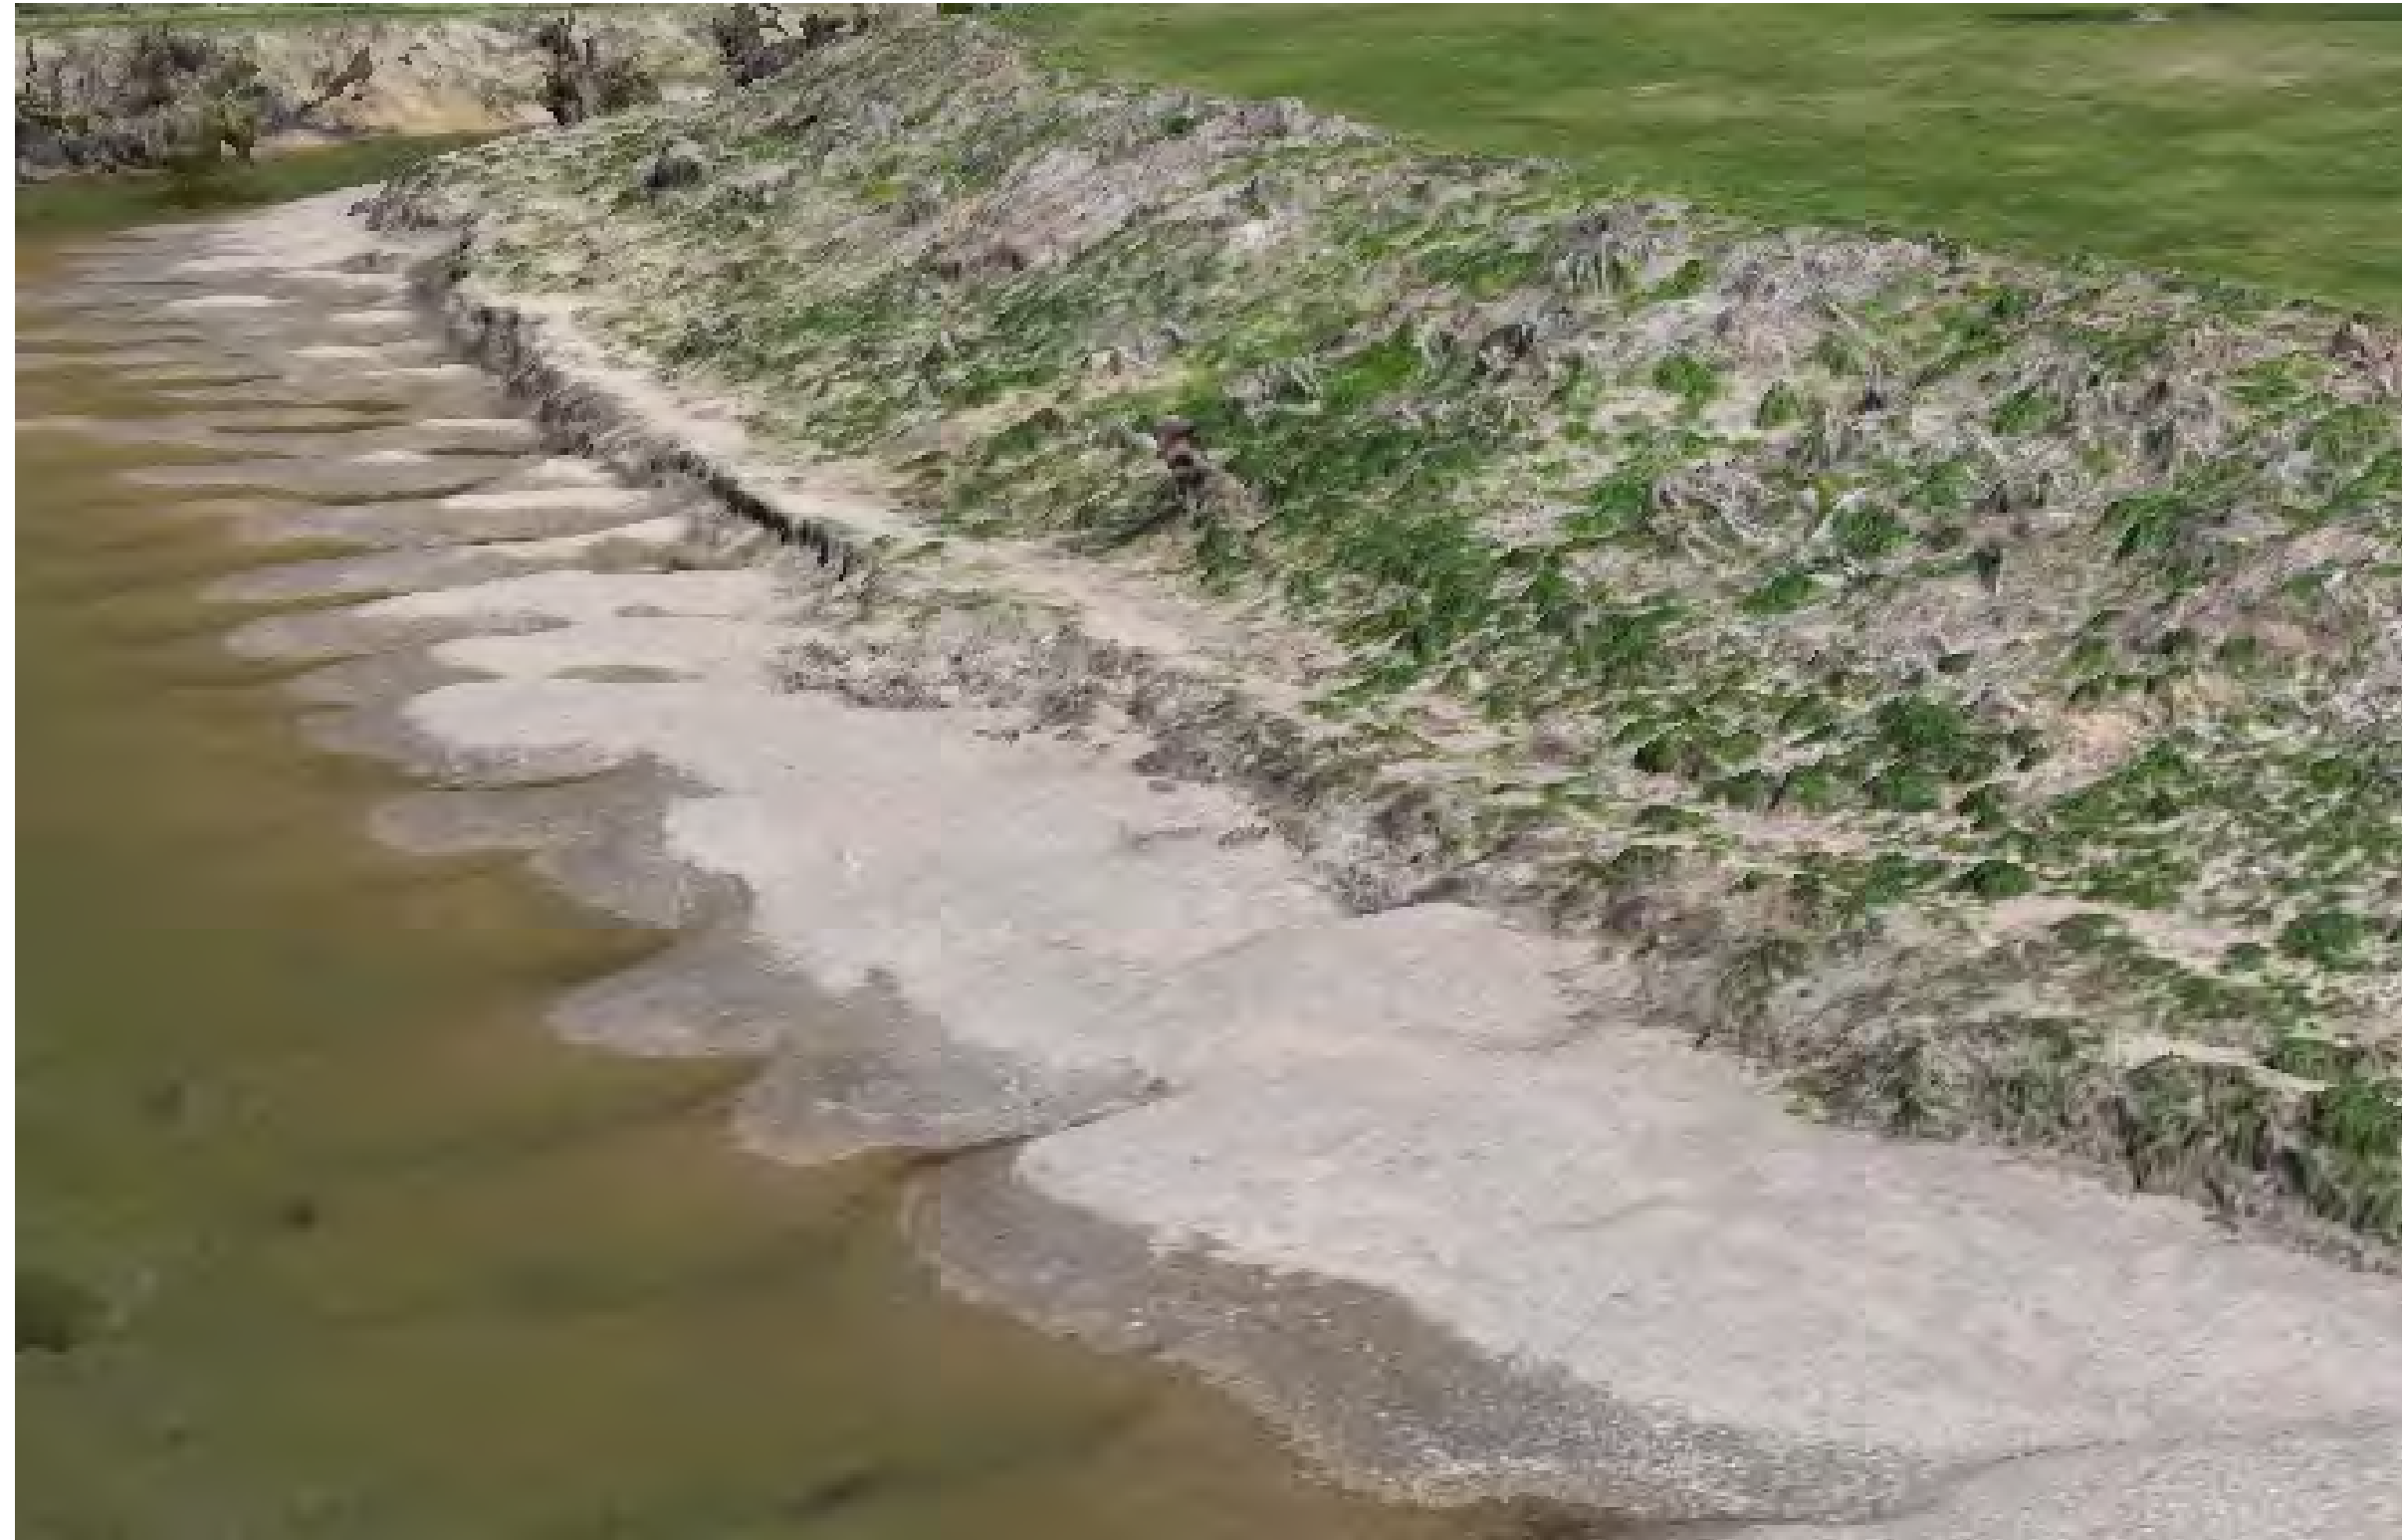
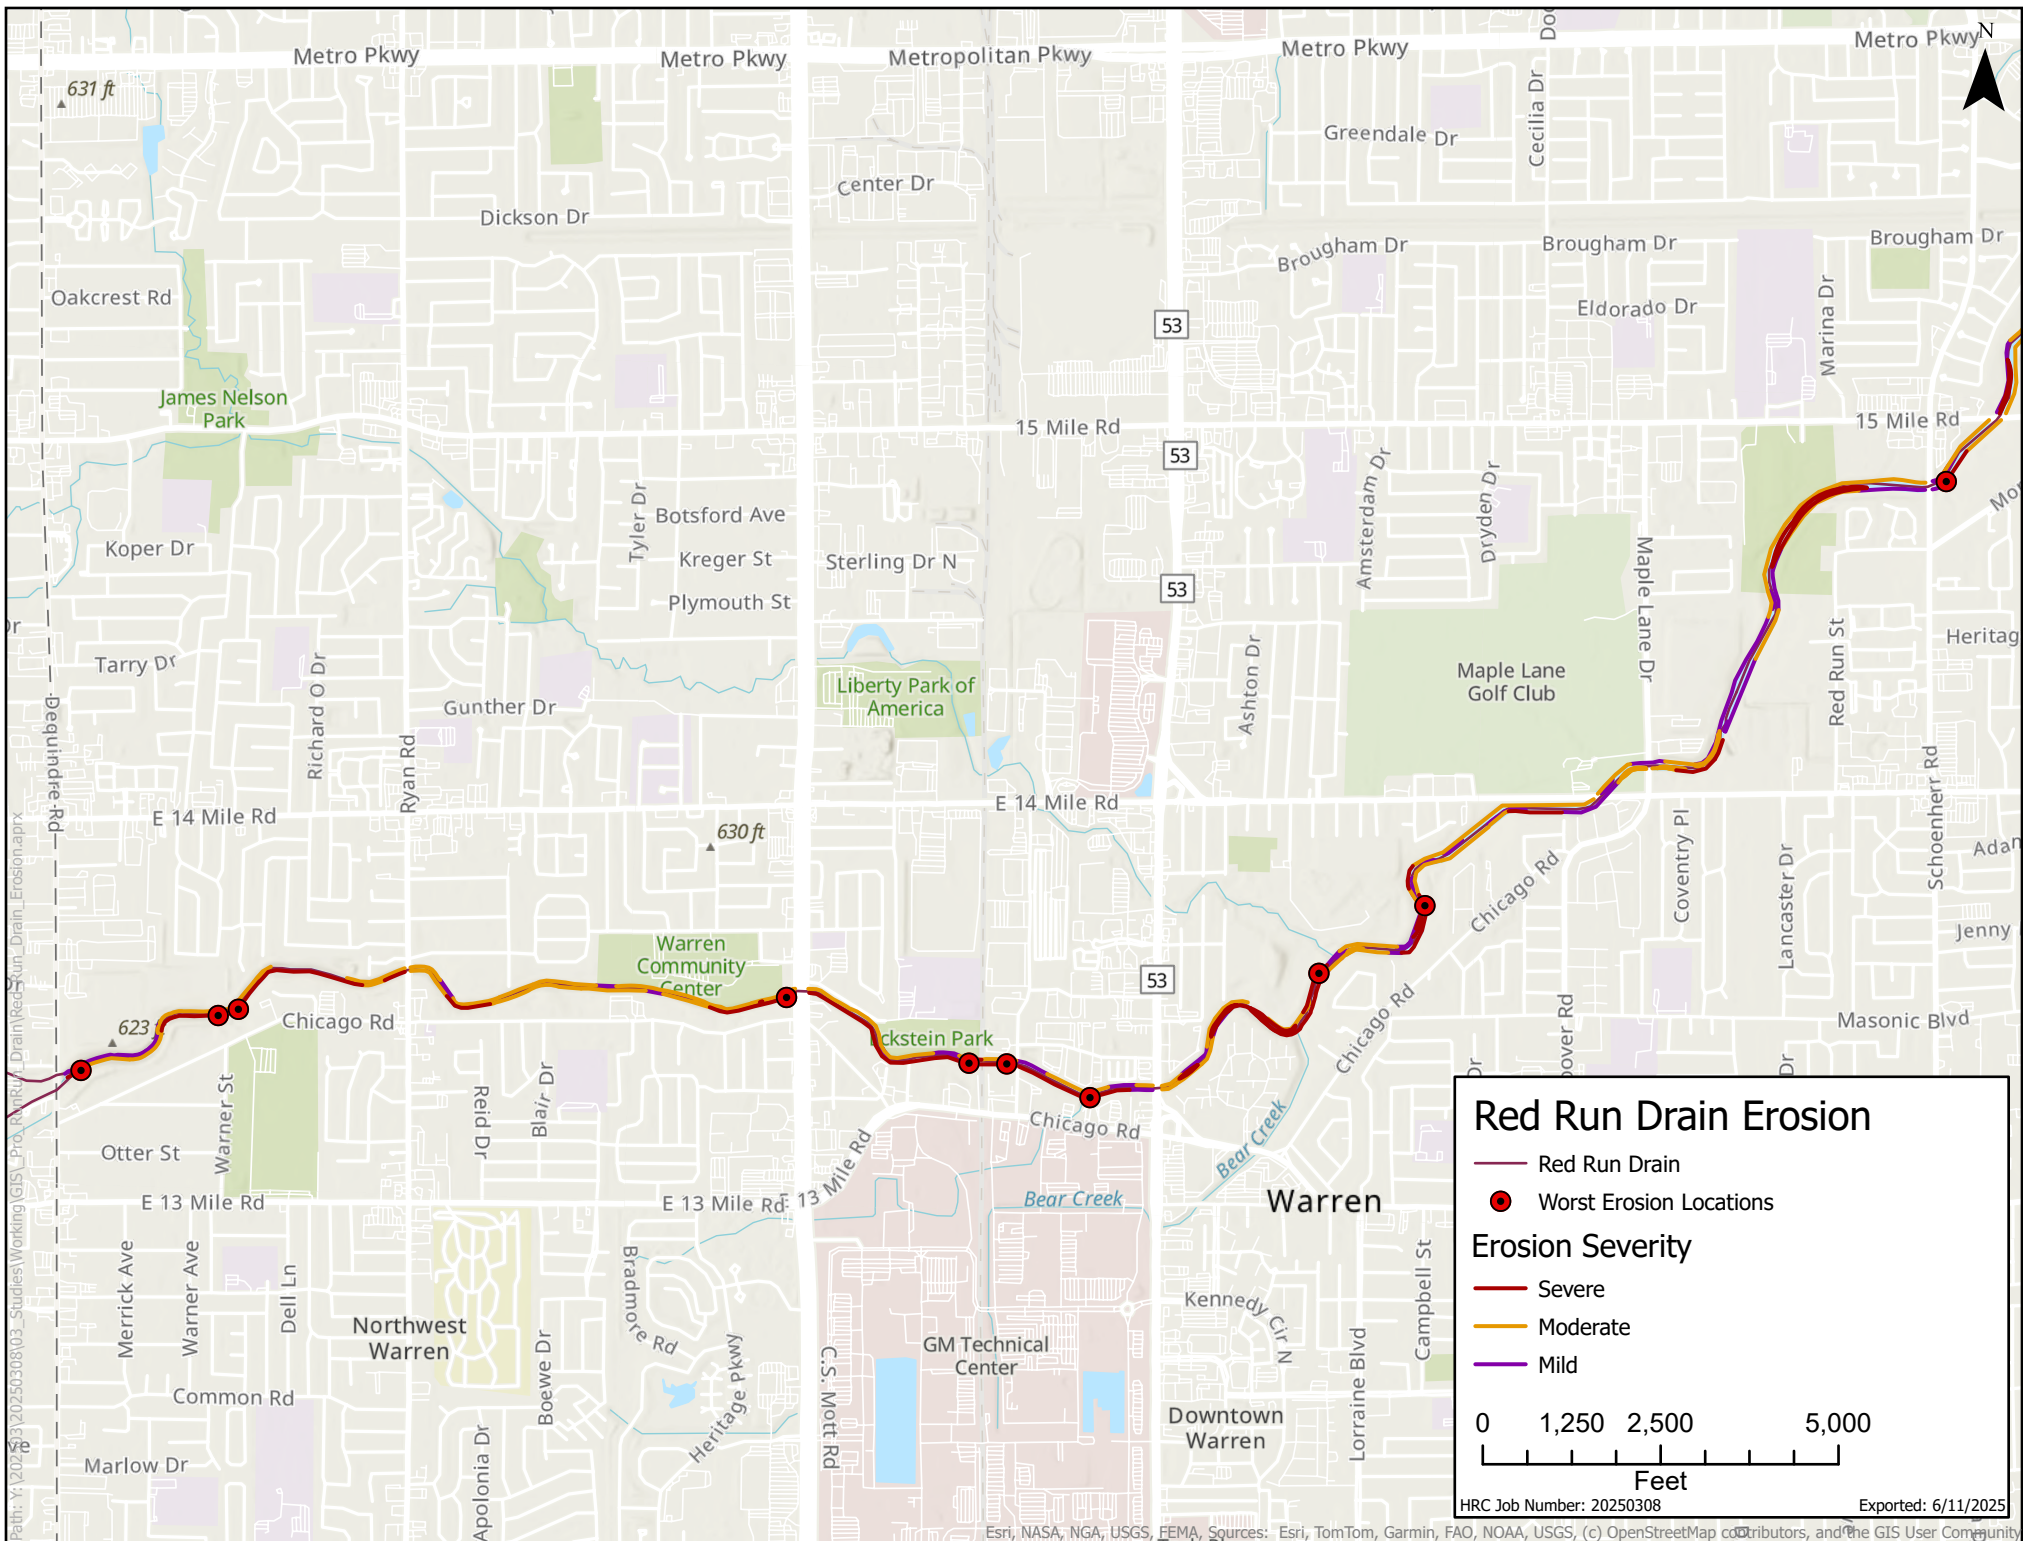
# **BANK CONDITION - Shoaling**

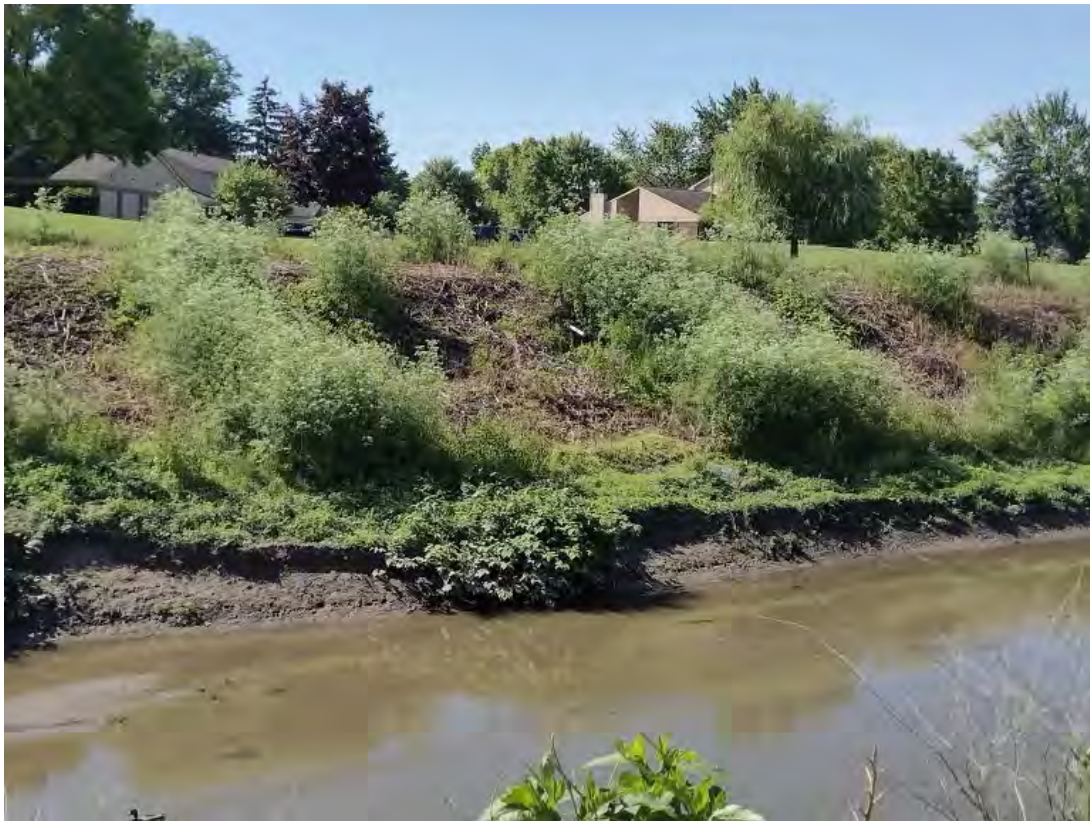
Warren public safety officials believe a man who was mowing his grass near the Red Run fell into the water and died Wednesday night. (SUBMITTED PHOTO)

“The bank is quite steep at that point, but it appears he went upstream and tried to climb out and somehow fell back into the water,” McAdams said.
