AGENDA

Red Run Intercounty Drain Drainage Board Macomb and Oakland Counties

Levee: Red Run Drain

Flood Damage Reduction Channels: Red Run Drain

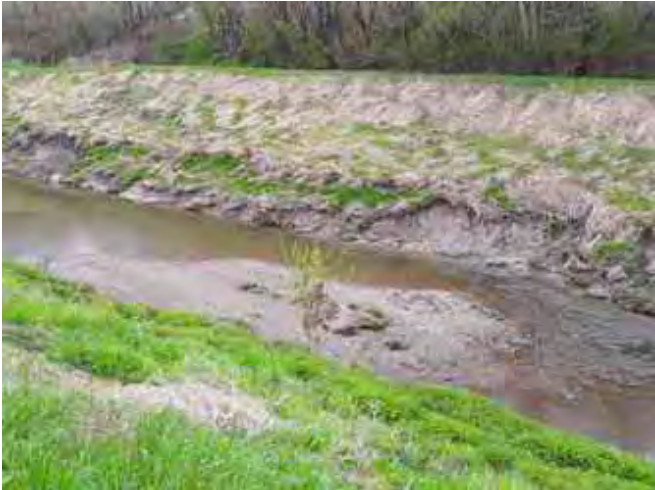
<p>Inspect ID: 2022-0003 Title: 2704000028_CELRE_2022_A_2022-0003_2_20220506T134434.jpg Rated Item: 2. Shoaling (sediment deposition) Caption: Minimally Acceptable - Minor shoaling of channel bottom.</p>

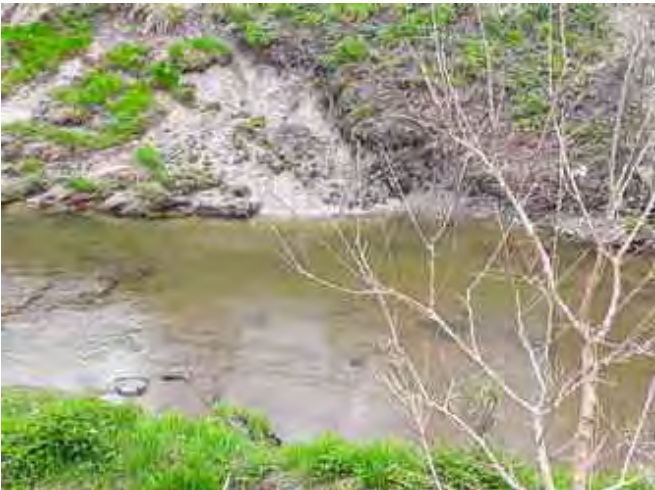
<p>Inspect ID: 2022-0005 Title: 2704000028_CELRE_2022_A_0005_1_20220506T134834.jpg Rated Item: 2. Shoaling (sediment deposition) Caption: Minimally Acceptable - Minor shoaling of channel bottom.</p>

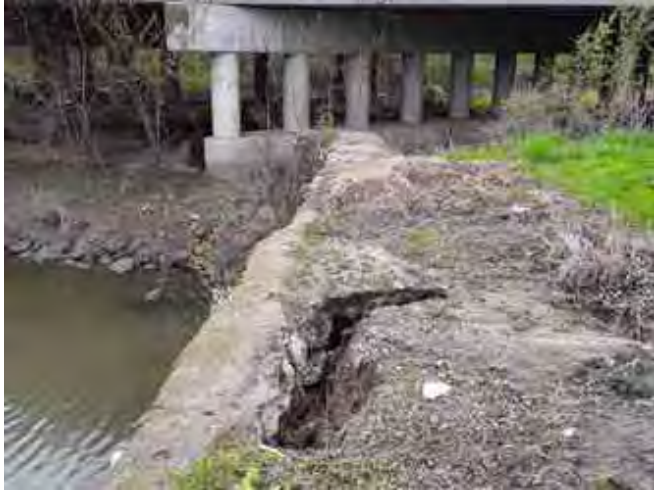
Inspect ID: 2022-0020 **Title:** 2704000028_CELRE_2022_A_0020_2_20220506T163542.jpg
Rated Item: 3. Encroachments **Caption:** Acceptable - An old pump shed noted, sink hole due to corroded pipe underneath. (noted, but not part of project)

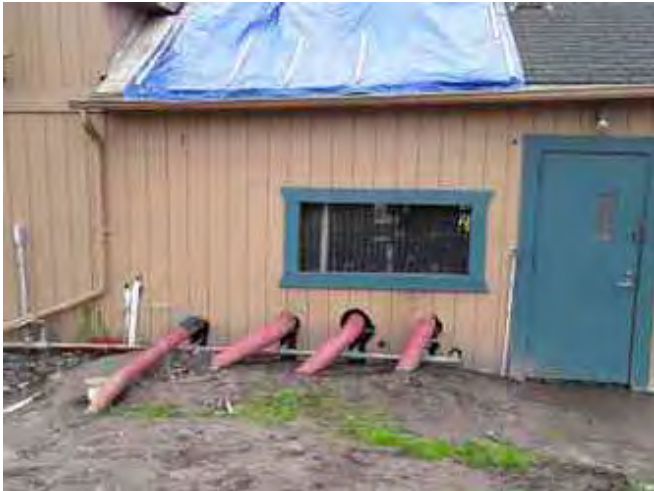
Inspect ID: 2022-0020 **Title:** 2704000028_CELRE_2022_A_2022-0020_6_20220506T163908.jpg
Rated Item: 3. Encroachments **Caption:** Acceptable - An old pump shed noted, sink hole due to corroded pipe underneath. (noted, but not part of project)

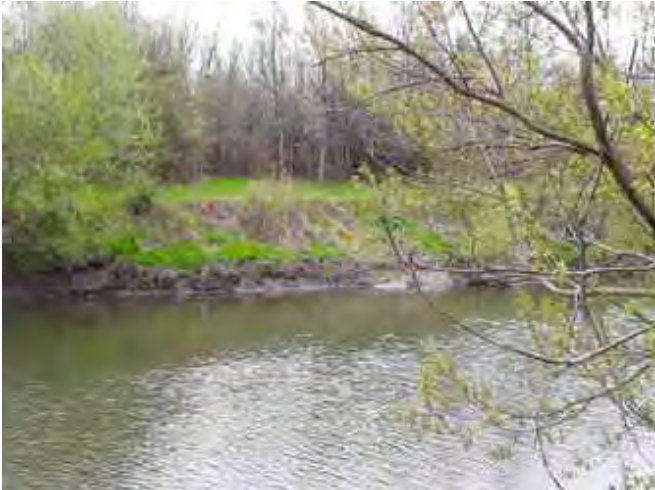
<p>Inspect ID: 2022-0025 Title: 2704000028_CELRE_2022_A_0025_2_20220506T172630.jpg Rated Item: 4. Erosion Caption: Minimally Acceptable - Typical conditions of bank erosion.</p>

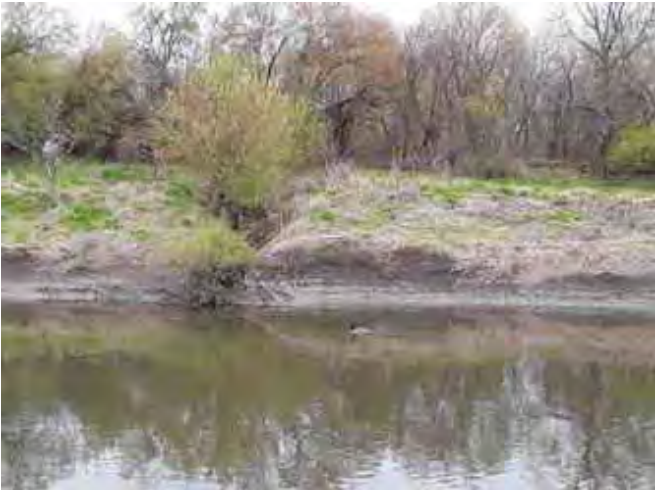
<p>Inspect ID: 2022-0026 Title: 2704000028_CELRE_2022_A_0026_1_20220506T173553.jpg Rated Item: 4. Erosion Caption: Minimally Acceptable - Large depression on bank.</p>

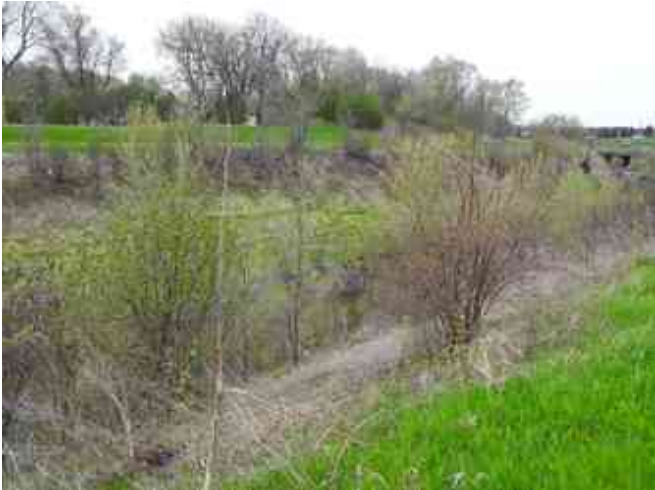
<p>Inspect ID: 2022-0301 Title: 2704000028_CELRE_2022_A_0301_2_20220506T133550.jpg Rated Item: 4. Erosion Caption: Minimally Acceptable - Erosion, slope stability. Overly steep slopes with past failures.</p>

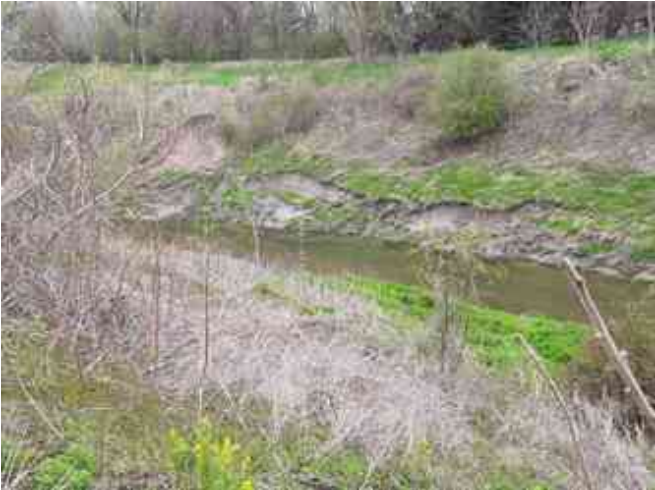
<p>Inspect ID: 2022-0302 Title: 2704000028_CELRE_2022_A_0302_1_20220506T133909.jpg Rated Item: 4. Erosion Caption: Minimally Acceptable - Slope failures.</p>

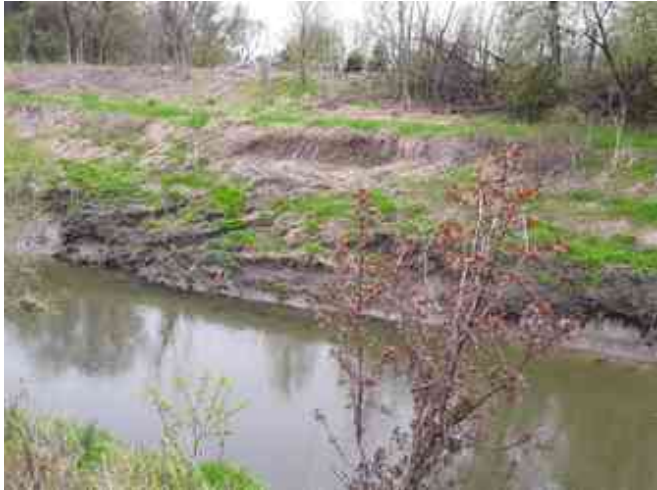
<p>Inspect ID: 2022-0315 Title: 2704000028_CELRE_2022_A_0315_1_20220506T140928.jpg Rated Item: 4. Erosion Caption: Minimally Acceptable - Bank failure.</p>

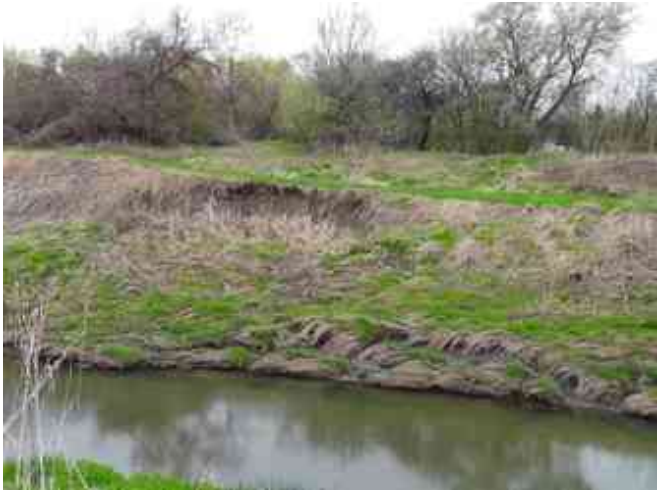
<p>Inspect ID: 2022-0316 Title: 2704000028_CELRE_2022_A_0316_1_20220506T141036.jpg Rated Item: 4. Erosion Caption: Unacceptable - Bank failure.</p>

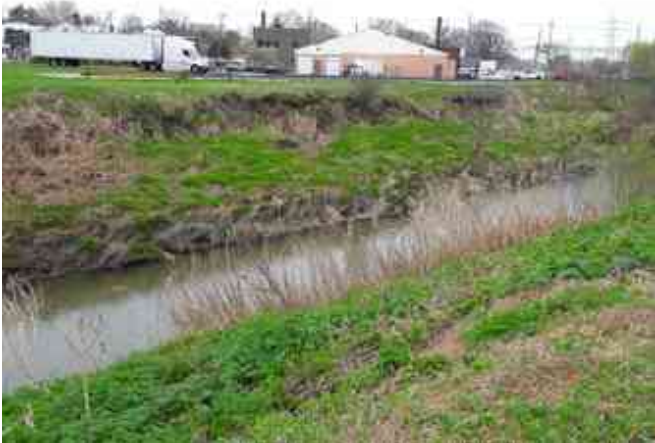
Rated Item	Rating	Rating Guidelines		Location/Remarks/Recommendations
4. Erosion	U	A	No head cutting or horizontal deviation observed.	2022-0002 : Steep slopes. Toe erosion. (M)
		M	Head cutting and horizontal deviation evident, but is less than 1 foot from the designed grade or cross section.	2022-0009 : Toe erosion (M) 2022-0011 : Bank erosion. (M) 2022-0012 : Toe erosion. Outlet location noticed. (M)
		U	Head cutting and horizontal deviation of more than 1 foot from the designed grade or cross section. Corrective actions required to stop or slow erosion.	2022-0013 : Bank erosion. (M) 2022-0014 : Bank and toe erosion. (M) 2022-0015 : Sloughing of bank. (M) 2022-0017 : Bank and toe erosion under Denton Dr bridge. (M) 2022-0018 : Typical condition of toe erosion. (M) 2022-0021 (U) 2022-0024 : Bank and toe erosion. (M) 2022-0025 : Typical conditions of bank erosion. (M) 2022-0026 : Large depression on bank. (M) 2022-0029 : Eroded banks. (M) 2022-0300 : Toe erosion. (M) 2022-0301 : Erosion, slope stability. Overly steep slopes with past failures. (M) 2022-0302 : Slope failures. (M) 2022-0303 : S : Toe erosion. (M) 2022-0304 : Heavier erosion of bank. Access road unsafe. (U) 2022-0305 : Recent slope failure. (M) 2022-0306 : Toe and bank erosion. (M) 2022-0309 : Repaired areas stable. (A) 2022-0310 : Typical erosion. (M) 2022-0313 : Toe erosion. Outlet location also noted. (M) 2022-0314 : Recent failure (M) 2022-0315 : Bank failure. (M) 2022-0316 : Bank failure. (U) 2022-0317 : Toe erosion. (M) 2022-0319 : Toe erosion. (M) 2022-0320 : Heavier slope failure, bank and toe. (U) 2022-0323 : Recent slope failure (U) 2022-0324 : Heavy erosion around manhole (M)

<p>Inspect ID: 2022-0323 Title: 2704000028_CELRE_2022_A_0323_1_20220506T145420.jpg Rated Item: 4. Erosion Caption: Unacceptable - Recent slope failure</p>

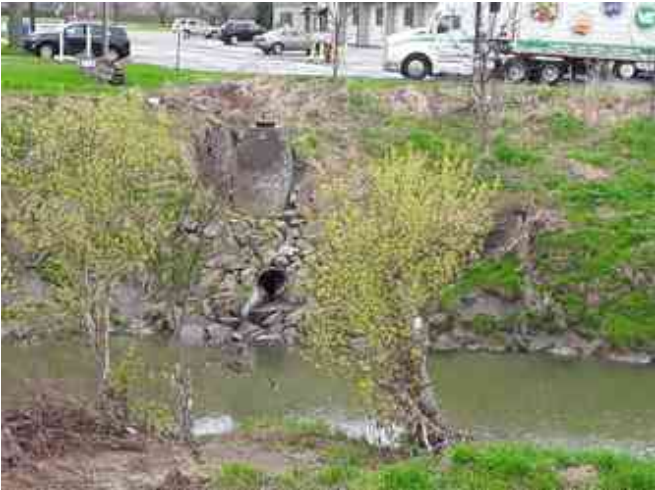
<p>Inspect ID: 2022-0324 Title: 2704000028_CELRE_2022_A_0324_1_20220506T150033.jpg Rated Item: 4. Erosion Caption: Minimally Acceptable - Heavy erosion around manhole</p>

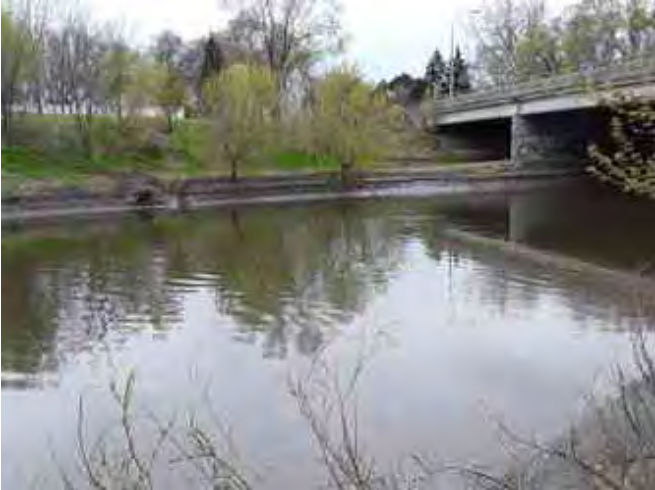
<p>Inspect ID: 2022-0342 Title: 2704000028_CELRE_2022_A_0342_1_20220506T172428.jpg Rated Item: 4. Erosion Caption: Minimally Acceptable - Depression on bank.</p>

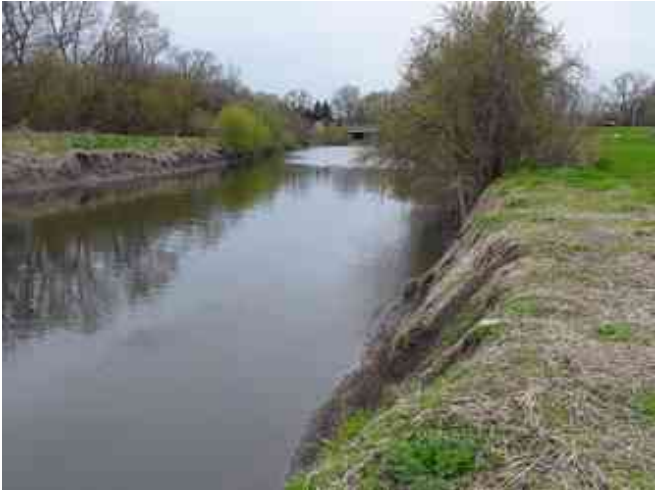
<p>Inspect ID: 2022-0344 Title: 2704000028_CELRE_2022_A_0344_1_20220506T173702.jpg Rated Item: 4. Erosion Caption: Minimally Acceptable - Steep slopes. Bank erosion.</p>

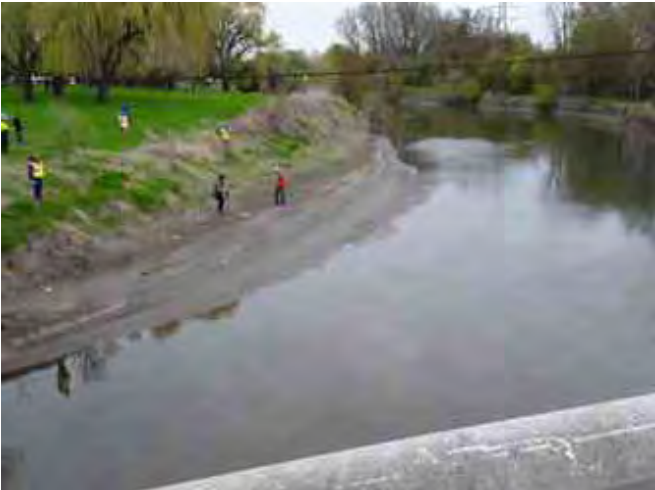
<p>Inspect ID: 2022-0345 Title: 2704000028_CELRE_2022_A_0345_1_20220506T173948.jpg Rated Item: 4. Erosion Caption: Minimally Acceptable - Eroded banks.</p>

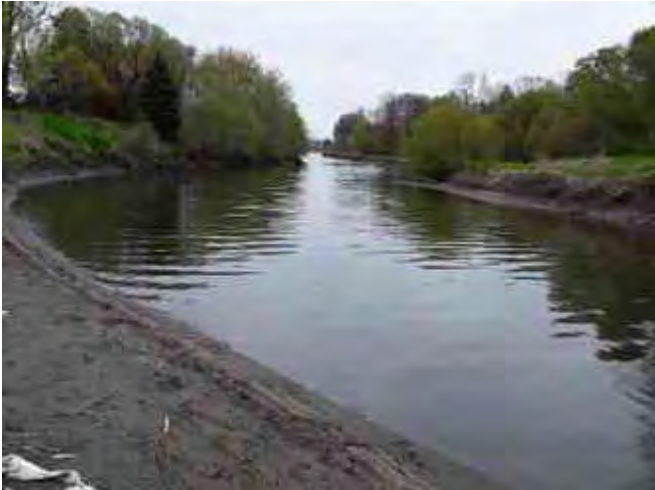
<p>Inspect ID: 2022-0349 Title: 2704000028_CELRE_2022_A_0349_1_20220506T174854.jpg Rated Item: 4. Erosion Caption: Minimally Acceptable - Toe erosion.</p>

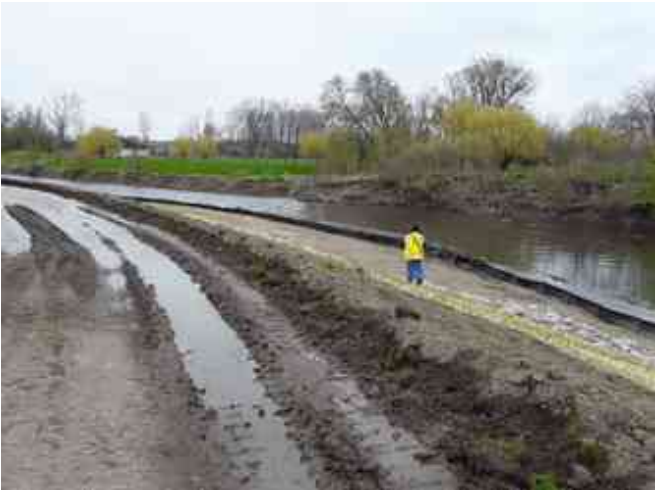
<p>Inspect ID: 2022-0350 Title: 2704000028_CELRE_2022_A_0350_1_20220506T182942.jpg Rated Item: 4. Erosion Caption: Minimally Acceptable - Eroded banks.</p>

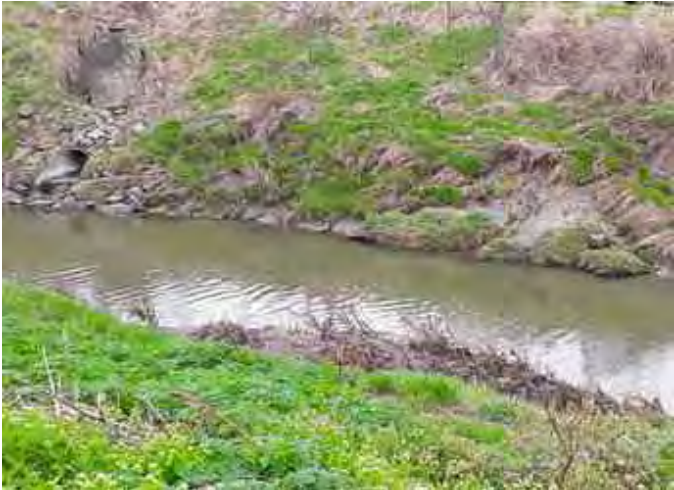
<p>Inspect ID: 2022-0016 Title: 2704000028_CELRE_2022_A_0016_1_20220506T150311.jpg Rated Item: 9. Flap Gates/ Flap Valves/ Pinch Valves Caption: Acceptable - Sediment deposition near left riverbank toe.</p>

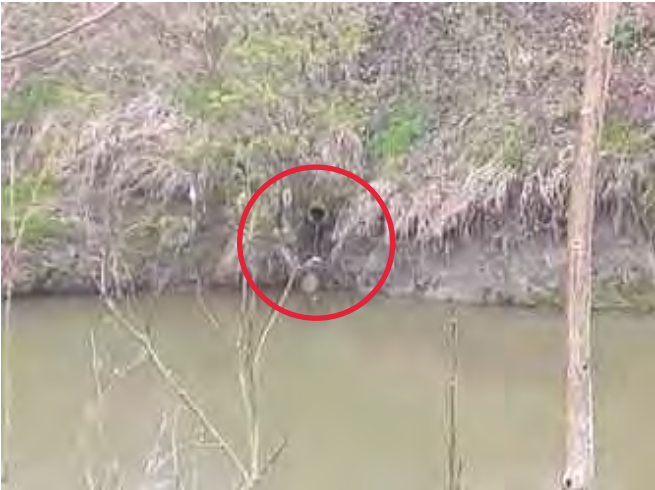
<p>Inspect ID: 2022-0019 Title: 2704000028_CELRE_2022_A_0019_1_20220506T152924.jpg Rated Item: 9. Flap Gates/ Flap Valves/ Pinch Valves Caption: Acceptable - Drain outlet.</p>

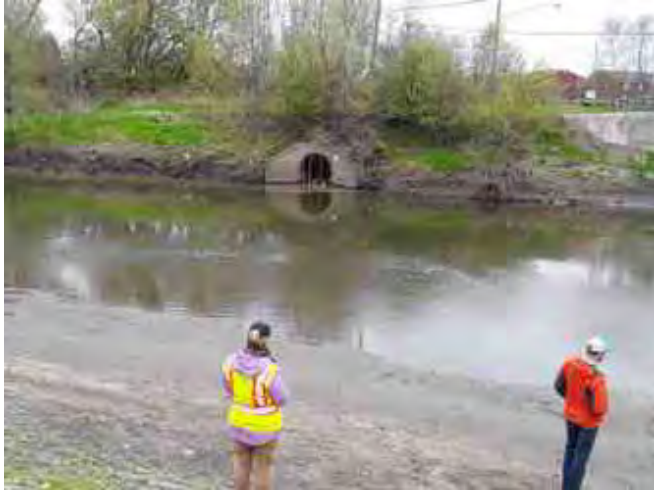
Inspect ID: 2022-0028 **Title:**
2704000028_CELRE_2022_A_0028_1_20220506T174044.jpg
Rated Item: 9. Flap Gates/ Flap Valves/ Pinch Valves
Caption: Acceptable - Outlet location.

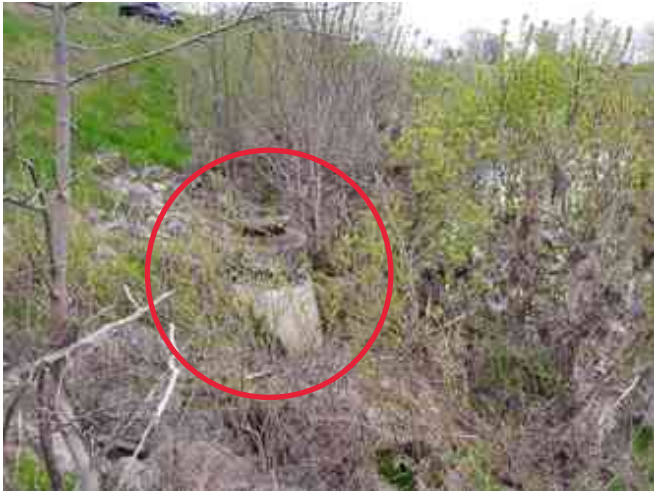
Inspect ID: 2022-0307 **Title:**
2704000028_CELRE_2022_A_0307_1_20220506T135413.jpg
Rated Item: 9. Flap Gates/ Flap Valves/ Pinch Valves
Caption: Acceptable - Manhole location.

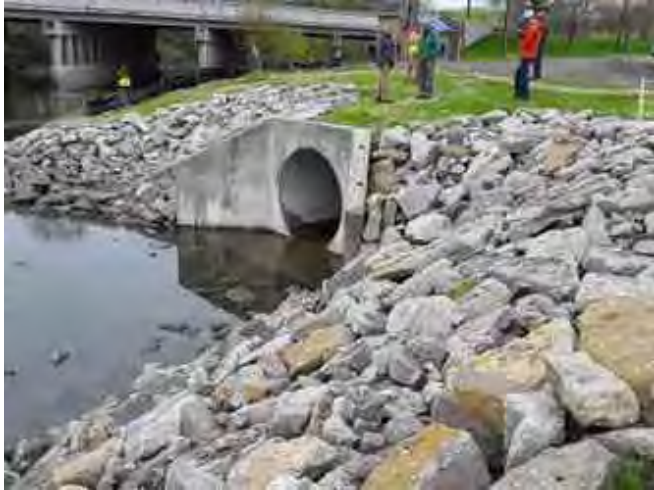
Inspect ID: 2022-0334 **Title:**
2704000028_CELRE_2022_A_0334_1_20220506T164014.jpg
Rated Item: 9. Flap Gates/ Flap Valves/ Pinch Valves
Caption: Acceptable - Outlet location.

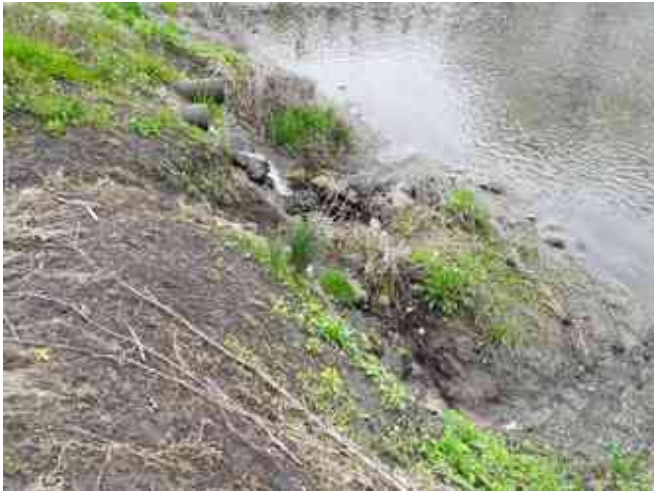
Inspect ID: 2022-0335 **Title:**
2704000028_CELRE_2022_A_0335_1_20220506T164400.jpg
Rated Item: 9. Flap Gates/ Flap Valves/ Pinch Valves
Caption: Minimally Acceptable - Erosion of bank due to drain outlets.

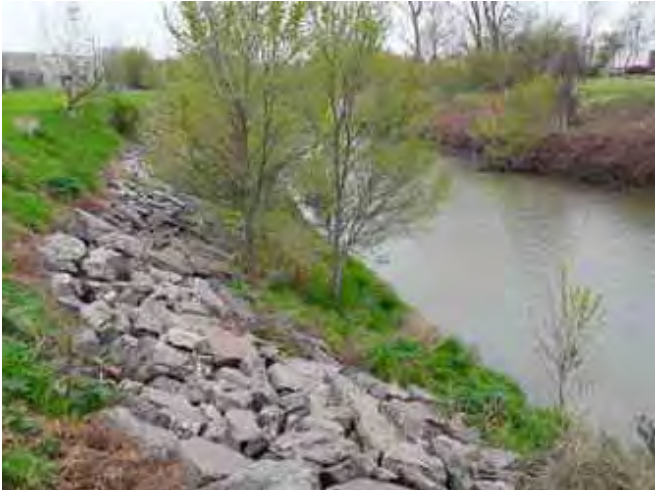
<p>Inspect ID: 2022-0328 Title: 2704000028_CELRE_2022_A_0328_1_20220506T151834.jpg Rated Item: 10. Riprap Revetments & Banks Caption: Minimally Acceptable - Trees in riprap</p>

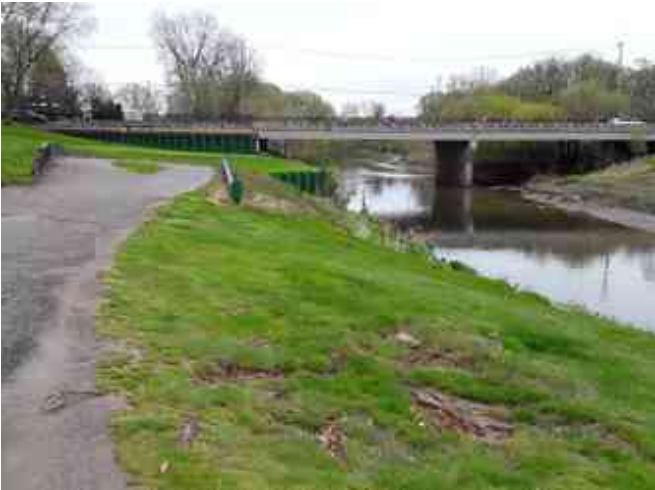
11. Revetments other than Riprap	M	A	Existing revetment protection is properly maintained, undamaged, and clearly visible.	2022-0336 : Steel sheet pile is tilting towards the channel. (M) Justification: Minor tilting of steel sheet pile.
		M	Minor revetment displacement or deterioration that does not pose an immediate threat to the integrity of the levee. Unwanted vegetation must be cleared or sprayed with an appropriate herbicide.	
		U	Significant revetment displacement, deterioration, or exposure of bedding observed. Scour activity is undercutting banks, eroding embankments, or impairing channel flows by causing turbulence or shoaling. Revetment protection is hidden by dense brush and trees.	
		N/A	There are no such revetments protecting this feature of the segment / system.

<p>Inspect ID: 2022-0336 Title: 2704000028_CELRE_2022_A_0336_1_20220506T164546.jpg Rated Item: 11. Revetments other than Riprap Caption: Minimally Acceptable - Steel sheet pile is tilting towards the channel.</p>
