Riparian and Aquatic Habitat Inventory & Management Plan Rouge Green Corridor Urban Habitat Conservation & Stewardship Project

November 28, 2008

ASTI Environmental

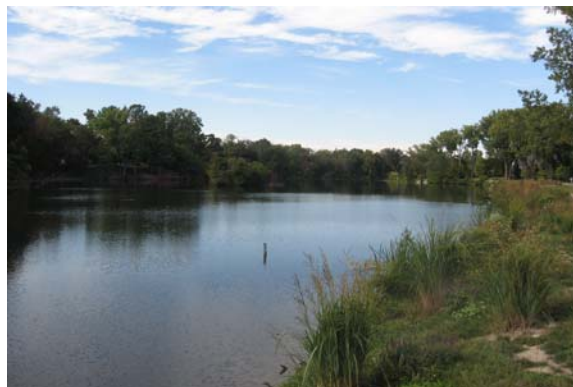
Open water impoundment within Quarton Lake Park.

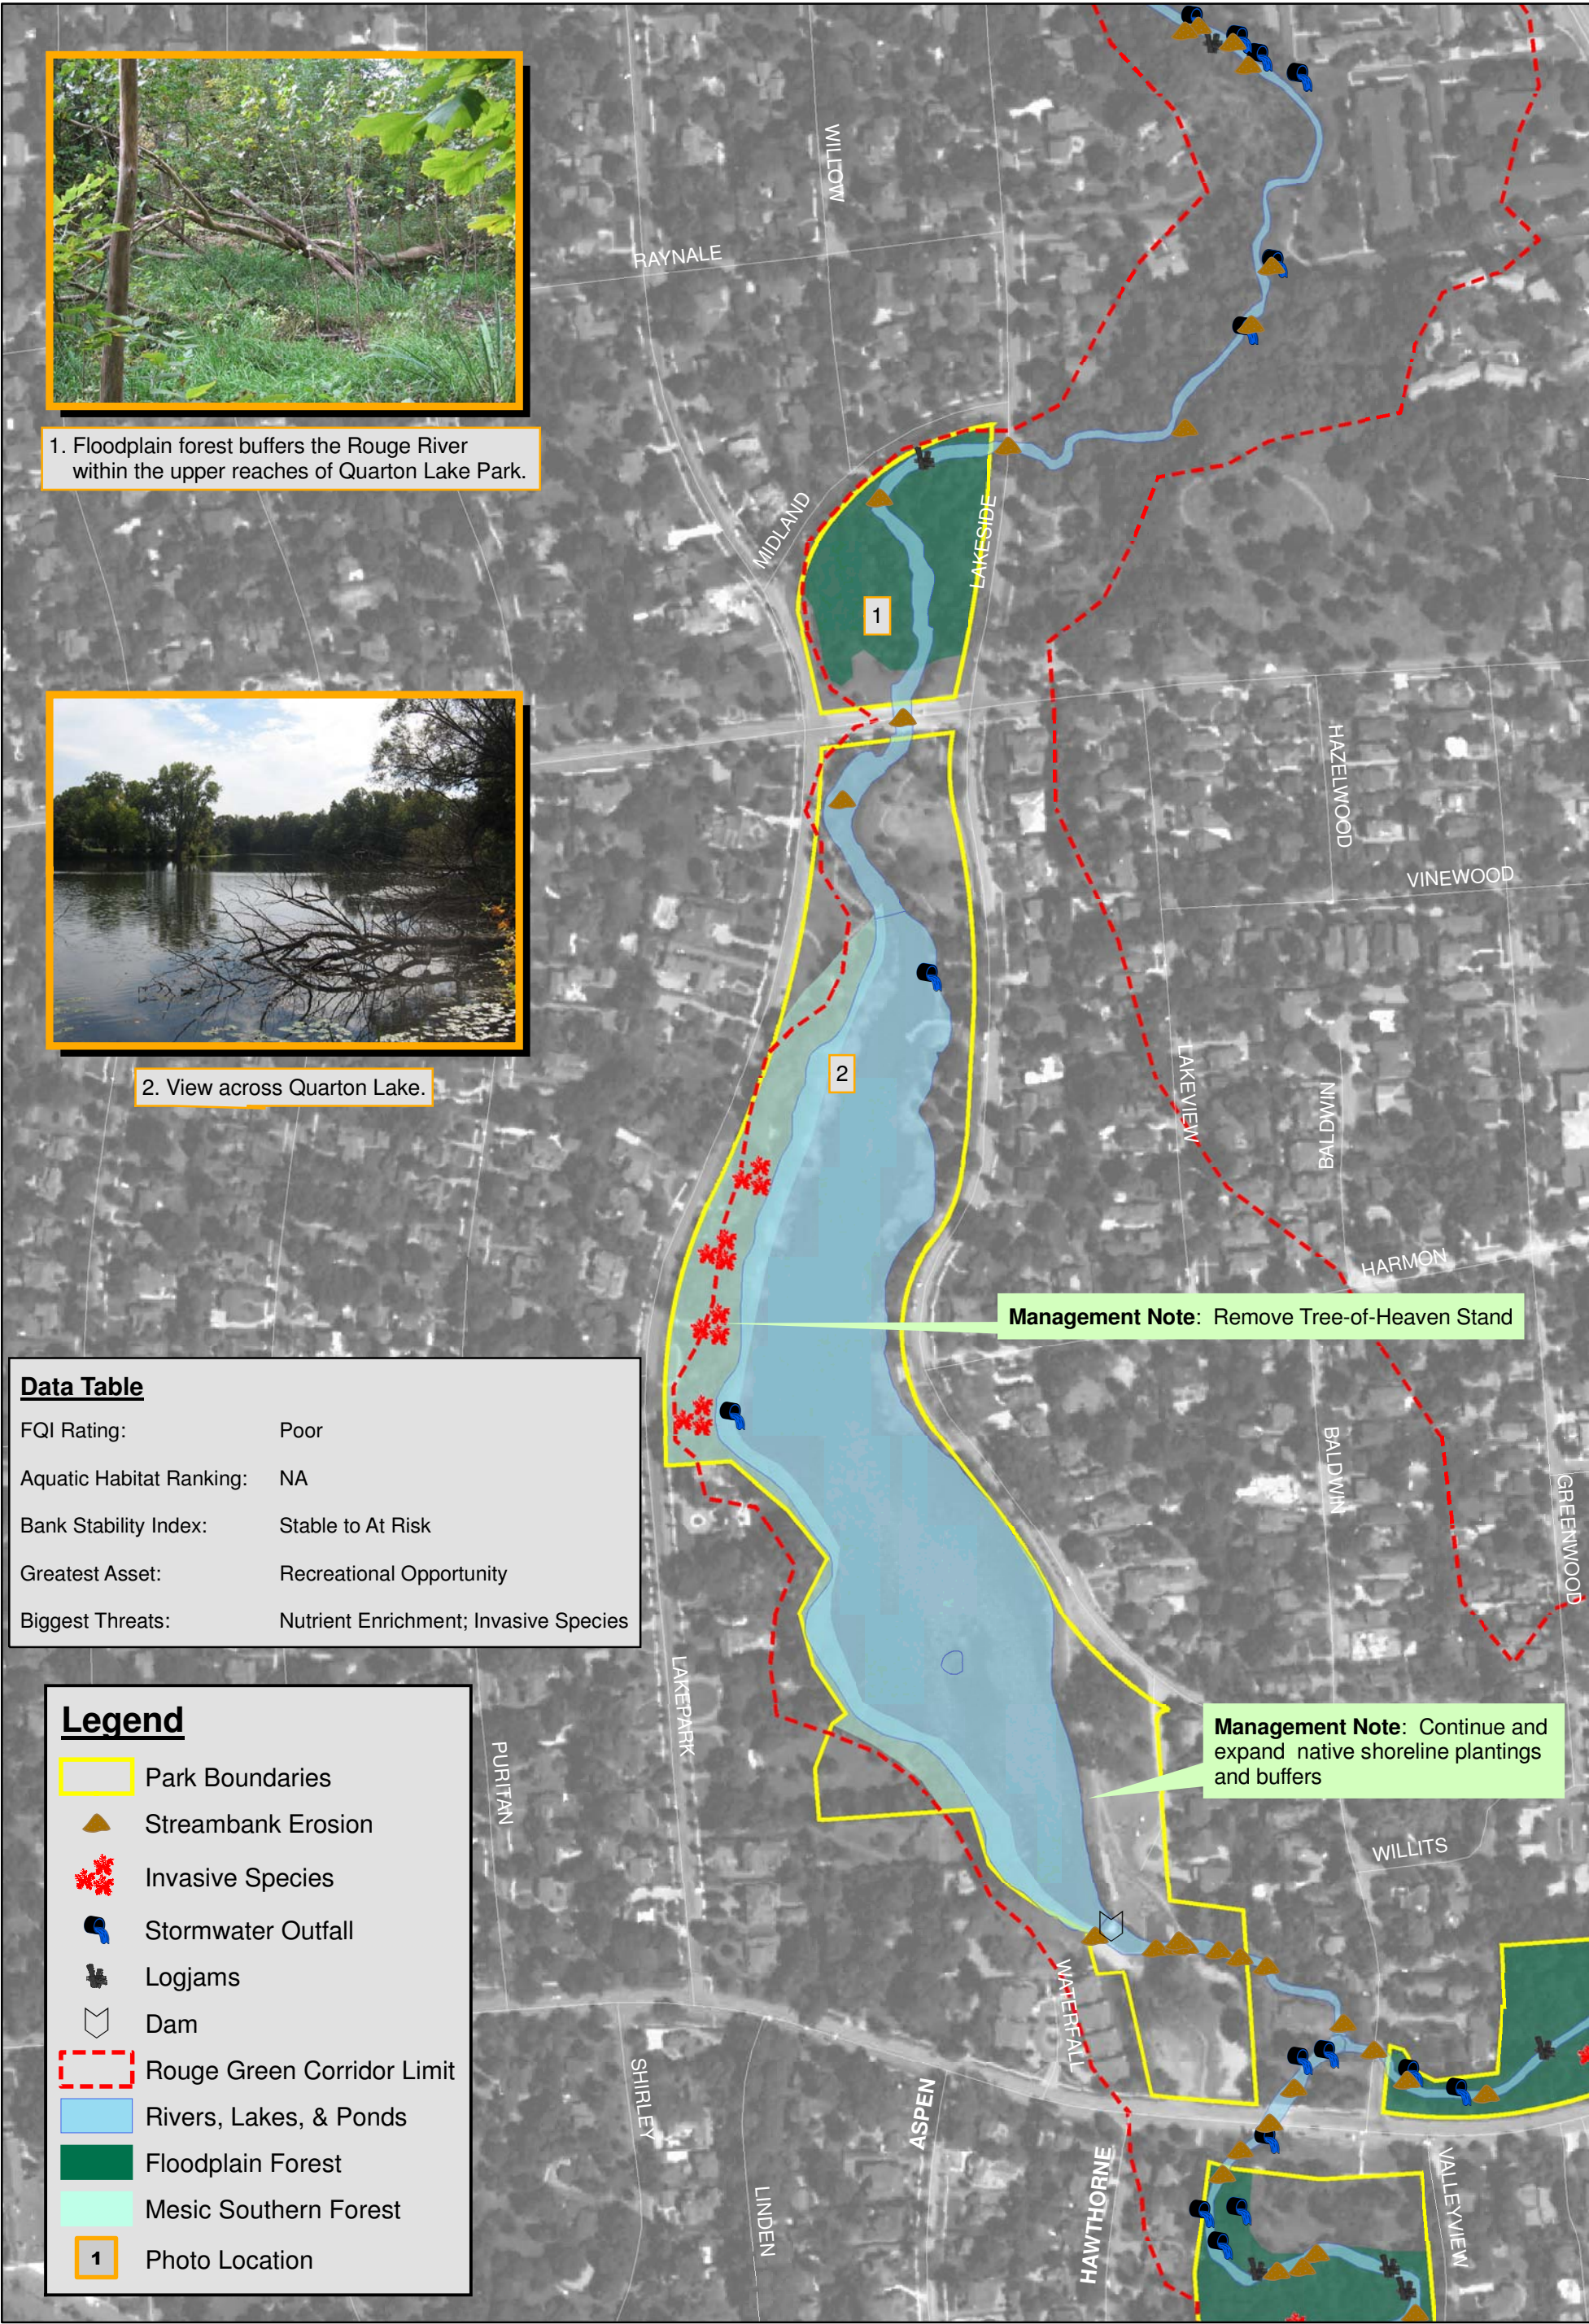
Figure 17 - Park/Preserve: Quarton Lake Park, Birmingham

Quarton Lake Park is 27.6 acres in size, the majority of which is an open-water impoundment of the Rouge River. The immediate shoreline consists of a narrow fringe of emergent vegetation, while the adjacent upland areas are either steep-sloped forested areas bordered by walking paths or mown turf areas with large trees. A few private residences border the lake on the southwestern end where the park boundary corresponds to the shoreline. A small section of Quarton Lake Park that lies north of Oak Road contains relatively undisturbed floodplain forest⁷² (Figure 17).

As stated, this reach of river consists of a shallow impoundment of the Rouge River created by a dam with a stair-like cascade located at the downstream end of the park (Figure 17). Additional spillways to release floodwaters are located immediately east of the dam. Within this impoundment, the flow of water is slowed and in-stream habitat and water quality are affected by the settling of sediment and associated nutrients from upstream and local sources. Quarton Lake does contain hard and coarse substrate types (i.e., cobble, gravel, and sand) that could provide suitable spawning habitat for a variety of fish species, but the majority of the bottom substrate is covered with algae and a layer of fine sediment, which limits its habitat value. Bluegill, other panfish, largemouth bass, and carp were observed within the lake by ASTI and northern pike (*Esox esox*) have been recorded there previously.⁷³

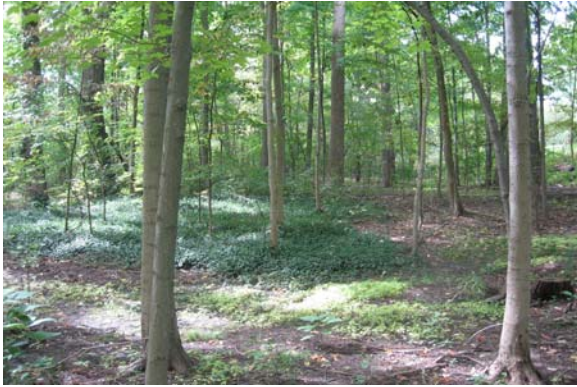
The Booth Park Trail includes 19.6 acres. Habitat at Booth Park Trail is dominated by floodplain forest (Figure 18).⁷⁸ Much of the overstory in this park is relatively intact and includes mature

Floodplain forest within Booth Park Trail.

maples (*Acer* spp.), oaks (*Quercus* spp.), and sycamore (*Platanus occidentalis*). The understory and herbaceous layers are substantially impacted by non-native species; however, some native herbaceous plants and shrubs are still present in certain areas.

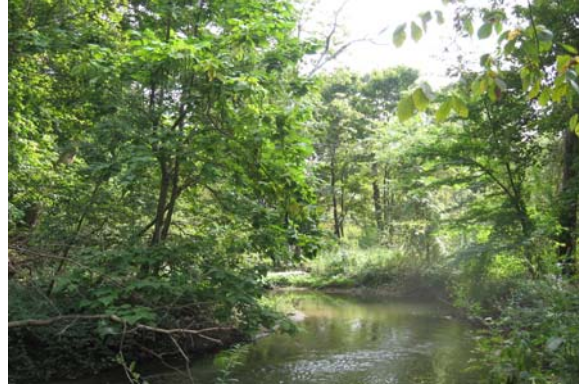
Rouge River winding through floodplain forest within Linden Park Trail.

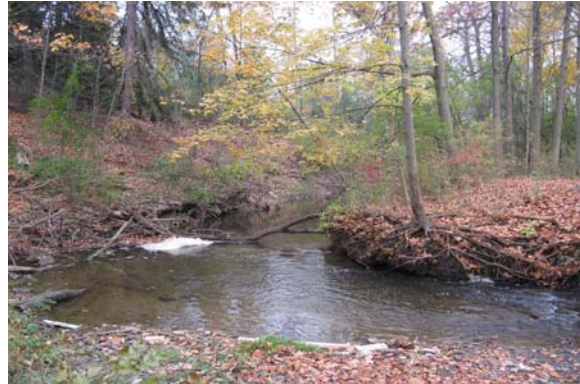
Habitat within this small park consists of a narrow band of low-lying floodplain dominated by eastern cottonwood, box elder, and willow, and small areas of mesic southern forest⁸⁴ dominated by maple and oak tree species higher on surrounding slopes. Other areas are open lawn and the surrounding land use is primarily residential (Figure 20).

Wooded slopes and floodplain forest within Fairway Park.

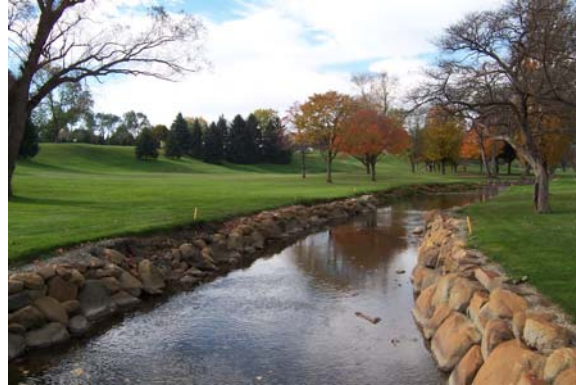
Streambanks at the upper end of this reach have been armored with large boulders, but the banks through much of this stretch are unarmored. Evidence of high water eroding behind these rocks is evident along the left bank (photo, right). Grass-lined banks also exhibit erosion and slumping and some areas of sloughed soil have become established as vegetated islands within the channel.

Stone stabilization and lack of riparian vegetation at Birmingham C.C.

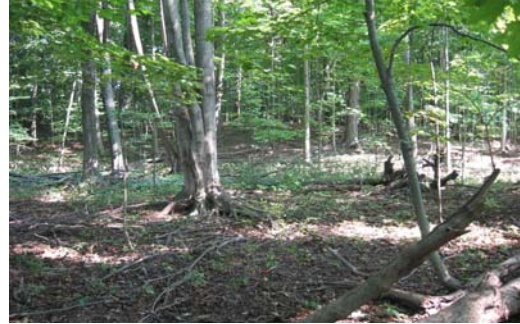
Hidden Rivers Nature Preserve and Riverside Park contain a variety of habitat types within approximately 20 acres. Riverside Park is dominated by an open water impoundment containing a small island of floodplain forest. Hidden Rivers Nature Preserve lies just upstream of the impoundment and contains a variety of branches of the river, oxbow and riverside emergent wetlands, floodplain forest and a small stand of mesic southern forest (Figure 22).

MNFI mesic southern forest near the center of Hidden Rivers.

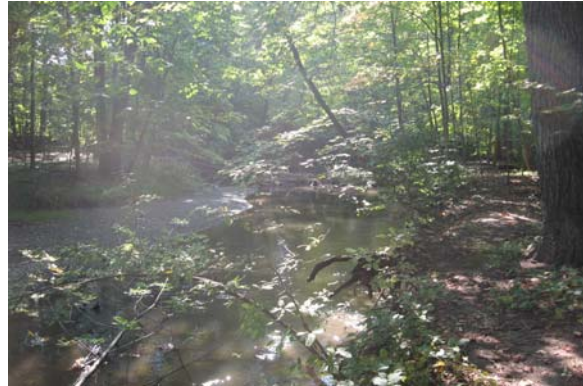
The majority of this 19-acre preserve is a mixture of mature mesic southern forest and floodplain forest (Figure 23). These areas contain several extremely large, mature oaks and a nearly intact overstory. The understory plant community is in places dominated by invasive species, whereas in other areas the native plant community is more intact and represented by several native spring ephemerals and woodland herbaceous plants.

The Rouge River meanders through the Douglas Evans Nature Preserve.

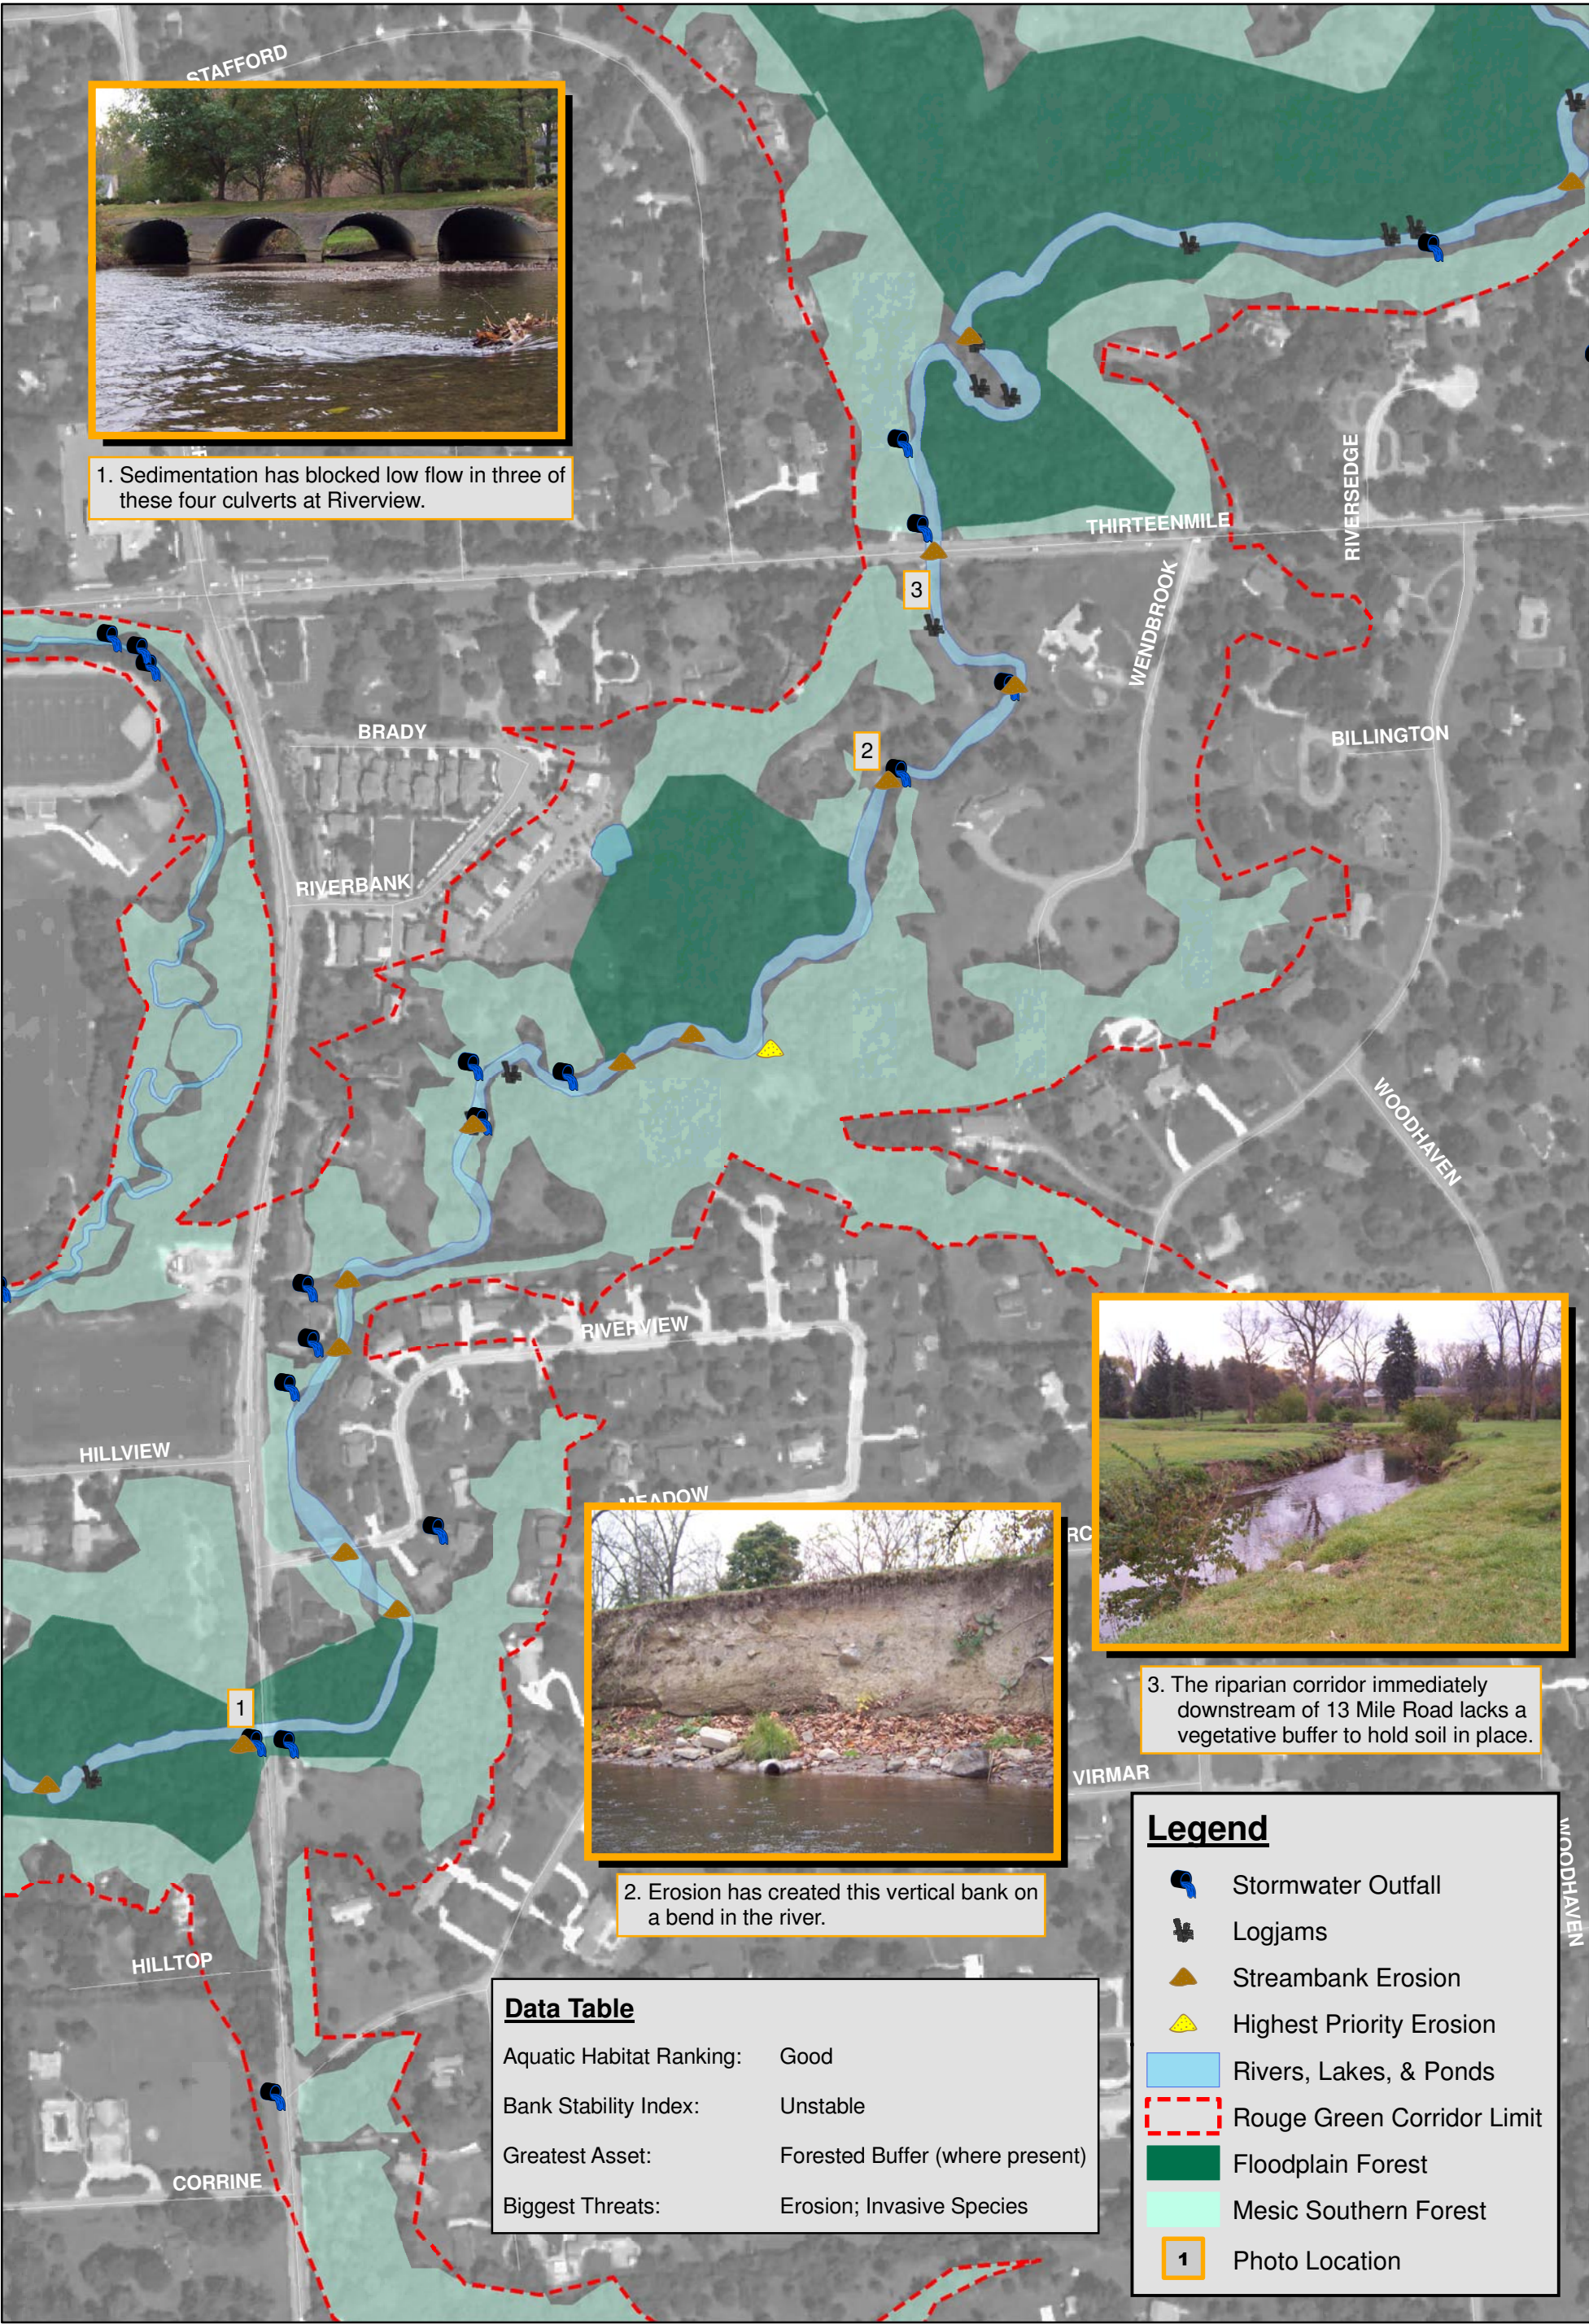
Figure 25 - River Stretch: Thirteen Mile Rd. to Lahser, Beverly Hills

Immediately downstream of 13 Mile Road the riparian corridor (Figure 25) is largely mown lawn with scattered trees and single family housing. A few invasive honeysuckles grow at the streambank along with turf, reed canary grass, and burdock (*Arctium minus*). Areas of bank failure have been treated with lava rock, concrete rip rap, and poured concrete. Approximately 300 feet south of 13 Mile Road the riparian cover changes to floodplain forest. The floodplain forest here is somewhat poor in quality and is dominated by eastern cottonwood, American elm, black willow, red ash, and Norway maple.

The most significant asset of this reach is the forested buffer adjacent to the river in much of this stretch. Yet a vegetated buffer is lacking at the upstream end of this reach and adjacent to scattered residences. Severe erosion threatens in-stream habitat and water quality at several

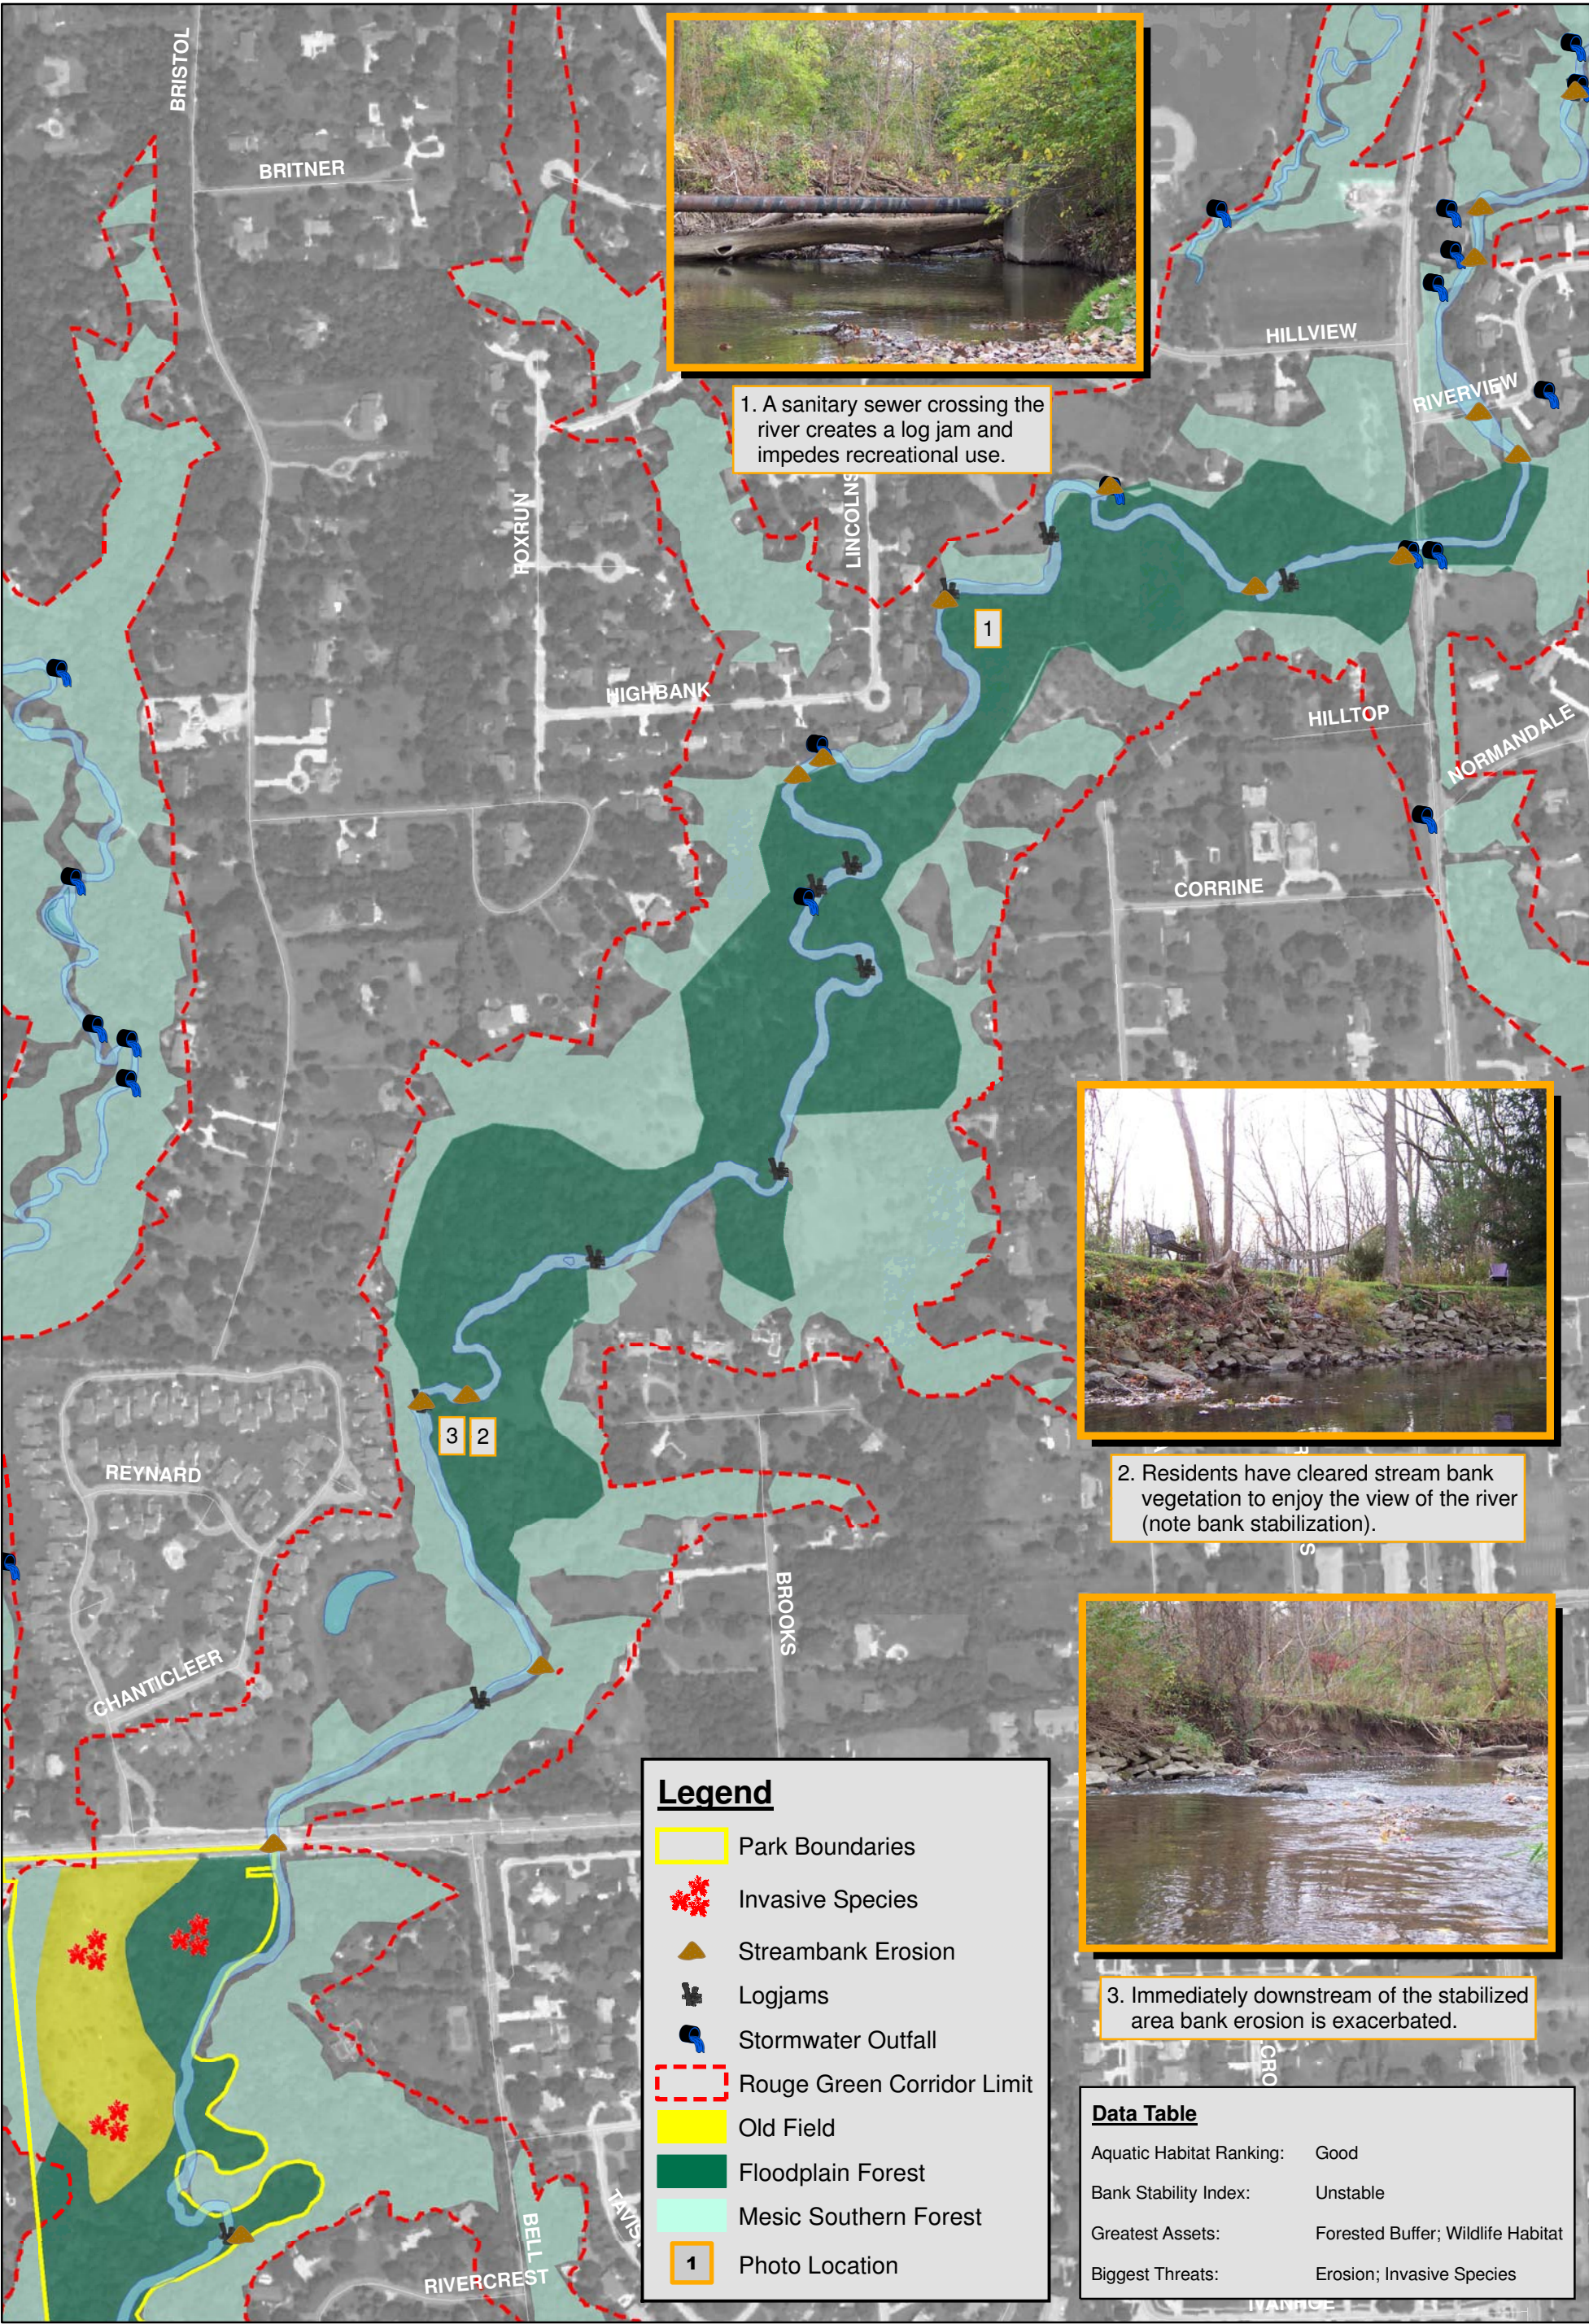
Figure 26 - River Stretch: Lahser to Twelve Mile Rd., Beverly Hills

The riparian corridor in the upper end of this reach is low quality floodplain forest dominated by box elder, eastern cottonwood, American elm, black willow, and red ash (Figure 26). Some areas have been cleared to the river's edge. Some areas of bank erosion have been treated with imbricated, or loosely placed, broken concrete rip rap.

The most significant asset of this reach is the forested buffer to the river and the wildlife habitat it provides. The native plant community is threatened by erosion and invasive forbs and shrubs.

The pipe crossing the river near the intersection of Lincoln and Highbank Streets will continue to capture LWD (photo inset 1, Figure 26) and, as such, restricts paddling access and paddlers are forced to portage on private property. As is, this location will require on-going, perhaps annual log removal if paddling access is to be maintained in this section of the RGC. Alternatives to the current infrastructure may eliminate this LWD collection point.

Recommendation 76: Work with riparian landowner(s) to replace existing riprap with vegetative or more aesthetically pleasing erosion control methods. (see photo insets 2 and 3, Figure 26).

Recommendation 77: Expand existing streambank stabilization area further downstream (likely in different ownership) to capture the section of bank eroded, in part, due to riprap immediately upstream (see photo insets 2 and 3, Figure 26).

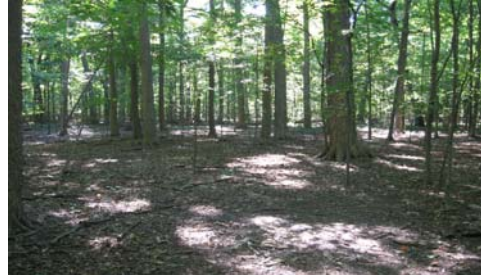
Mature MNFI floodplain forest dominated by maples (*Acer* spp.) within the Berberian parcel of Valley Woods Nature Preserve at Streamwood.

The central (a.k.a. Berberian) parcel of this preserve contains mature, intact floodplain forest, mesic southern hardwood forest, and possible small remnants of dry-mesic southern forest.⁹¹ The lower portions of this parcel are dominated by mature sugar and black maples and likely flood infrequently; although a number of oxbow wetlands probably pool water seasonally.

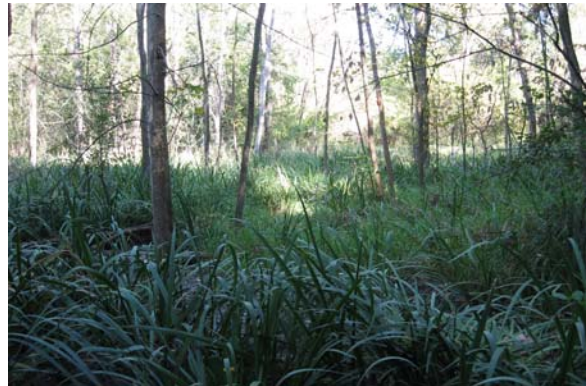
Forested and shrub-carr wetlands are present along the toe of the floodplain slope within Valley Woods Trail at Civic Center.

This park has been historically disturbed by trail building, river channelization, and from fill and debris pushed into the floodplain from outside the current park boundaries. The relatively intact floodplain forest present in parks immediately upstream and downstream of this park is absent here, likely cleared in activities related to this site's history as a mill pond and celery farm.

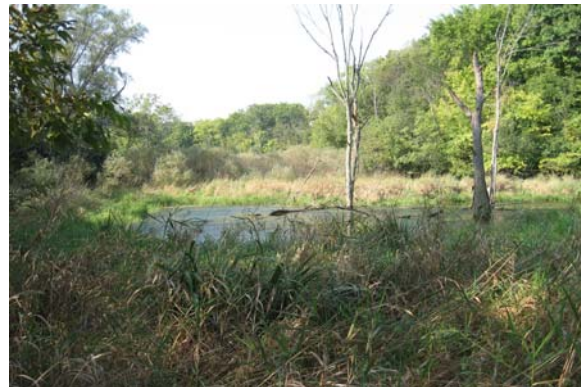
In essence, the existing culverts and shallow ditches which are draining water from the floodplain wetlands into the river channel could be removed or blocked, essentially pooling and storing rainfall and storm water from neighboring streets and properties within the wetland areas rather than having it flow more-or-less directly into the river channel. Additionally, rock-armored inlets could be placed within the spoils banks at the upstream and downstream ends of the park allowing and encouraging floodwaters from the river to over-top and flood the wetland areas, thus providing additional floodwater storage within the RGC. These wetland enhancements would also have many other side-benefits, including improved wildlife habitat, aesthetic values, and deeper water levels that may discourage many of the invasive wetland plants currently present.

Valley Woods Nature Preserve at 10 Mile Road contains a variety of wetland habitat types, including emergent wetland.

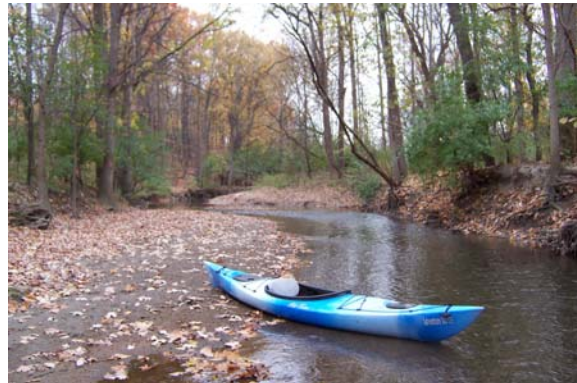
Characteristic view of the Rouge River channel at Valley Woods Preserve at 10 Mile Road.

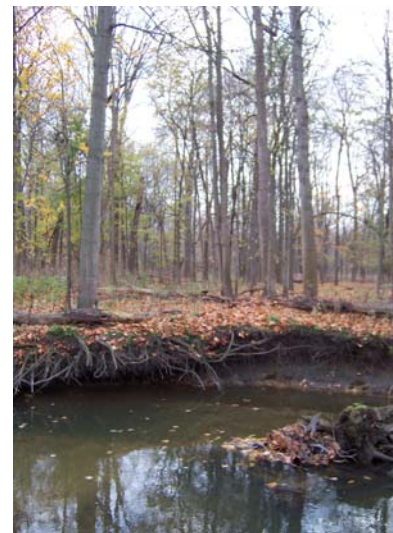
Erosion is prevalent and severe on outside bends throughout most of this reach, but the banks are seemingly more cohesive than in many areas upstream

Although still exhibiting significant bank erosion, cohesive soils provide overhanging cover for fish.

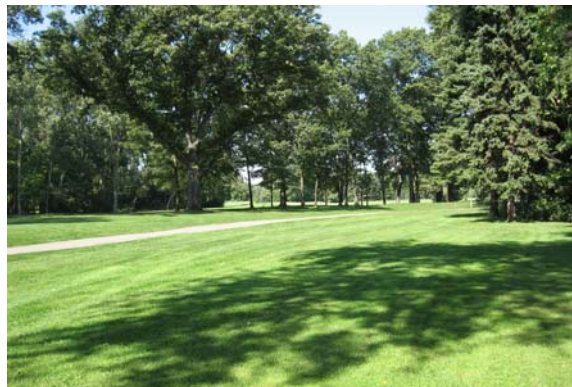
The 86-acre Beech Woods Park is comprised almost entirely of golf course fairways, greens, and associated structures. Natural habitat is limited to the river and a few areas of mature mesic southern forest. A number of scattered mature trees are located in turf areas, and there are two man-made ponds on the property (Figure 33).

Mature trees line the fairways of Beech Woods Park.

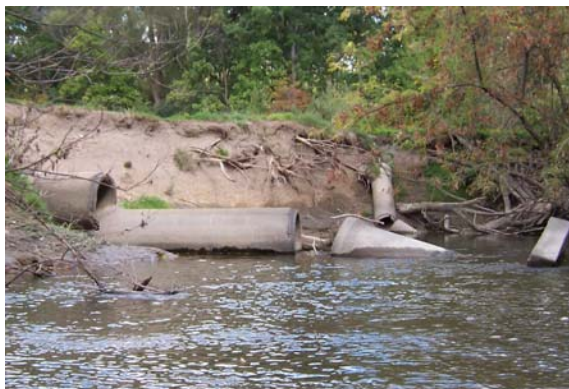
Although erosion is relatively severe throughout this reach, it is in these meanders where bank erosion is most prominent. Along the westernmost meander (Figure 20) the outside bank along the golf course is nearly vertical, extending 4-6 feet above the water. A concrete storm sewer pipe and headwall have broken off due to the erosion and have fallen into the river channel at this point (accompanying photo). High flows bypass a logjam at the upstream end of this same meander, and it appears that the river will soon cut off the meander to create a braided channel or oxbow at this point. The riparian corridor is wooded on both sides throughout most of this reach, but is only 4-feet wide at the golf course meander. Erosion on the outside of that meander has cut the bank back to the golf course turf.

Eroded storm pipe, headwall, and bank at Beech Woods Park

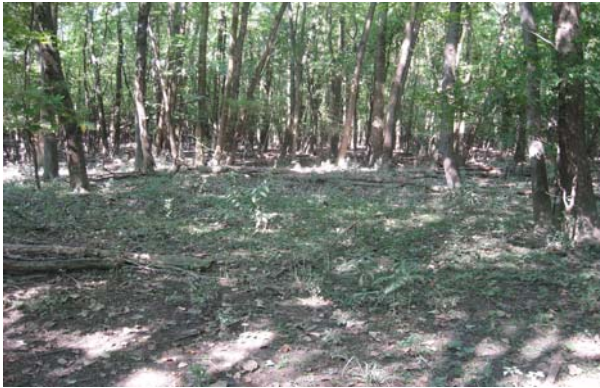
Young floodplain forest within Valley Woods Nature Preserve South

The 24-acre Valley Woods Preserve South is located at the downstream end of the RGC, bound on the south by 8 Mile Road and bisected by Bridge Road (Figure 35). Habitat within the preserve is primarily floodplain forest⁹⁶ associated with the Rouge River. These floodplain forests are dominated by silver maple, red maple, eastern cottonwood, and elm. Other tree species observed include American basswood, black willow, box elder, northern catalpa, and hawthorn (*Crataegus* spp.) Elsewhere within the preserve, there are isolated areas of upland forest on the slopes leading out of
