Bald Eagle Lake Drain

Condition Assessment Report
Prepared By: Geoff S. Wilson, P.E.

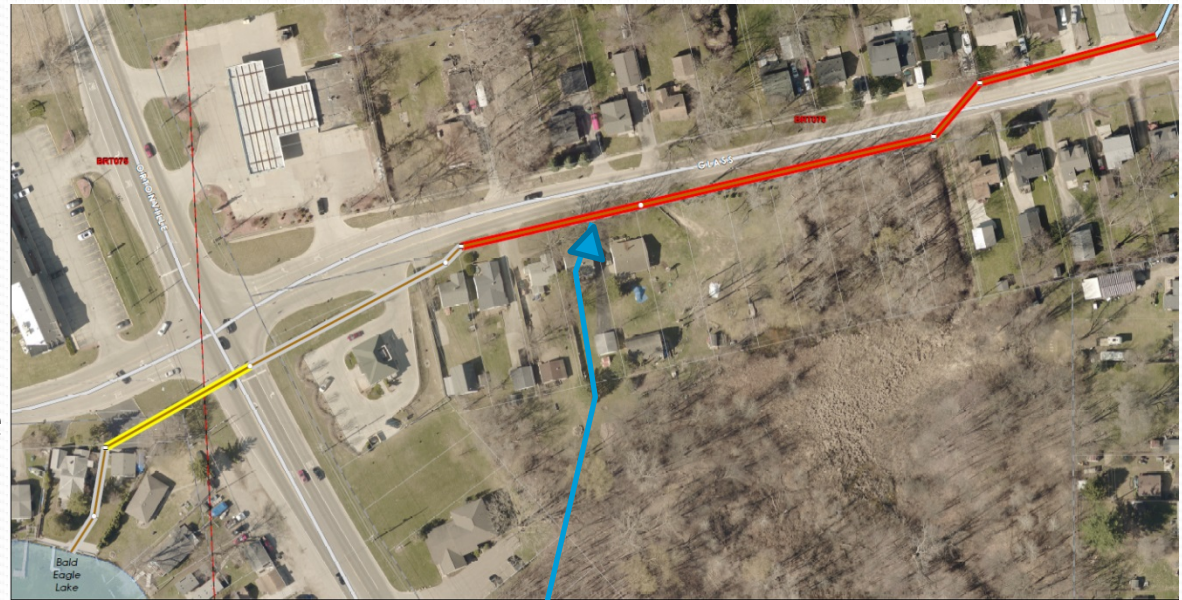
- Typical conditions include corroded metal and small but frequent holes and voids in the pipe.
- Once holes and voids are present, conditions deteriorate rapidly and sinkholes begin to form.
- Sinkholes are expensive to fix and risk property and utility damage.
